Safety Alert

ALERT 15-03

Lifeboat Unintentionally Released Results in Two Fatalities

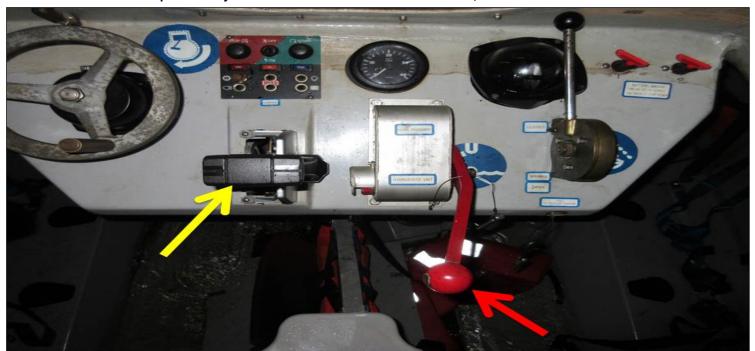
Photo of lifeboat's control panel - the yellow arrow indicates the lifeboat's throttle, & the red arrow indicates its release lever.
