Safety Alert

ALERT 15 - 05

RWC - SMASHED FINGER ON TONGS

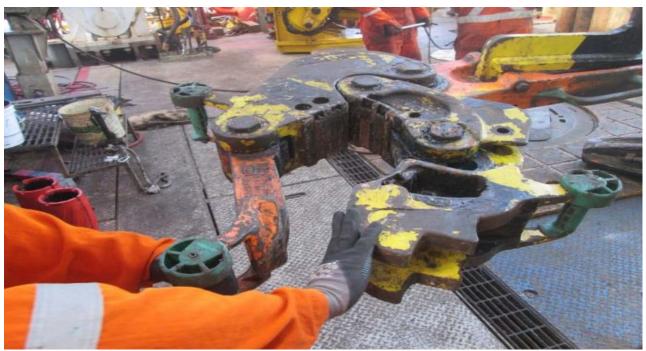
While tripping 5 7/8" drill pipe stands out of the hole, the Injured Person (IP) smashed his finger between the tong latch jaw handle and the tong latch lug jaw. The IP was in the process of helping the tong operator remove the tong from its position onto the drill string. The IP placed his left hand on the latch jaw handle and his right hand on the latch lug jaw when his finger was smashed. IP was taken to the onshore clinic where it was diagnosed that he had multiple fractures on his right ring finger.

- •Usually, the iron roughneck would be used for this operation. The iron roughneck was out of service at the time of incident.
- •No Job Hazard Analysis (JHA) had been performed as Tripping out of the hole was thought of as a "Routine Task".
- •The tongs were in a position where the Driller had no direct line of site. This prevented him from being able to supervise all aspects of the task.
- •Failure to follow standard: The Injured Person (IP) did not make use of the green handles supplied on the tong as per HSM-2-STD-045, Personal Protective Equipment (PPE) Standard

Hand in wrong position

- •Job Hazard Analysis (JHA) to be written and reviewed prior to all Tripping Operations.
- •Spare parts for iron roughneck should be kept on hand for any repairs that may be needed.
- •Holding position of the tongs should be in view of the Driller, so he can effectively supervise the task.
- •All Drill Floor equipment purposely have green handles on them for manual use. All drilling equipment should only be touched where there are green handles. "Green on Green" (Green gloves on green handles)
