Safety Alert

From the International Association of Drilling Contractors

ALERT 15 - 10

FATALITY ON DRILL FLOOR

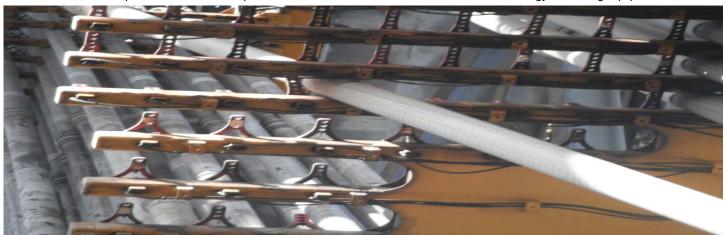
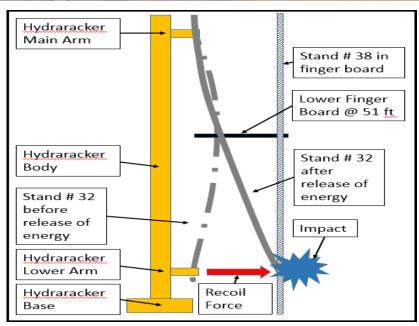
A drill crew was in the process of running a 36" casing string on a 6 5/8" landing string. They had run 31 stands of 6 5/8" landing string with no problems. The hydraracker (HR) was positioned and latched onto stand 32. After getting verbal confirmation from the spotter that the finger latches were open, the HR operator attempted to remove stand 32 from the finger boards. The stand was retracted towards the HR but got blocked by a finger on the lower finger board. See photo below. The HR operator continued to retract the HR arms. With all 3 arms in a retracted position and the stand still held firm behind the finger latch, energy became built up in the stand. This energy was suddenly released when the latches of the HR lower tailing arm could no longer withstand the forces, allowing the stand to recoil back towards the setback area, striking the IP who was engaged in the operation and unaware that he had placed himself in the line of fire. See diagram below. His injuries were immediate and fatal.

All Rigs to review this alert with crew members at pre-tours and weekly safety meetings and include discussions regarding line of fire hazards (especially as related to the release of stored energy).

All Rigs to verify that when performing similar operations, the opening and closure of fingers in the finger board is being observed and communicated, from a position that avoids exposure to line of fire of a sudden release of stored energy or moving equipment.
