Deepwater Horizon Accident Investigation Report

September 8, 2010

Analysis 5A. Well Integrity Was Not Established or Failed

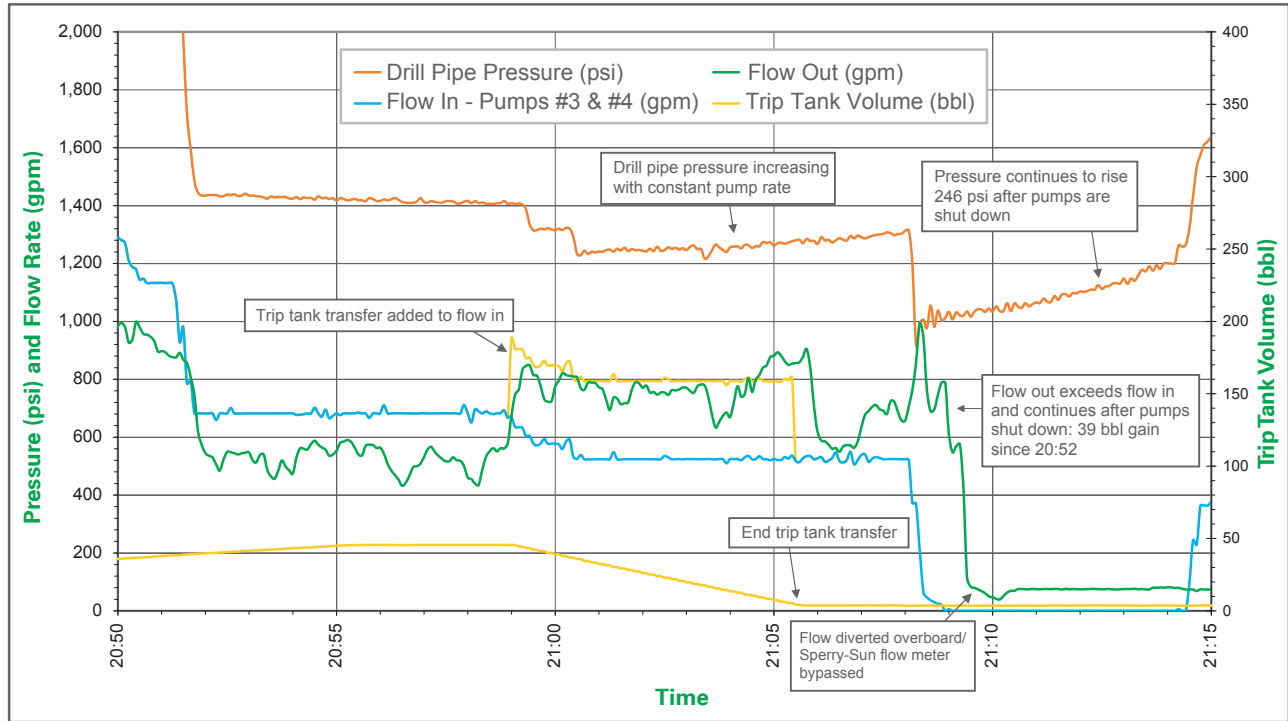
Figure 8. Flow Indication Graph Showing Anomalies (Real-time Data).

The first indication of flow likely would have been at 20:58 hours, but emptying of the trip tank could have masked this flow indication in the real-time data. The pressure abnormality starting at 21:01 hours would have been the first clear indication of flow visible to the rig crew and mudloggers.

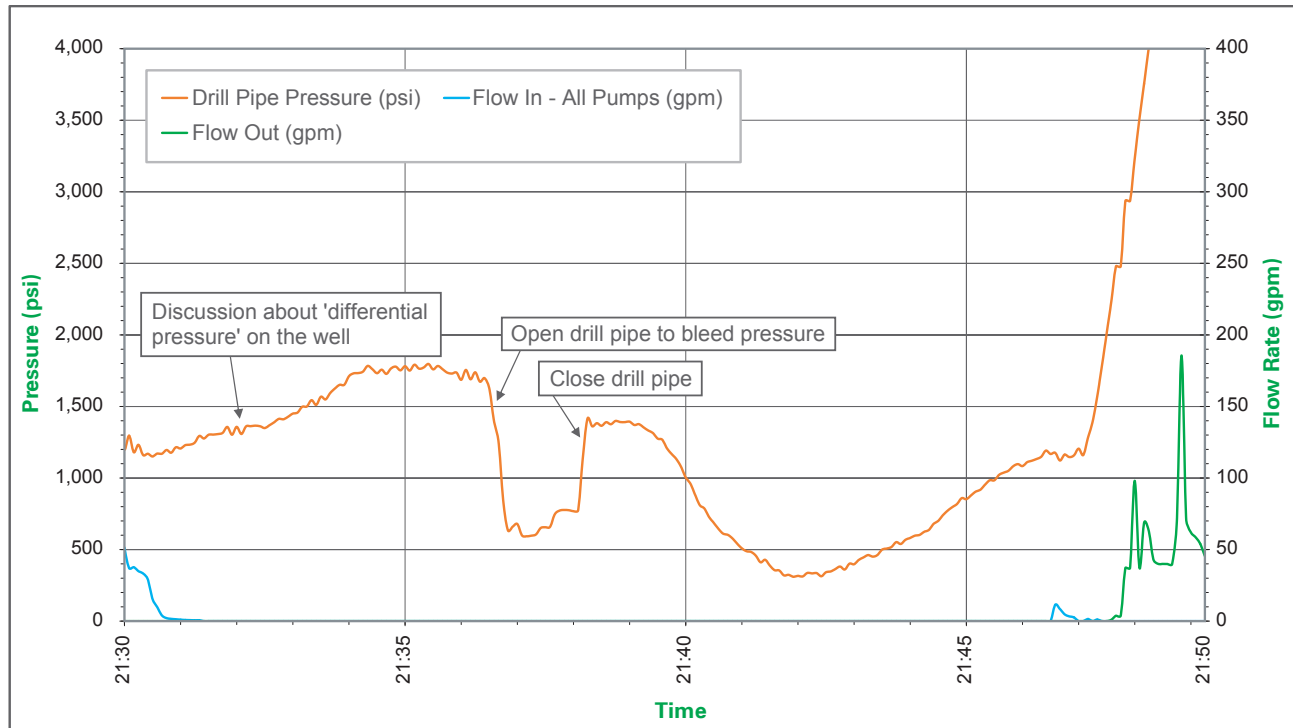
Figure 15. Investigation of Pressure Responses After Shutting Down Pumps (Real-time Data).

- The sudden pressure changes between 21:36 hours and 21:38 hours were indicative of a bleed-off at the surface. Modeling supported the bleeding of the drill pipe at the surface through a 4 in. surface line as the likely action taken at this time because the pressure response is immediate. (Refer to Figure 15.) A pressure transient caused by a pressure drop deep within the well would have been indicated by a slower pressure change on the real-time data.

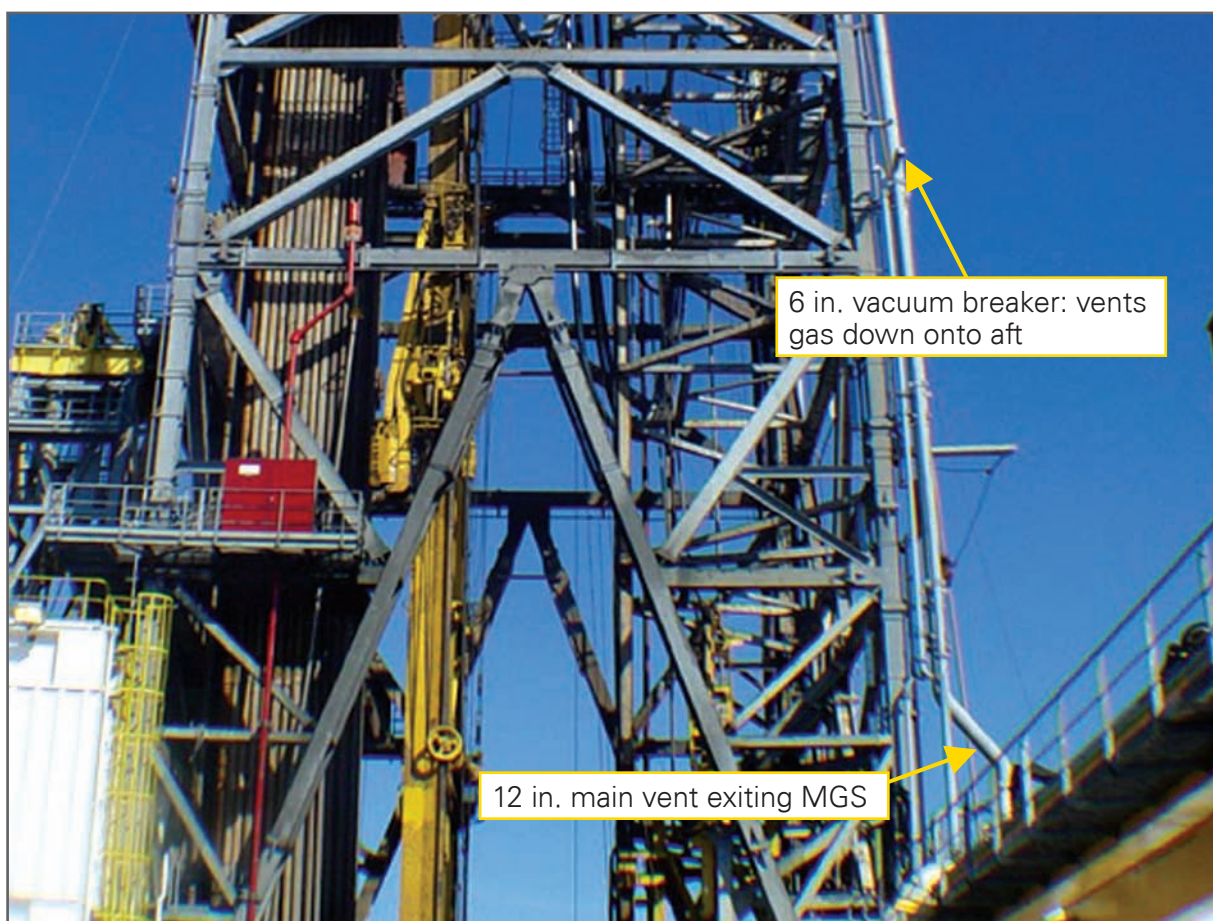
Figure 5. Photograph of 6 in. Vacuum Breaker Line Gooseneck Vent.

6 Diversion to the mud gas separator resulted in gas venting onto the rig. Once diverted to the MGS, hydrocarbons were vented directly onto the rig through the 12 in. goosenecked vent exiting the MGS, and other flow-lines also directed gas onto the rig. This increased the potential for the gas to reach an ignition source. *The design of the MGS system allowed diversion of the riser contents to the MGS vessel although the well was in a high flow condition. This overwhelmed the MGS system.*
