# REPUBLIC OF THE MARSHALL ISLANDS

## DEEPWATER HORIZON MARINE CASUALTY INVESTIGATION REPORT

Official Number: 2213

IMO Number: 8764597

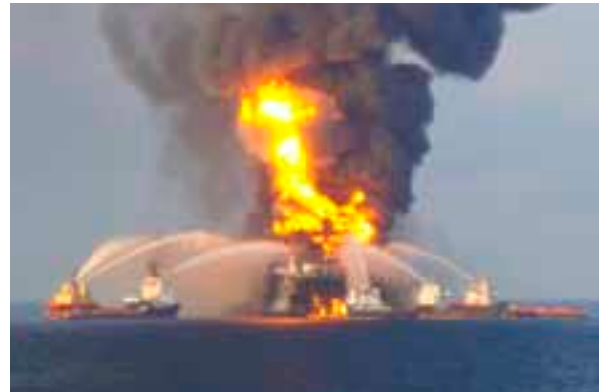
- 3.62 The DEEPWATER HORIZON capsized and sank approximately 36 hours after the ignition occurred. It is probable that decks, bulkheads, ventilators, and weather/water tight doors and windows were damaged and or distorted by falling debris and heat providing paths for fluids to flow below deck. The damage caused by the falling derrick increased the probability that the fluids collected in the Sack Room, causing the Unit to heel to starboard. Once the heel to starboard was established, the flow of fluid continued to favor the starboard side and collect in any accessible space. Once the heel had increased to the point of deck edge immersion, other openings, which would normally be well away from the water, were submerged under the sea's surface and flooding accelerated.
