US CHEMICAL SAFETY AND HAZARD INVESTIGATION BOARD

INVESTIGATION REPORT VOLUME 1

EXPLOSION AND FIRE AT THE **MACONDO WELL** (11 Fatalities, 17 Injured, and Serious Environmental Damage)

REPORT NO. 2010-10-I-OS

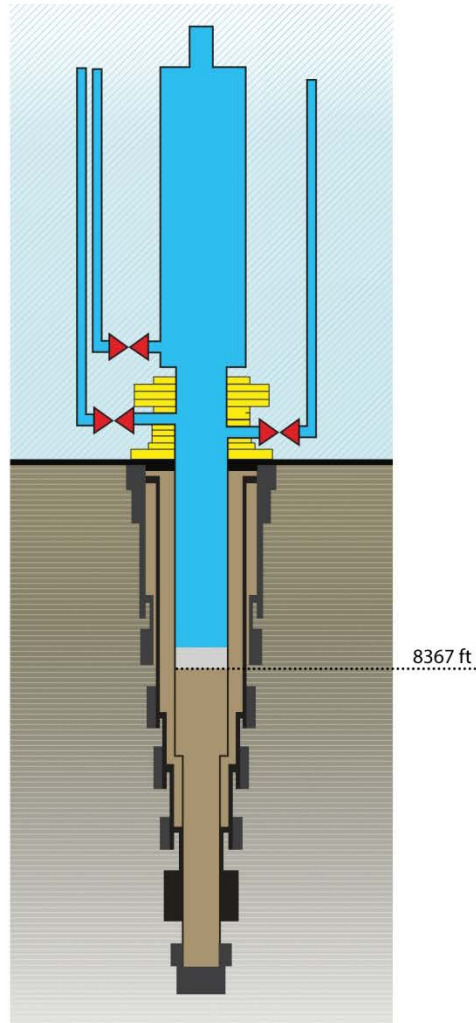
Figure 2-4. The final Temporary Abandonment configuration intended to remove drilling mud down to 8,367 feet to install a cement plug in seawater.

The process of preparing the well so that the drilling rig can depart until another rig or production facility returns is called temporary abandonment. For temporary abandonment to occur, the well needs to be sealed; until it is, the hazards of a well kick and blowout are still very real. US regulations require cement to be placed at the bottom of the well and the installation of a surface “retrievable or a permanent-type bridge plug or a cement plug at least 100 feet long in the inner-most casing” with the top of the plug required to be “no more than 1,000 feet below the mud line [sea floor]”⁴⁶ unless the company seeks approval for an alternative plan from the regulator.⁴⁷ At Macondo, BP gained approval to set a surface plug at approximately 3,000 feet below the seafloor.^{a,48} In its request, BP acknowledged this was a deep surface plug and stated it planned to extend the surface plug length to 300 feet rather than the minimum requirement of 100 feet “to compensate for the added setting depth.”⁴⁹ In addition to choosing the deep placement of the surface plug, BP also decided to set the surface plug in seawater rather than drilling mud.^b (Figure 2-4).

To prepare for the negative pressure test at Macondo, a drillpipe was lowered to the depth identified for the bottom of the cement plug (Figure 2-4). A viscous and dense water-based Loss Circulation Material (LCM) followed by seawater was pumped down the drillpipe to displace the mud by pushing it above the BOP toward the rig.^e After stopping displacement and closing the BOP,^f the crew observed the pressures and/or flow from the well four times over three hours.^g Each time, they observed unexpected results, so

they made adjustments before deeming the well passed the final test. The crew's actions suggest they did not realize that the unexpected readings were indications of a failed negative pressure test and that integrity of the cement had not been secured. (See Appendix 2-A for details.)

After the final negative pressure test was erroneously accepted as a "pass," the Deepwater Horizon crew continued the process of displacement, replacing the drilling mud in the wellbore and riser with seawater in preparation to set the surface plug. Replacing dense drilling mud with seawater had the effect of lowering the hydrostatic pressure on the bottom of the well. With the fluid column removed and no surface plug yet set, the only means left for preventing the hydrocarbons from entering the riser and eventually making their way up the well to the rig was detection of the kick by the crew and manual activation of blowout prevention equipment to seal the well.^a

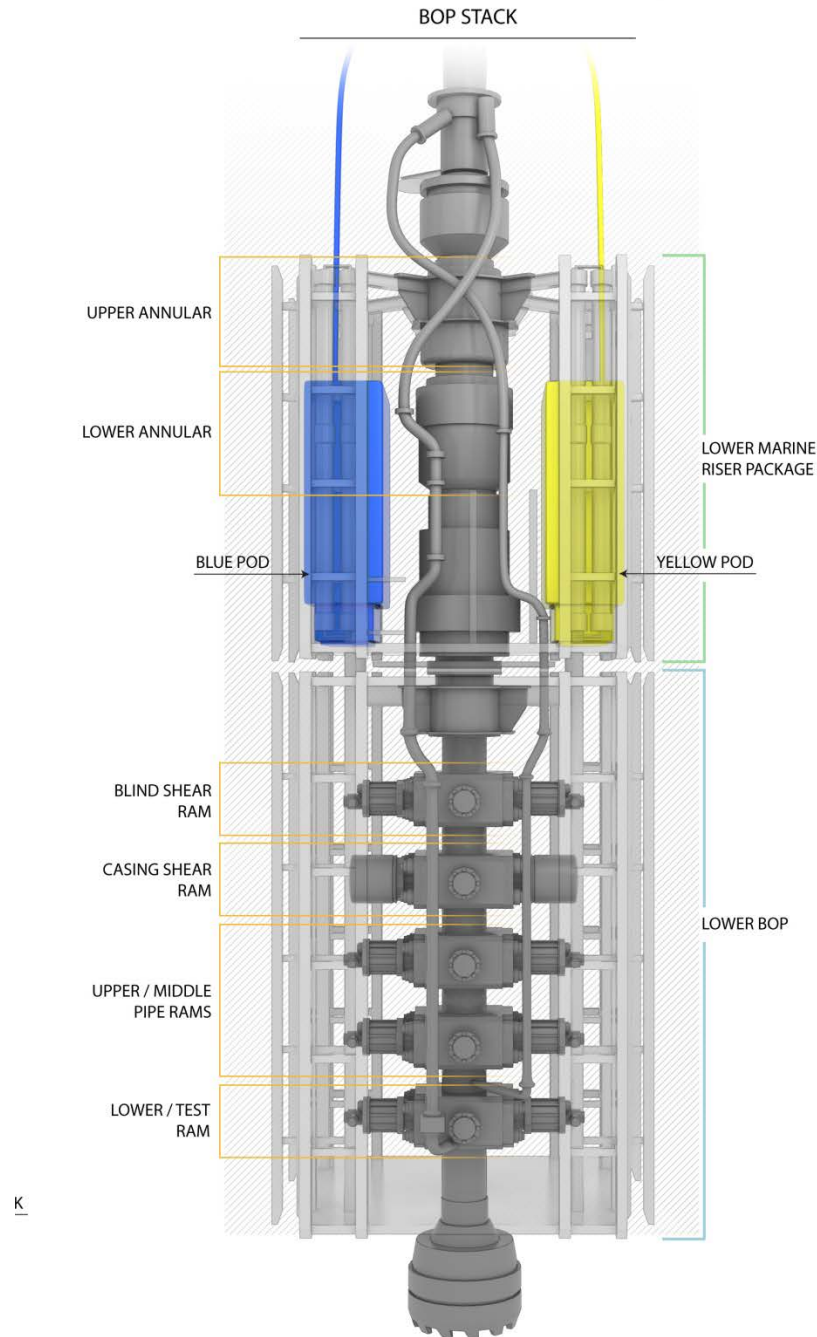
Figure 2-5. The Deepwater Horizon BOP

When drilling mud and hydrocarbons began pouring out of the well and onto the Deepwater Horizon, the drilling crew activated a component called an annular preventer, which should have sealed the space around the drillpipe and prevented further hydrocarbons from rising above the BOP.^a However, well data indicate that this component failed to seal the well.^b Not only did the riser fluids—the hydrocarbons, drilling mud and seawater—that already passed above the BOP continue to travel up the riser and release onto the rig floor, but the riser was also being replenished by the flow of even more hydrocarbons through the leaking component.

Pressure data^c indicate that the crew closed at least one additional sealing component of the BOP called a pipe ram, which successfully shut in the well but caused the pressure in the drillpipe to build substantially as evidenced by the surface drillpipe pressure building. (See Volume 2, Section 2.3 for details.) Riser fluids above the BOP continued to unload onto the rig floor, but their replenishment temporarily ceased. About two minutes later, the first explosions occurred on the rig and data transmission from the rig to shore ceased.

The explosion likely activated the AMF/deadman automatic emergency response system. This system was meant to shear the drillpipe and seal the well, but as evident from the major oil spill that ensued, the well remained unsealed. The likely activation of the AMF/deadman system and the failure of the BOP to seal the well is discussed in detail in Volume 2 (Chapter 3) of the CSB Macondo Investigation Report.
