Alert 6-17 Offshore Crane Operator Falls through Dislodged Grating

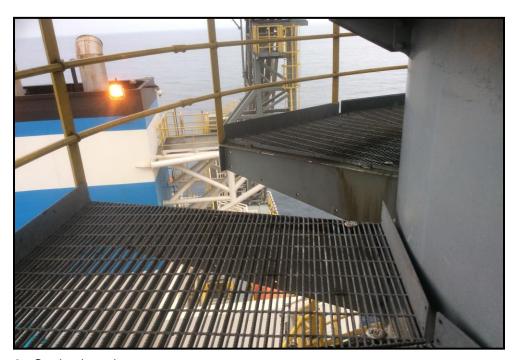
2. Grating Location

Once the upper limit was reset by the Electronic Technician, the Crane Operator was able to park the crane in the boom rest and exit the crane cabin to start inspecting the upper crane walkway for damage. During the inspection, the Crane Operator stepped onto a piece of grating causing it to flip up and fall 58 feet (17.6 meters) to the main deck below. As the grating flipped up the Crane Operator managed to grab part of the upper walkway structure and fell 15 feet (4.5 meters) to a staircase below resulting in a fracture of his left leg.

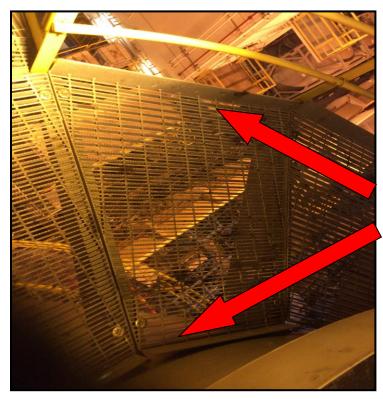
3. Grating kick plates

- Crane block swung in an uncontrolled manner and hit the walk-around grating, damaging the fastening devices of the grating.
- Crane Operator did not identify hazard and walked onto unsecured grating.
- The current grating design has the front and rear kick plates secured directly on the grating itself
 and not the walkway frame, negating the possibility of using the kick plates as a retention
 mechanism for the grating.
- The potential fall exposure was not identified by the Crane Operator.

Kick plates welded on the grating rather than the walkway frames.

The company conducted a hazard hunt on all rigs to locate similar walkway designs where the kick plates are not welded to or an integral part of the walkway frame and support structure.

The company engineering group in collaboration with the manufacturer will review the adequacy of the grating design, and implement any improvement fleet wide.
