SMALL BORE TUBING FAILURE ON BOP CONTROL SYSTEM ALERT 3-18

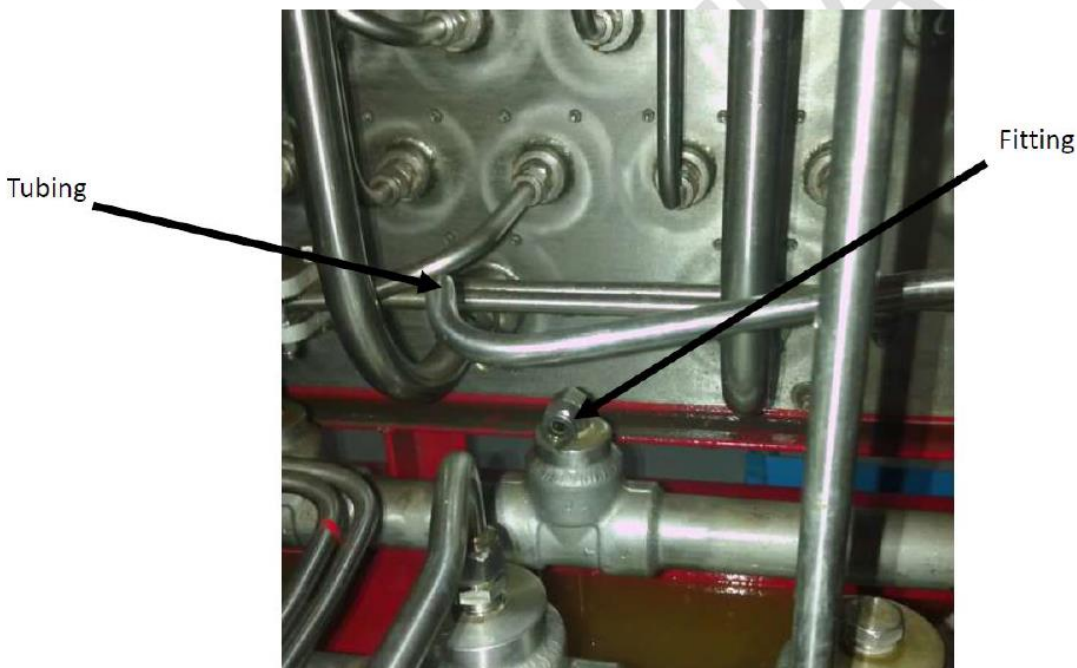
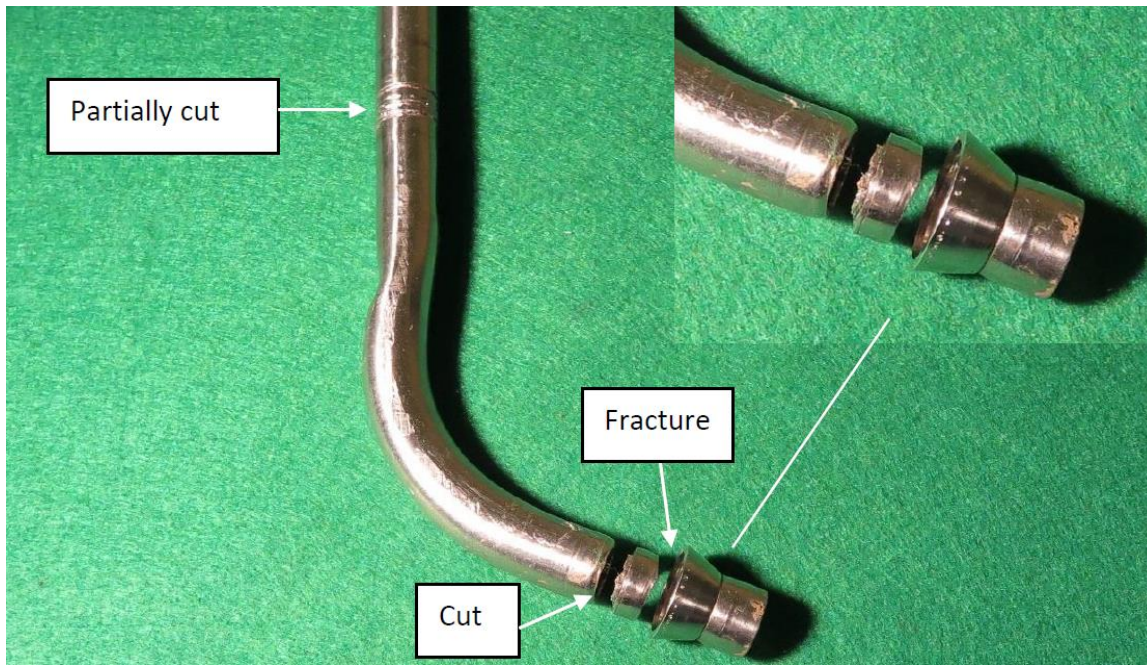
While starting up the control system for the BOP stack during maintenance activities, there was a release of hydraulic fluid from a small bore tubing which had separated from the 3,000 PSI manifold of the system. An estimated 196 litres (51 gallons) of fluid was released from the system into a bunded area.

The failed section of pipework was sent onshore for failure mode analysis, which revealed the cause to be a fatigue fracture caused by deep bite marks, resulting from excessive tightening of the compression nut. Inspection of the unit identified several fittings that had also been overtightened.

Inspect piping and tubing connections and ensure there are no loose or over tightened connections.
Consider marking correctly torqued connections to easily identify which have been torqued.
Use gauge/tool provided by manufacturer to avoid damaging small bore tubing.
