Racker Cab Window Pane Falls to Drill Floor

Alert 3-19

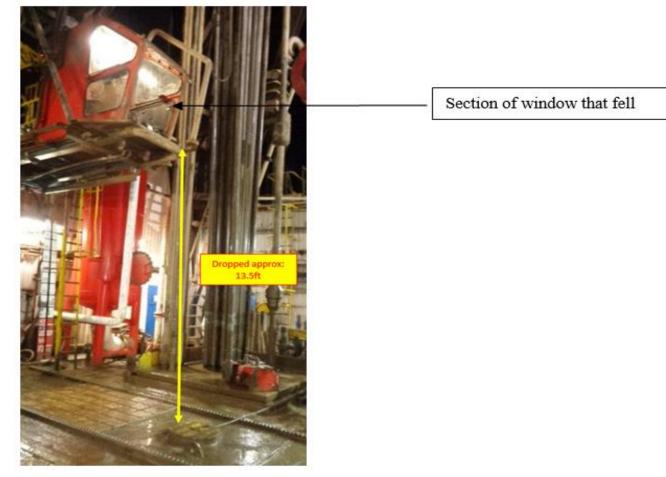
At the time of the incident, the drill crew was tripping in the hole with 4" drill pipe. While the next stand was being moved into position with the racking arms, the racker operator, in an attempt to gain the attention of the roughnecks, began to knock on the racker unit window pane.

The racker operator wanted to confirm with the roughnecks that the pin of the stand had been lubricated with pipe dope and was clear of the elevators. While knocking on the window pane, the pane dislodged from the window frame and fell approximately 13.5 ft to the drill floor. The pane came to rest on the mouse hole, the roughnecks were standing clear of the area and no one was struck.

- Racker operator knocking on the window
- Durability The condition of the window seal had been affected by Oil Based Mud (OBM) contamination
- Communication pathways Racker Operator did not use the installed talkback system to communicate with the roughnecks
- Drops perception Failure to recognize the drops potential presented by the windows on the racker cabs

- All windows on the drill floor & racker cabs were immediately checked to ensure they were secure
- Safety stand down held with the Drill Crew, Senior Toolpusher, OIM and Drilling Supervisor
- All personnel informed of incident at pre-tour meetings and "Flash Alert" sent for sharing
- Temporary window and retention fitted and secured to racker cab
- Additional rig wide drops sweeps carried out by all departments in all areas
- Secondary retention devices fitted to the exterior of the racker cab windows
- Windows and seals of racker cabs to be added to the racker cab inspection schedule, along with the inspection of the seals as part of pre-use checks
- Create a pre-use checklist for the racker cabs
- Investigate the potential to re-configure the Driller's talk back system to allow direct communication from the racker cabs to the drill floor
