SAFETY ALERT

PULSATION DAMPENER FAILURE

ALERT 5-19

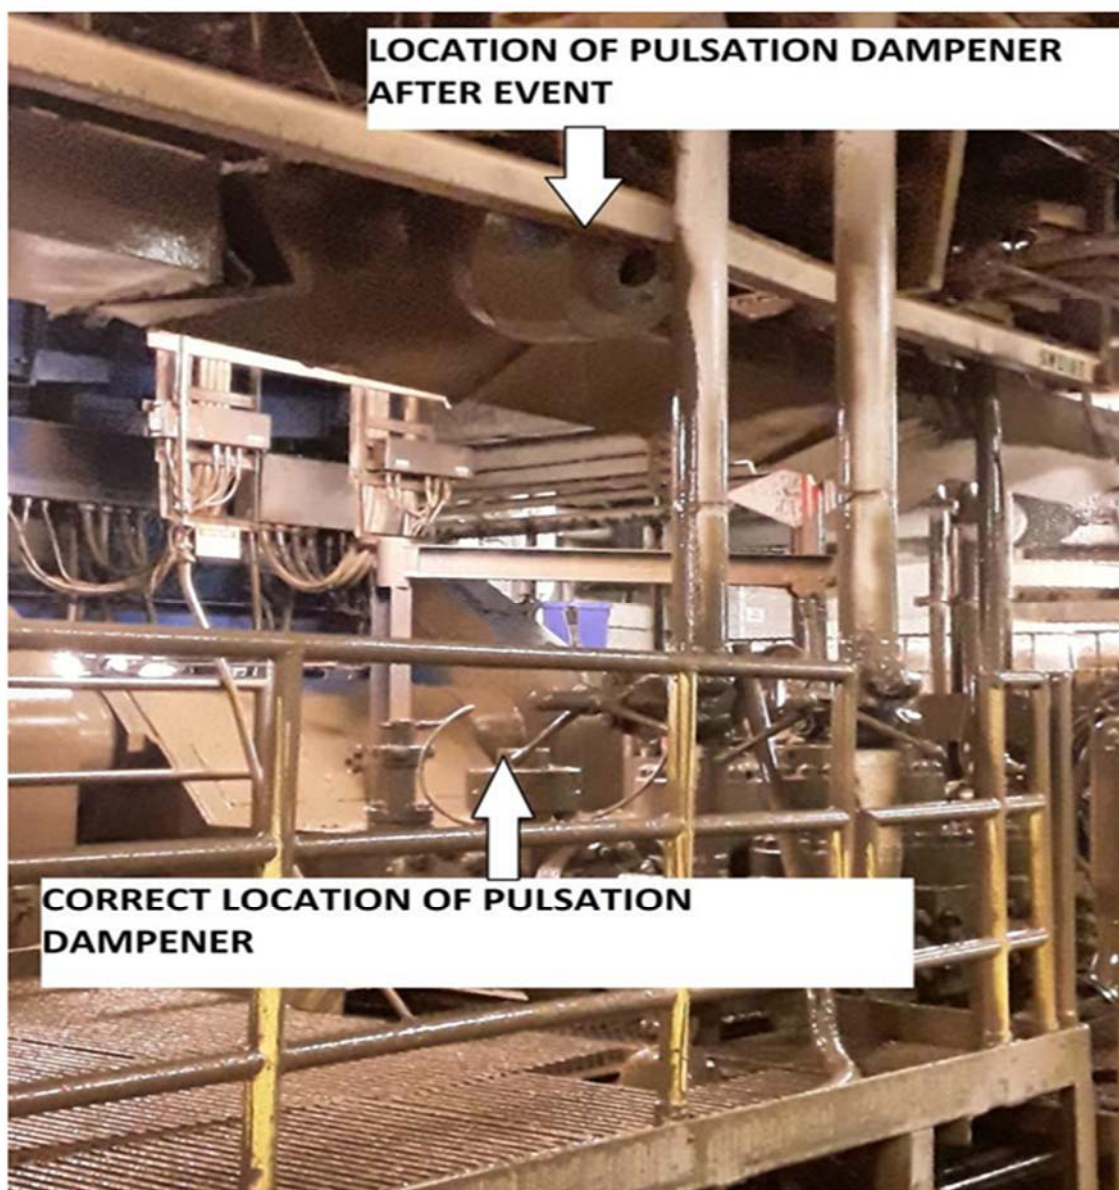
During well displacement, a sudden loss in standpipe pressure was observed. (Max circulation pressure at time of the incident was 1750psi). The Driller immediately shut down all mud pumps. The Derrickman confirmed that the discharge dampener on Mud Pump # 3, had separated from the flange area and was wedged in the overhead ducting/pipework above the pump. *Note: No personnel were in the pump-room area at the time.*

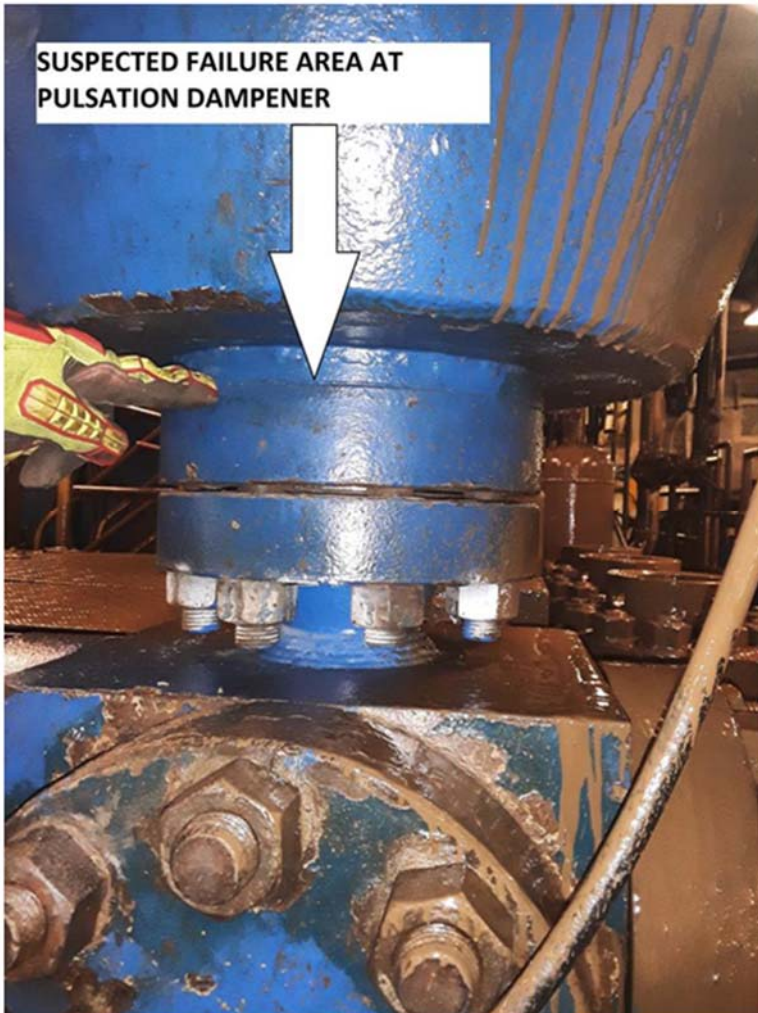
The # 3 Mud Pump Pulsation Dampener separated from its flange and was lodged in the ducting/ beam structure 1.6m above its flanged connection. Operations were immediately suspended. Displacement operations were shut down and the well confirmed secure. Relevant offshore and onshore persons were notified of the incident. Barriers were established around # 3 Mud Pump to prevent access to the area.

- Failure of pulsation dampener components.
- Investigation ongoing to determine reason for the failure.
- Red Zone barrier restrictions reduced the potential for personnel being in the mud pump vicinity.
- Barriers were put in place immediately, until an assessment of the area and situation could be carried out.
