# Safety Alert

ALERT 13 – 04

## LOWER MARINE RISER PACKAGE (LMRP) CONNECTOR FAILURE

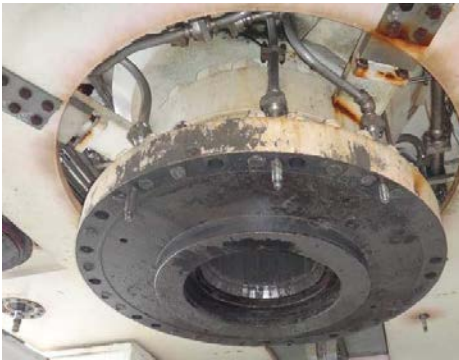
Upper half of failed LMRP Connector

- Stress corrosion cracking caused by hydrogen embrittlement is believed to have caused this situation. It appears that zinc electroplating without proper baking (per ASTM B633) caused this embrittlement.

- Operators and rig owners should check the bolts of their LMRP and Wellhead connectors to ascertain if they may be defective. Information on identifying affected bolts can be obtained by calling GE Oil & Gas at +1 (281) 985-3428 (accessible 24 hours a day) or by email at [Drilling.Support@ge.com](mailto:Drilling.Support@ge.com).

- Operators and Contractors with H-4 connectors, as identified through the above source, should also consult with their contractors and subcontractors to determine the appropriate inspection, disposition and/or corrective actions. Operators in the US Gulf of Mexico should notify BSEE, who will require an independent third-party certification that confirms proper inspection and refurbishment processes were completed prior to reinstallation of any affected bolts.

- Operators and contractors should review the QA/QC programs for all equipment vendors (contracted and sub-contracted) to ensure that all equipment is being manufactured to the required specifications. Special attention should be given to ensure proper heat treating has taken place in accordance with the specifications.

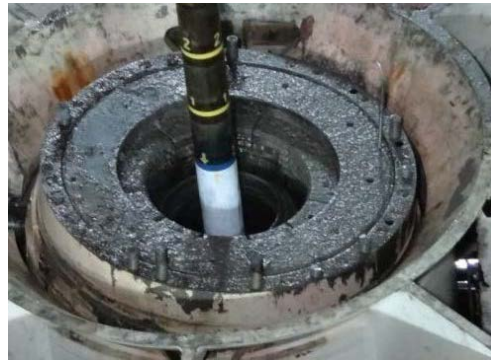
Lower half of failed LMRP Connector
