## **Safety Alert**

**ALERT 13 - 07**

#### IMPROPER HAND PLACEMENT RESULTS IN MINOR INJURY

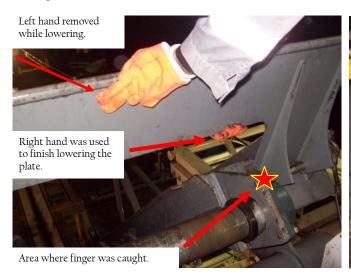
While drilling ahead, two employees were assigned to rig up the wire line machine. The attachment point for the wire line sheave is located under the transition plate between the hydraulic catwalk and rig floor (the plate hinges away from the floor). The two employees, together, lifted the transition plate so that one employee could show the other where to hook up the wire line sheave. After showing his co-worker where to install the sheave, they began to lower the transition plate back down. One employee decided to let go of the plate as it was getting close to the floor. The other employee had his right hand on the catwalk side of the plate and his left hand on the floor side. To keep from mashing his fingers between the plate and floor, he removed his left hand and continued to lower the plate. As he did, he felt a "pinch" to his right pinky finger, so he jerked his hand out and told the other employee that he thought he had injured his finger. It was found that his finger got caught between the transition plate and the metal plate supporting a bearing housing.

- A general walk around and review of the floor plate, v door, and catwalk did not reveal the hazard between the transition plate and the bearing plate.

- The employees did not use a hoist to raise the plate from its resting position to vertical.
- The manufacturer did not install a lifting eye, slot, or D-ring to attach to the transition plate to raise and lower it into position.

- Employees were counseled regarding company expectations for Job Safety Analysis (JSA), reminding them that Hazard ID is expected prior to performing any task.
  - o Critical Tasks require documented JSA with all affected persons.
  - Non-critical tasks require Hazard ID, prior to performing the task.
- All affected personnel were reminded that fall protection (harness and lanyard) is required when performing maintenance or similar tasks with the v-door gate open.
- The transition plate is under review to determine if an engineered method can be installed to provide employees with a means to safely lift the plate and to help prevent recurrence of this type of incident.
- A cable was attached to the pad eye so the plate does not have to be lifted to attach the sheave in the future; the plate will still need to be handled during Rig Up and Rig Down situations.
