# Safety Alert

**ALERT 13 - 15**

#### UNEXPECTED MOVEMENT OF CARGO BASKET RESULTS IN FIRST AID CASE

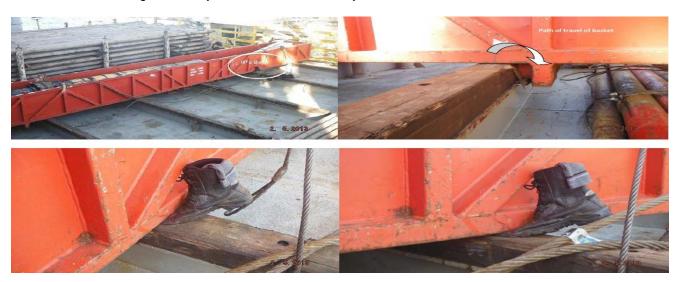
The Deck Crew was preparing a basket for backload and was loading it with guideposts. The guideposts were lowered in to the basket, but they were not sitting correctly. A crewmember, injured person (IP), asked the Crane Operator to lift the load so as to allow for adjustment of the guideposts in the basket. As the load was lifted, it swung and knocked against the basket thereby dislodging it from the timber on the pipe deck beam. The basket came down to rest on the crewmember's foot. Instructions were then given to the Crane Operator to pick up the load and the crewmember was able to remove his foot from his boot. The IP was Medevac'd from the rig on the day of the incident and x-rays confirmed that there were no broken bones.

- Initial placement of the basket allowed it to be dislodged
- No 360 degree check was carried out when basket was landed or when the cargo was to be loaded
- IP did not recognize the hazard of placing his foot under the basket
- Design of the basket, which had footers, in combination with the deck beams allowed the basket to drop
- A Task Risk Assessment (TRA) in use at time of incident was generic for general deck lifts and did not cover the specifics of loading and unloading baskets/containers
- TRA did not address the landing of "footed" type baskets
- Currently there is no drilling contractor control over the type of cargo basket sent offshore by client and/or service providers

- The company has communicated with the client that flat bottomed cargo baskets are the preferred method of shipment.
- Where this is not possible, the company informed its employees that a specific TRA must be utilized for loading and unloading baskets/containers when offshore.
- The above was formally placed in a procedure by the company.
- The drilling contractor has ensured that TRAs and written work instructions have been created to capture the handling and loading/unloading of cargo baskets and containers on deck (fleet wide).
