Safety Alert

ALERT 13 – 20

DROPPED OBJECT RESULTS IN NEAR MISS

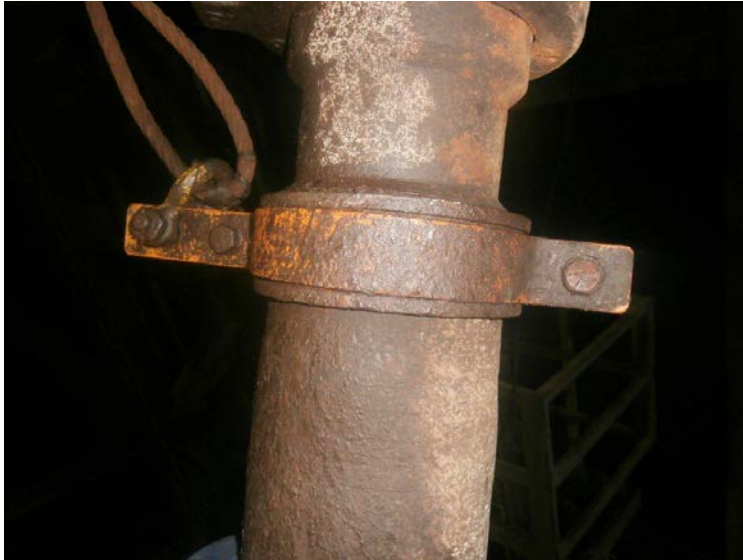
Lifting Collar Clamp Assembly

A half-moon clamp insert weighing 1.9kg (4.9lbs) had been identified as redundant equipment and was being removed from a hose. The work party, who removed the clamp, was not aware that the assembly contained inserts. It was assumed that the inserts were integral to the swaged end fitting of the hose. However, the inserts were held on by friction and had “weathered” in place. Two days later, one of the clamp inserts fell 12 meters (39 feet) from the compensator fluid hose to the drill floor. Even though this incident could have resulted in a fatality, no personnel were struck by the dropped object and the remaining half-moon insert was safely removed and brought to the drill floor.

- The clamp assembly had been in-situ since 2009 and had been used as a form of secondary retention.
- The lifting clamp assembly had been identified during specialist DROPS inspections as a method of secondary retention. It was not known that the lifting collar was not designed to carry out this function.
- Upon further investigation of the OEM documentation, it was discovered that the clamp assembly was only designed as a lifting collar to assist with hose installation and should not be used as a form of secondary retention.
- The OEM documentation was available on the MODU but had not been referenced and the clamp assembly was not identified as a potential hazard.

- All facilities were instructed to conduct an inspection of all derrick hoses to check for any similar arrangements.
- All facilities were instructed to contact their hose supplier and request that the lifting clamp assemblies are suitably identified and marked as being “for installation purposes only.”

- All rig personnel were reminded that OEM documentation states that the lifting clamp assembly may be left on hose after installation but that it is not for secondary retention. The rig personnel requested that this be amended by the company to reduce the risk of re-occurrence and potential dropped objects being left at height.

- The company contacted the DROPS inspection companies to inform them of this issue.
- The company amended their task risk assessments (TRA) to include specific detail on the removal of lifting clamp assemblies.

- The company amended their DROPS procedure to state that the removal of items from the derrick should be verified by a supervisor and to reference OEM/Technical guidance when required.

- The company updated their DROPS Inspection Manuals to reflect the fact that lifting clamp assemblies are now removed.
