Safety Alert From the International Association of Drilling Contractors

ALERT 06 – 16

NEAR MISS – SECTION OF WINDWALL BECAME DETACHED

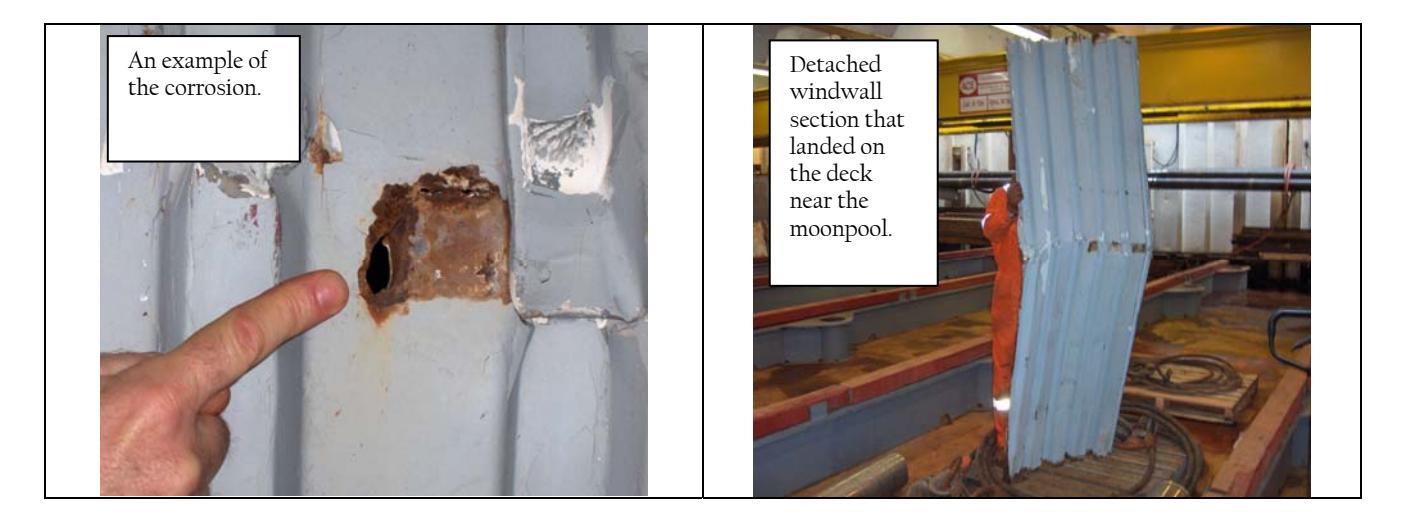
An incident with an extremely high potential to cause injury to employees and equipment occurred on a rig after a period of high wind conditions. This incident was recorded as a near miss involving a section of windwall that became detached from its attachment points and landed on the deck near the moonpool.

WHAT CAUSED IT: Windwall sections had become corroded allowing the bolts and oversized washers to strip through the paneling.

- If damaged windwall sections are found, they should be repaired/replaced as quickly as possible.
- If damaged windwall sections are found and it is not possible to repair/replace quickly then a temporary back-up securing system should be considered until the repairs/replacement can be completed. See pictures below.
- Windwall sections should be included in the Derrick DROPS register which is generated each month by the company's Preventative Maintenance System.
- Windwall sections should also be included in the list of items inspected annually by a 3rd Party contractor.
