Safety Alert From the International Association of Drilling Contractors

ALERT 11 – 22

FAILURE OF BOP RAM YOLK RESULTS IN A NATURAL GAS RELEASE FROM BOP

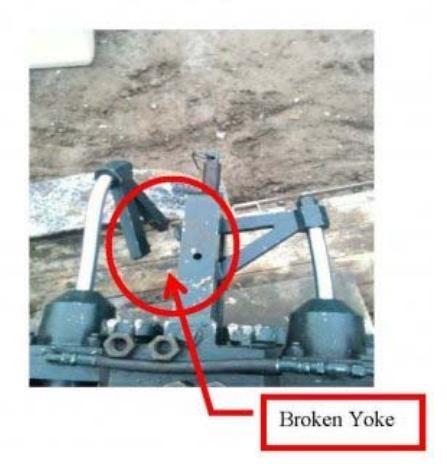
A rigless snubbing unit was preparing to stage a production tubing string into a well. The average well bore pressure was recorded at 28mPa (4000 psi). At that pressure it is required to snub the tubing using the ram to ram staging method. As the snubbing operator was staging the coupler of joint #44 into the staging chamber of the snubbing unit, he closed the lower stripping Quick Ram Change (QRC) rams, de-pressurized the chamber, and opened the upper stripping QRC rams. Immediately after the upper QRC rams were opened there was a natural gas release from the closed annular blowout preventer (BOP) on top of the snubbing stack. The operator closed the upper QRC rams and investigated the cause of the release. It was noticed that the lower stripping QRC rams had malfunctioned and did not close properly. The operating yoke of the QRC stripping ram was found to be broken on the left side. This made it impossible to apply the correct closing pressure to the QRC stripping QRC rams and the damaged QRC rams were removed from the snubbing stack and sent for analysis of the failure.

- The immediate cause of the incident was the failure of the operating yoke on the QRC BOP.
- The original purchaser of the rams had requested the manufacturer to modify the original equipment design to improve overall ease of handling, as well as, rigging in and rigging out of the BOP.
- The underlying causes of the failure included a faulty design that did not account for the conditions the QRC BOP was being used.
- A full management of change review was not conducted prior to the changes made to the equipment and assumptions were made about the strength and durability of the operating yoke and QRC.

- The company has 6 sets of the faulty QRC BOPs and all were upgraded with new, heavier yokes. The yokes that were removed from service were sent for Non-Destructive Testing (NDT) and it was discovered that they were ALL cracked in the same spot.

- Recommended that snubbing operators add a visual inspection of BOP components to the supervisor's daily checklist.
- Recommended that snubbing operators utilize original equipment manufacturer (OEM) or an OEM approved vendor for BOP service and recertification.

- All companies that purchase remanufactured equipment must not take for granted that all designs are flawless and to ensure that a management of change process is developed and followed when any changes are made to equipment or processes.
