Safety Alert From the International Association of Drilling Contractors

ALERT 10 – 24

AIR VALVE MALFUNCTION RESULTS IN HIGH-POTENTIAL NEAR MISS

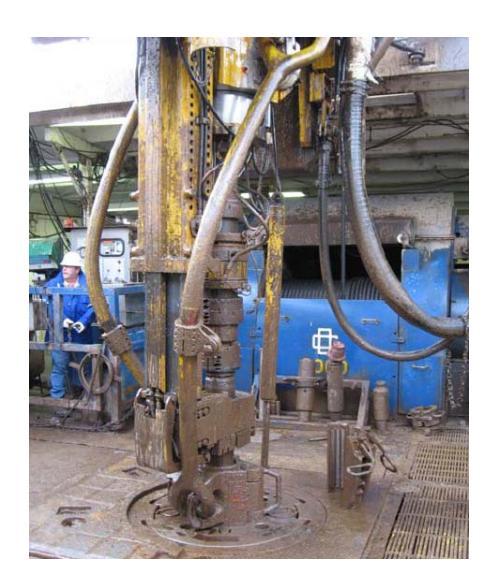
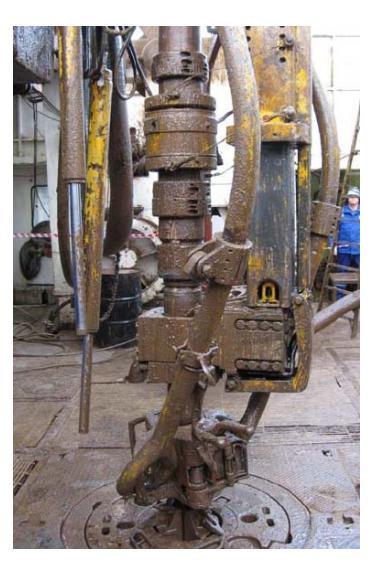
The driller was in the process of back reaming when the air supply to the drum clutch of the draw works suddenly bled off. This allowed the drum clutch to release and the top drive system, with a 5-inch drill string attached, to move down approximately 4-meters (13 feet). The drill pipe elevators came in contact with the rotary table resulting in damage to the bails and the link tilt hydraulic cylinders.

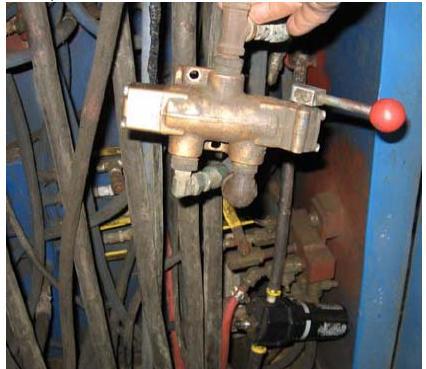
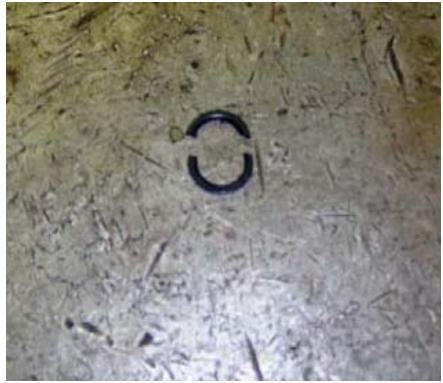
Combination of leaking o-rings and the valve "tattletale hole" being plugged.

- The o-rings were found to be brittle and allowed air to leak by the shaft into the end cap.
- The "tattletale" hole was found to be plugged causing the pressure leaking by the o-rings to build up in the end cap exerting internal pressure against the end of the valve.
- The reverse pressure shifted the valve into the vent position which shut off the air to, and dumped air from, the drum clutch.

- 1. As an immediate corrective action, the o-rings were changed on this valve.
- 2. Contacted the valve manufacturer and informed them of the incident and inquired if there have been similar incidents in the past.
- 3. Obtained recommended maintenance and inspection procedures from the valve manufacturer and added the procedures to the company Preventative Maintenance System.
- 4. Communicated these procedures to maintenance personnel.
