From the International Association of Drilling Contractors

ALERT 02 - 05

DEEP WELL PUMP REPAIR RESULTS IN A FATALITY

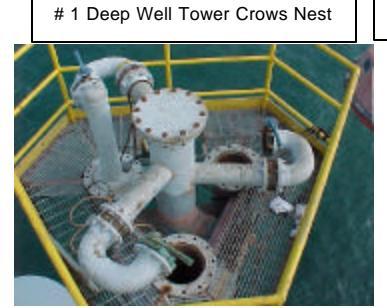
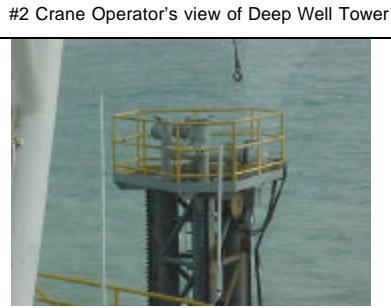
The Electrician locked out the pump motor's electric controls and disconnected the pump/motor power cables from the junction box on the Deep Well Pump Tower. To access the PVC piping as it was hoisted the Electrician and Motorman were positioned on top of the Deep Well Pump Tower (see photo). The power cord attached to the pump/motor was pulled along with the pipe and as it was retrieved from the well the men fed it over the handrail, letting it fall to the deck. As the last section was hoisted out of the well, it was observed that the pump had partially separated from the motor. At this time the Electrician elected to deviate from the documented JSA and disconnect the last section of PVC pipe from the pump/motor and lay them down separately. A clamp was installed on the crossover below the PVC coupling, yet above the separation in the pump/motor. To disconnect the PCV pipe, the pump/motor was lowered into the well and disconnecting the last section of PVC proved difficult to the point that a 12-pound sledgehammer was used to help tap the pipe free. When the connection came free, the lower portion of the pump/motor assembly with the power cord still attached, separated and fell through the well. As the power cord was being pulled down the well, it was whipping over the handrail (see photo #1) and as the end of the power cord came over the top of the handrail, it struck the Electrician causing fatal injuries.

There was deviation from the documented Job Safety Analysis and upon the deviation of JSA, there was a failure to stop the job and assess any new hazards introduced to the job. This resulted in a failure to recognize hazards existing in the operation. Additionally, there was mechanical failure of the pump/motor assembly.

- Communicated this incident to all Rigs within the fleet, stressing the importance of following documented JSAs and procedures.
- Had supervisors instruct all personnel that if deviation from a JSA is required, personnel should stop work immediately, assess all hazards, then seek approval from their immediate supervisor.
- Conducted additional JSA and Hazard Analysis Training with all crews.
- Assigned Engineering and Operations personnel to investigate ways to improve the process of pulling Deep Well Pumps.
- In order to highlight other potential risks involved in pulling Deep Well Pumps, Engineering and Operations personnel were assigned to work with Deep Well Pump manufacturers to develop a better understanding of different types of failures.
