From the International Association of Drilling Contractors

ALERT 02 – 20

CHEMICAL EXPOSURE RESULTS FROM TRAPPED PRESSURE IN MWD TOOL

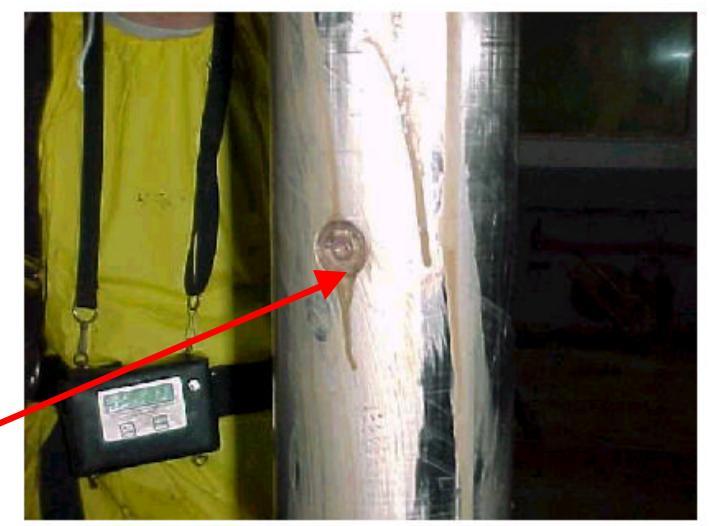
Down Load Port

While tripping out of the hole and after an aborted attempt to download an MWD tool, two crewmembers were exposed to what is believed to have been acid from a Lithium/Thionyl Chloride Battery. The MWD engineer had opened a download port in the tool (see photo) in order to download tool memory and found it to be slowly leaking drilling fluid. After unsuccessful attempts to reinstall the plug back in the port, the tool was raised 20 feet and a second port was used. While the tool was being downloaded, a "mist/gas" was observed escaping from the original top port. The affected employees were approximately 15 feet from the rotary table and suffered severe vomiting and shortness of breath.

A washout in the tool allowed mud invasion into the electronics package and led to battery failure. Downhole pressure and/or pressure from the reaction of the battery acid was trapped in the tool and given an escape path when the download port was opened. Trapped pressure potential was not recognized when it was noticed that mud had invaded the tool.

- The rig floor was cleared of personnel and the area was allowed to ventilate.
- A JSA was performed on how to handle the tool.
- The tool sealed and laid down by personnel in full protective gear.
- Issued the following to all rigs: "Caution must be exercised when handling any downhole tools that may trap pressure, such as measuring, sampling, logging or coring tools."
