ALERT 1-18: WIRELINE TOOL MANIFOLD SHEARS – RESULTING IN DROPPED OBJECT

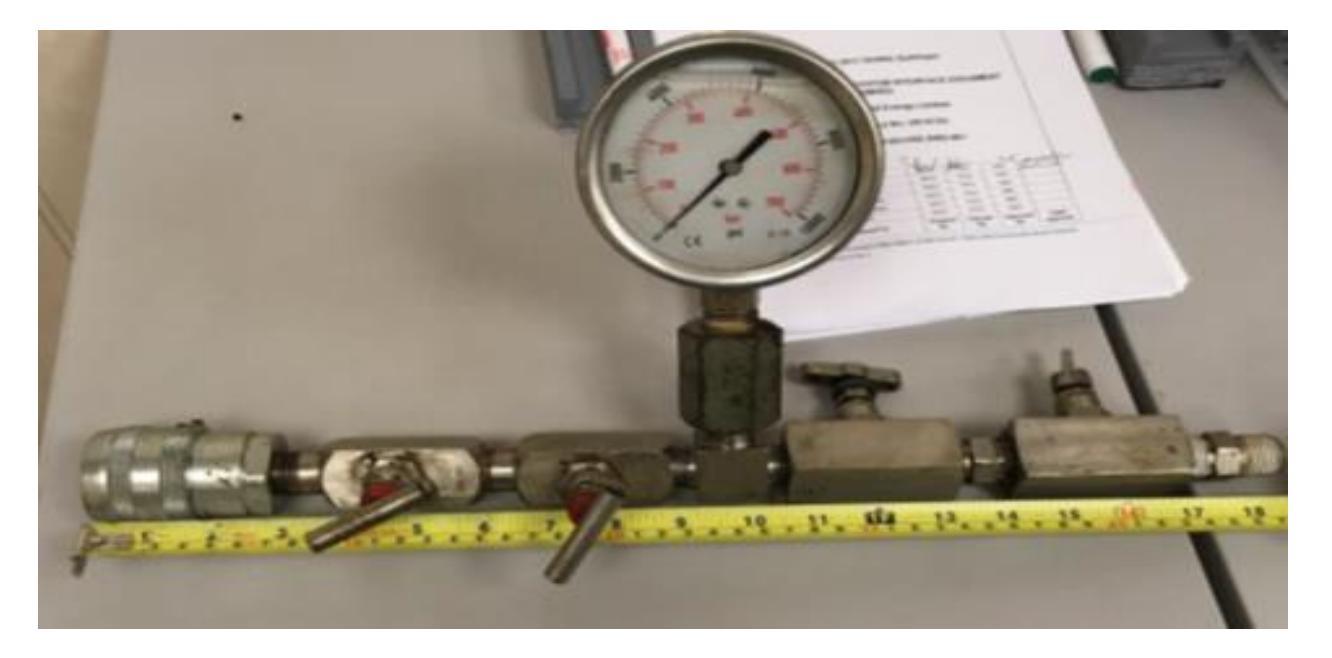
While making up a wireline tool assembly, the rig heaved while the wireline string was being lowered by a rig floor winch. As the rig heaved, a needle valve bleed off manifold on the Coil Tubing Lift Frame (CTLF) made contact with the tool string lifting bridle. Upon contact with the bridle, the needle valve bleed off manifold sheared off at the threaded coupling and fell directly to the rig floor. The needle valve bleed off manifold weighed 7lb. and fell 30ft. No injury to personnel resulted from this incident.

The needle valve manifold had been put together in a linear fashion and protruded too much from the lubricator (approx. 18"). This had not been identified as a hazard by the Service Provider or the rig crews. The requirement for; and method of pulling back and securing the lubricator to the CTLF was not specified in the procedure. Not securing the lubricator to the CTLF allowed lateral movement of the lubricator which contributed to its close proximity to the tool string.
