## Safety Alert

**ALERT 99-35**

## SCBA FACEPIECE SAFETY NOTICE MSA Ultra Elite®; SCBA facepiece

## Install corrective valve stem guard

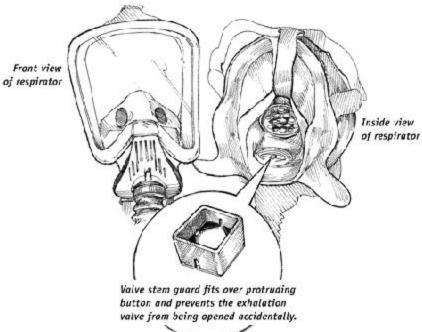
A safety design defect has been found with the exhalation valve on the MSA (Mine Safety Appliances Company) Ultra Elite® SCBA facepiece. The exhalation valve can be opened for cleaning. The button that opens it protrudes above the surrounding facepiece. As a result, the button can accidentally contact the user's chin, push the exhalation valve open, and permit outside air to enter, possibly causing injury or death.

The protruding button may contact the user's chin when the user looks up, when the user leans forward and looks directly down, or when the user opens his or her mouth wide to breathe.

MSA has developed a retrofit guard that prevents the button from being accidentally depressed. The guard and installation instructions were to have been sent to all customers who purchased this facepiece. Employers should ensure that the guard is installed according to the manufacturer's instructions. Anyone who has not received the guard should contact MSA at 1/416-667-9400 or toll-free at 1/800-267-0672.
