Safety Alert

ALERT 05 – 35

LOAD BINDER INJURY

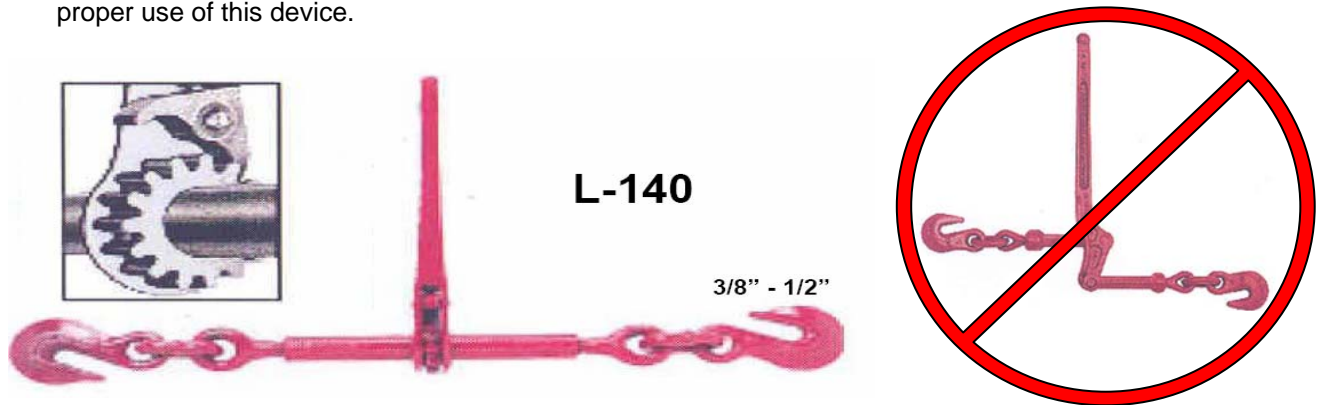
An injury recently occurred on a company rig when a truck driver was unlatching one of the load binders on his trailer. The employee was struck in the face by the cheater pipe placed on the handle of the binder when it sprang open unexpectedly. This is the second injury of this type within the year. In addition, other similar injuries have occurred while opening or closing load binders.

- The employee was using a regular break over style load binder which presents a great risk to the user.
- Recommended use of ratchet type load binders as per a previously issued company safety alert was not followed.
- No procedures to be followed were available for the safe use of load binders.

- Company Equipment Standard for Ratchet Type Load Binders is to be issued replacing old style binders and to eliminate the hazard of binders springing open.
- All employees who use load binders should be given written procedures along with training relating to the proper use of this device.

IADC Note: Lever binder manufacturing companies recommendation against use of cheater pipes when either closing or opening lever binders.
