Safety Alert

From the International Association of Drilling Contractors

ALERT 05 – 44

BOP OVERHEAD CRANE WIRE LINE FAILURE

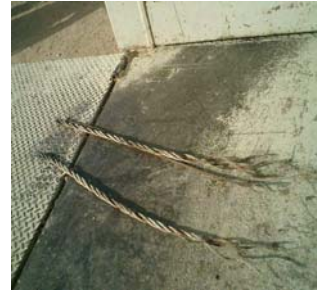
Figure 1 – Anchor end approx 10 foot.
