Safety Alert

ALERT 05 – 02

DROPPED OBJECT - EMPLOYEE STRUCK BY SLING

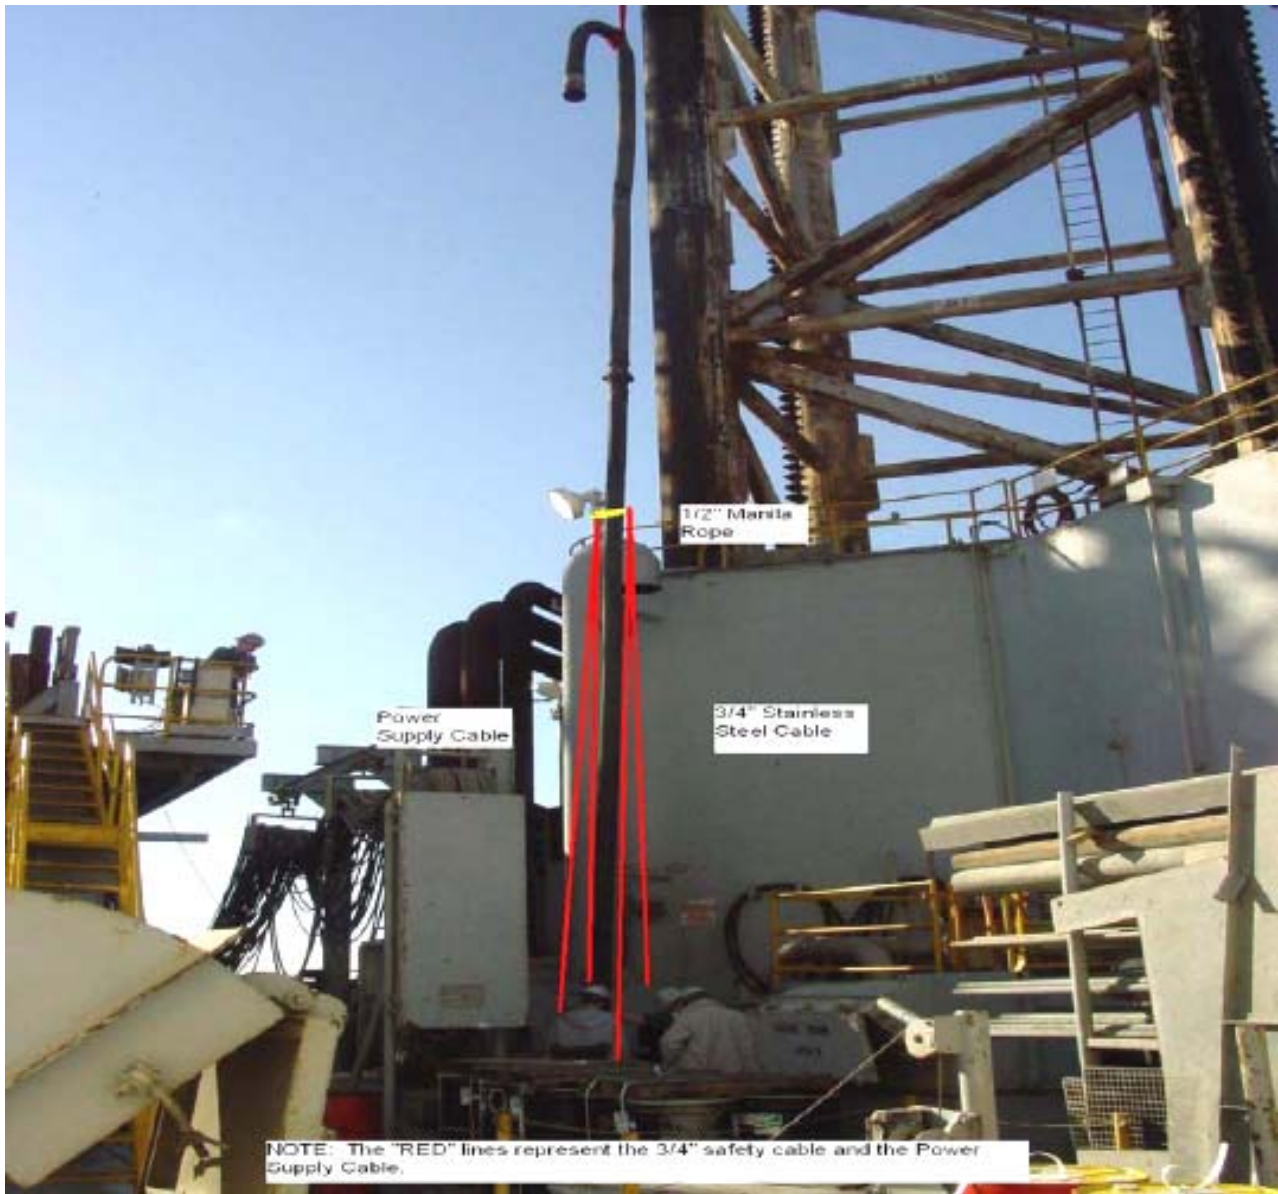
A serious incident occurred on a Jackup Drilling rig when an employee was struck in the head by the eye of a ¾" stainless steel sling, resulting in a skull fracture and multiple sutures to the face and hand. The crew was in the process of picking-up and laying-down the #3 Deep Well Pump. A nylon sling was secured to the 6" deep well hose, and the hose was lifted 50 ft through the opening on the main deck. The power supply cable and the safety cable for the deep well pump were tied to the deep well hose with a ½" manila rope. As the hose was lifted the rope parted. As the cables fell through the hole on the main deck the eye on the end of the safety cable struck the employee on the forehead rendering him unconscious.

The **Safety Committee** for each rig will review all JSAs and identify specialty lifts (installation of boat ropes, take-on hoses, deepwell installation, etc.). After identification, each JSA must be reviewed by the Safety Committee to ensure that the rigging utilized in these operations is specified in the JSA and is fit for purpose for the intended job. **Due Date: 30-Jan-2005**

There have been several incidents recently where rope failed while supporting weight. The **Operations** and **HSE Departments** are currently revising the procedures manual section on Rigging Module, Fiber Rope so the allowable applications for fiber rope are clearly defined. **Due Date: 15-Jan-2005**

Operations and **HSE Departments** will develop a company approved rigging and support system for running submersible pumps over the side. **Due Date: 15-Jan-2005**
