Safety Alert

ALERT 05 – 13

UNGUARDED ENGINE FAN RESULTS IN AN INJURY

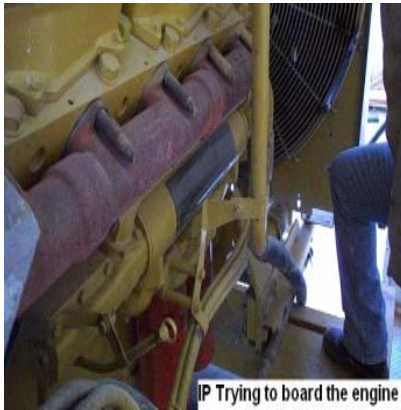
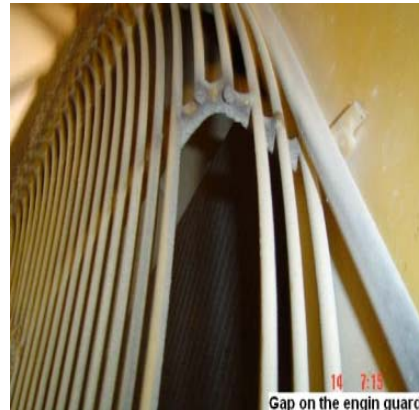
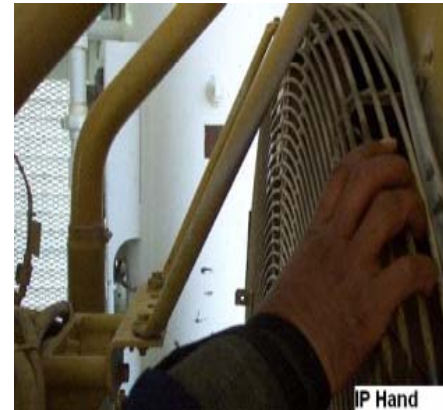
While attempting to check the water level in the generator, the mechanic had stepped up on the engine mount and placed his hand through a gap in the radiator fan guard to lever him up and gain access to the radiator cap. As the generator was running at this time, he suffered cuts and abrasions to four fingers when the fan blade made contact with his hand

1. Two protective guard bars on the generator fan had been previously removed for cleaning purposes, leaving a gap large enough to place the hand in harms way.
2. No climbing device was available for the employee to gain access to the radiator cap.
3. The hazard caused by the unauthorized alteration of the fan guard had not been noticed during rig safety inspections or by the mechanic

- The opening in the fan guard was immediately fixed and all other generator fans were checked for a similar safety problem
- A ladder was specially built and installed to allow workers safe access to the radiator cap
- Training was given to ensure rig safety audits and the hazard identification process is effective and that effort is made to safeguard equipment
- Safety guards are provided for a reason. These guards must not be altered in any way without approval from Houston HSE department.
