Safety Alert

From the International Association of Drilling Contractors

ALERT 09 – 33

PICKING UP DRILL COLLARS RESULTS IN LTI

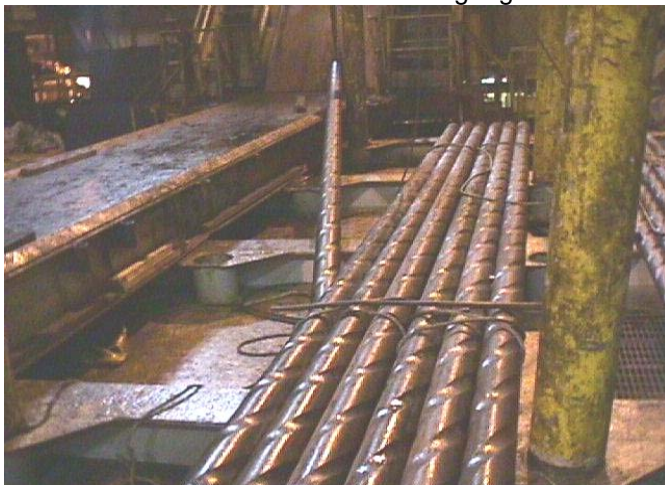
While picking up 6 ½” drill collars two 3” X 12” X 36” planks were placed on the catwalk to facilitate removal of the crane slings. When the rig floor hoist picked up the box end, the pin end of the drill collar was resting on a piece of wood (3” high) which made the drill collar ½” higher than the 2 ½ inch angle iron rail edge of the catwalk. As the box end of the collar was being pulled up the beaver slide (pipe/tool slide) to the rig floor, the pin end of the drill collar rolled off the board and over the angle iron then off the cat walk. The drill collar struck the roustabout from behind breaking his arm. The injured roustabout had turned his back to the drill collar and was preparing to connect the crane slings onto another collar on the pipe rack. (see the photo)

- The catwalk is designed for post stops to be installed on each end and in the center section. Posts were installed on each end but none was installed in the center section.
- The crew members failed to recognize the possibility that the pipe might roll off once the pin end of the drill collar was pulled past the first post.
- Crewmembers also failed to recognize the unsafe position of the injured employee while the pipe was being pulled up the beaver slide.
- The deck supervisor, crane operator, and other crewmen were in the immediate area but did not recognize the hazard.
- The JSA was only in English and not in the native language of the roustabouts.

- Instructed rig personnel that JSAs are to include hazards of turning your back to a load being hoisted whether it is by a crane or a rig floor hoist.
- Instructed rig personnel to stay out from between the catwalk and drill collars while a drill collar is being pulled up the beaver slide.
- Instructed supervisory personnel to keep focused on the big picture and the hazards involved. Do not become too “hands-on” or too preoccupied with the current task, but watch for hazards.
- Instructed supervisors to ensure personnel are clear of potential pinch points before a load is lifted.
- Instructed supervisors to ensure that when there are two main languages are spoken on the well site, the JSAs are to be created in both languages.
