# Safety Alert

ALERT 11 – 27

## LACK OF PROPER TOOL RESULTS IN FINGER INJURY

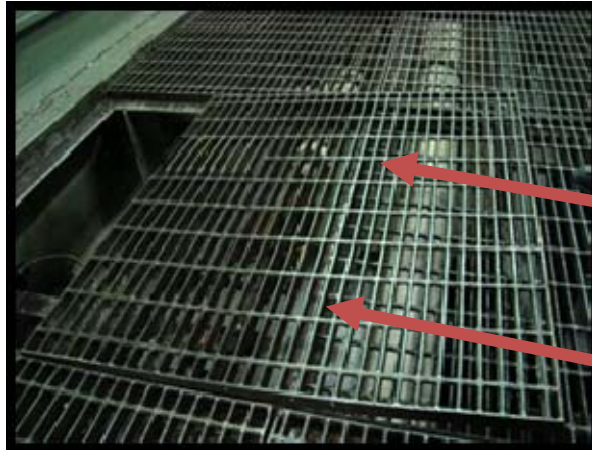
Position of IP's  
fingers at the  
time of incident

While sliding the grating to attain access, the crew member trapped his finger between the section of grating he was moving and the deck grating underneath.

The investigation revealed that the practice of sliding the grating, for access purposes, had become common practice onboard this installation.

- Recommended that grating pullers (pictured below) be purchased or built following engineered design. The grating pullers are designed to provide a hands free approach to removing sections of grating, which will minimize the possibility of trapping or crushing fingers in-between grating sections.
