# Safety Alert

From the International Association of Drilling Contractors

ALERT 12 – 17

## SUDDEN SLEWING OF CRANE BOOM DISLODGES LOAD

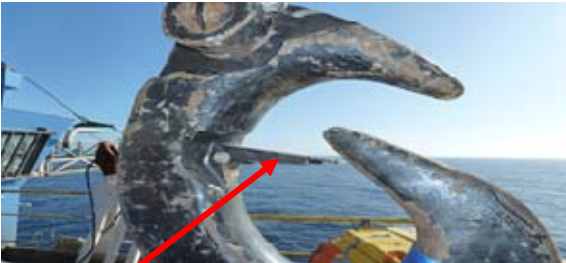
- Spring loaded latch was easily dislodged due to the swing of the pennant.
- Change of direction of the crane resulted in the pennant doubling back on itself.
- The crane operator was new to the position and tried to correct the swinging of the pennant. His action resulted in the pennant doubling back against itself and slipping past the hook latch.

Retractable Hook Used Resulting In Incident

- Starboard and port crane hooks have been changed out for locking mechanism.
- A locking mechanism was fabricated and attached to the aft crane to prevent the pennant from becoming detached (moused).
- All crane operators have been instructed to ensure that the locking mechanism is in place prior to any lifts occurring.

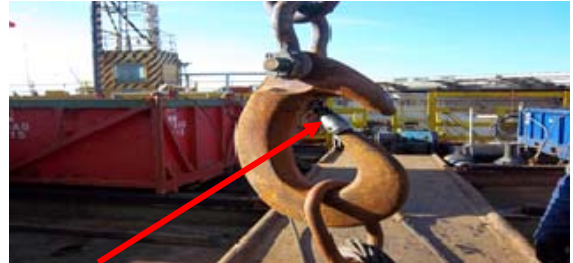
New Locking Mechanism In Place As A Result Of Incident

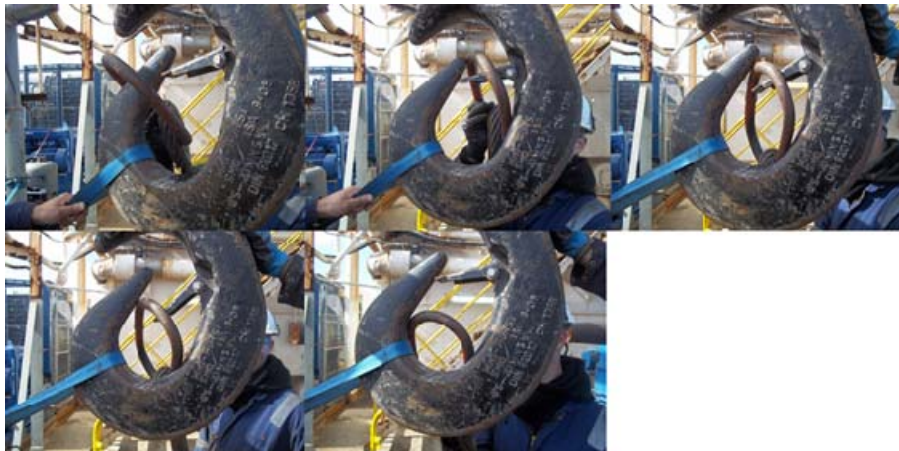
The crane operator slewed the crane right, causing the pennant to swing. He immediately attempted to correct the pennant line swing by slewing left. This action caused the pennant to double back on itself which resulted in the pennant becoming detached from the main hook. These actions resulted in a high potential serious injury incident.

Simulation of Pennant becoming detached from Hook
