**Safety Alert** From the International Association of Drilling Contractors

## ALERT 12 – 23

# **EXPLODING BALL VALVE RESULTS IN NEAR MISS**

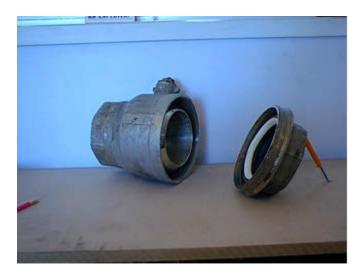
The rig welder was instructed to cut a mild steel hose fitting from a 4 inch (10cm) brass ball valve. Working at his bench with a hot work permit, the welder used an oxy-acetylene torch to cut the mild steel fitting close to the threaded end of the valve. Having finished the job the welder turned to put his torch away. At this time an extremely loud explosion took place and a short threaded section of the valve closest to the cut fitting blew across the lease, hit the ground, making a small crater approximately 26 feet (8m) away from the bench. The threaded section bounced and flew another 39 feet (12m), hitting and denting a steel cargo container.

- The valve had not been taken apart before the steel fitting was cut from the valve. As the valve was in the completely open position, the valve seal ensured that the void space between the ball and the housing was completely enclosed.
- This valve had been in service in a water line; therefore, it is presumed that fluid inside the sealed void space between the housing and the ball was turned into steam by the heat of the cutting torch.
- The applied heat also allowed the valve body to expand. The built up pressure of the steam, coupled with the expansion of the valve body, resulted in the explosion that sent the smaller part of the valve across the lease.

• Instructed rig welders that all valves must be disassembled prior to hot work.
