Safety Alert

ALERT 11 – 18

DROPPED OBJECT - PIN FALLS FROM TOP DRIVE RESULTS IN A NEAR MISS

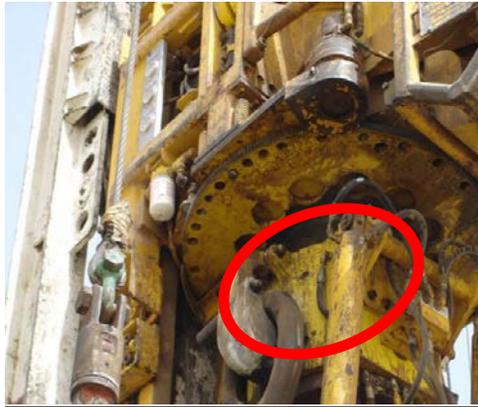
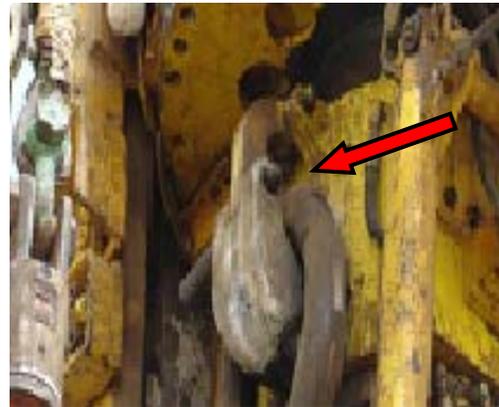
While laying down 5" Drill Pipe, the upper pin of the top drive link support assembly came loose and fell approximately 15-18 feet to the rig floor near the driller's side. No injury was reported.

- The safety pin was sheared off allowing the upper pin to work its way loose and drop to the rig floor.

- Conduct routine scheduled inspection of all equipment that has a potential to drop from the derrick. Utilize the company "DROPS Prevention Scheme" checklist and complete a Dropped Object Management System (DOMS) Rig Inventory List. Attach pictures to the inventory list and retain in the rig file.
- Use safety pin with spring latch instead of using nuts similar to the ones used in 350 ton top drive.
- Develop a JSA to be used when conducting the top drive routine inspection check.
- Reference the following internal documents
 - Dropped Object Management System (DOMS)
 - Job Safety Analysis
 - Top drive manufacture's (OEM) operating manual
 - Perform monthly inspections
