# Safety Alert

From the International Association of Drilling Contractors

## ALERT 07 – 03

### MAST RAISING LINE FAILURE

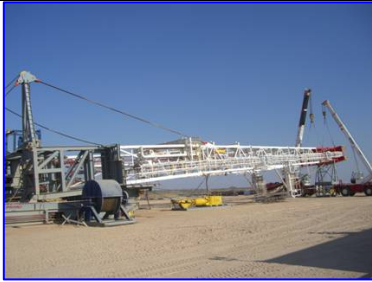
Picture 1

During the rig move, the drilling rig mast was to be raised. It was initially lifted 30 cm (12 inches) from its horizontal position on the high derrick stand and operations stopped for 15 minutes with the mast hoisting system under tension. This was done to allow the crew to fit Blowout Preventer (BOP) lifting beams below the sub-structure. Lifting operations then re-commenced pulling 220 tons, lifting a further 60 cm (2 feet). A bang was heard and the mast fell back 90 cm (3 feet) uncontrolled, landing on and damaging the high derrick stand. The monkey board and mast were also damaged. . No personnel injury but there was major asset damage.

It was found that the short leg of the 2 1/4" diameter mast raising line had failed at the first sheave. The mast had been raised 30 cm (12 inches) and left static with the failure weight 220 ton held on the brake. No clear cause of the raising line failure could be established at the initial site visit. Further metallurgical and dimensional checks need to be carried out by independent cable examination laboratories. The line had exceeded its life span as set by the contractor, but not its number of cycles. A step-out was generated for this, but not on sound engineering principles.

- Change out your raising line on time. Do not exceed the working life or cycles set by the company. Question the assumptions on which the change out is based.
- Ensure that all step-outs are based on sound engineering principles, not just to keep a unit in action. Do a reality check on the risk assessment in the step-out, what if this piece of equipment failed, what would the end result be, do not understate the results
- Understand the loads applied in the system and the safety factors applied.
- Under no circumstances allow anyone to walk or work under the mast or in the sub-structure area when the lifting of the mast is taking place. If work needs to be done, find another way to do it.
- Refer to raising-line procedures in pre-job discussions, recognize loads quoted and question when these figures don't match reality.
