Safety Alert

From the International Association of Drilling Contractors

ALERT 07 – 13

DROPPED CRANE BLOCK HOOK LATCH

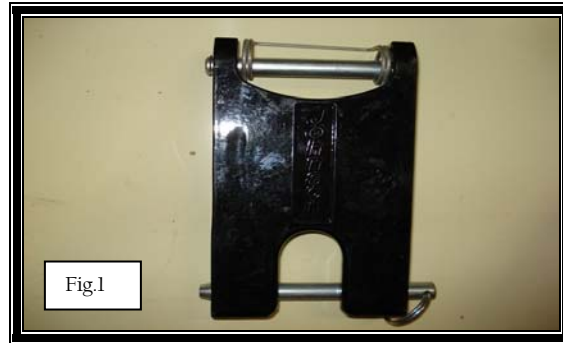
The deck crew was changing out cutting skips. A full skip had just been landed and unhooked from the whip line of the starboard crane. As the crane was booming into position for the next lift, the J-latch (Fig.1) from the main block's hook fell approximately 40 meters and landed on top of the cuttings skid, then bounced between two employees and came to rest on the main deck. No injuries or other damage occurred. The incident was designated "High Potential" for severe injury.

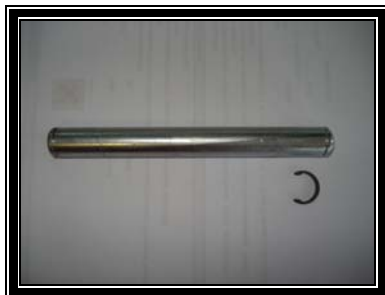
The impact dislodged the circ-clips which allowed the pin to be knocked out of place which allowed the latch to fall (see Fig. 3 below).

Fig. 3: The pin that was displaced after the circ-clips were dislodged when the block struck the boom.

Circ-clip installs in the grooves at each end of the pin that retains the hook latch.

It has been ascertained that the circ-clip and pin system used to retain the hook latch is designed for easy disassembly for equipment inspection and should not be altered.

- **Maintenance personnel** are to ensure the J-latch system is placed on preventive maintenance plan for annual change-out of renewable / replaceable parts (pin and circ-clips; and main latch if required). Have complete spare latch assembly on hand.

- **Crane operator** is to conduct an immediate post-impact inspection if the block is seen to contact the boom or other object. Verify pin is in place with circ-clips intact.

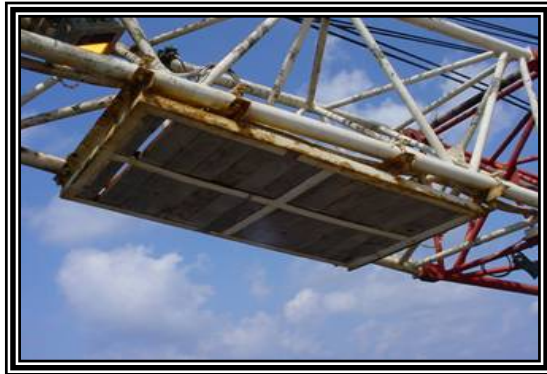
Fig. 4: The boom saver pad that did not prevent main block from contacting the boom.

- **Crane Operators** during pre-tour inspections are to ensure the following:
 - The anti-two block is correctly positioned so the block cannot be stopped above the boom saver.
 - The J-latch system is intact—circ-clips are securely in place on the pin.
 - The boom saver pad is in good condition and positioned to prevent metal-to-metal contact (see Fig. 4 below).

- **Crane operator** is to operate crane in such a way to prevent excessive swinging of the main block.
- **Maintenance personnel** are to consider changing boom saver pad to wrapped nylon line, as it may be more effective and lighter.
