Safety Alert

ALERT 08 – 02

STANDPIPE PRESSURE GAUGE THREAD NIPPLE FAILURE (UNDER PRESSURE)

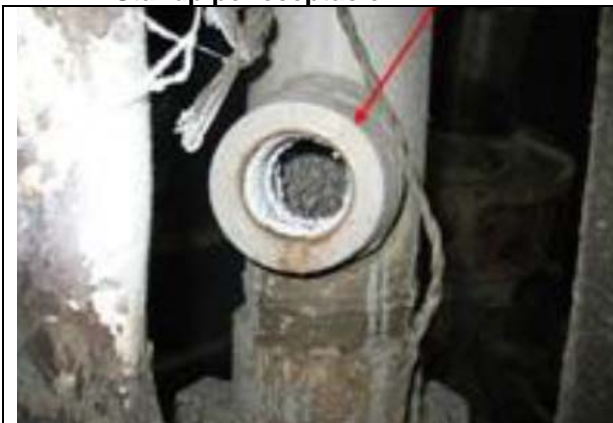
Standpipe receptacle

The investigation determined that the two inch nipple had only three threads buried (threaded) into the standpipe receptacle.

1. Rig supervisors are to review this incident with all crewmembers.
2. Rig supervisors are to ensure crewmembers know how to properly install a high pressure nipple and / or attachments (i.e., gauge, nipple, blow-plug, “T-junction’s”, etc.).
3. When installing or repairing a high pressure line and /or attachments, this task must be supervised by the Rig Manager or Driller to ensure proper nipple selection and installation.
4. Inspect all high pressure lines and fittings to ensure the correct amount of threads have been “buried” (threaded) into the receiving receptacle.
5. A new standard for high pressure lines and fittings will be implemented at a later date within company.

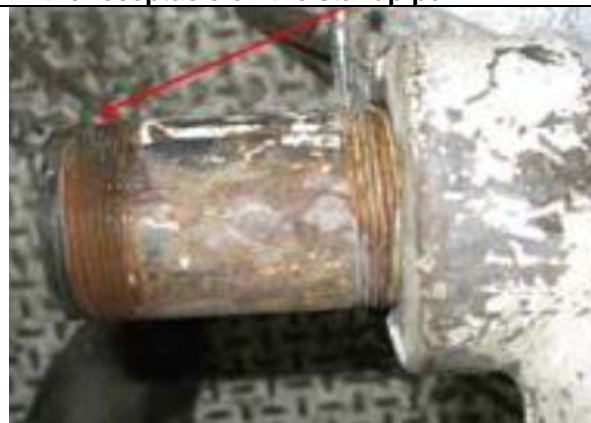
Only three threads were buried into the receptacle on the standpipe.
