# Safety Alert

ALERT 08 – 03

## CRANE RIG UP RESULTS IN FALL FROM HEIGHT

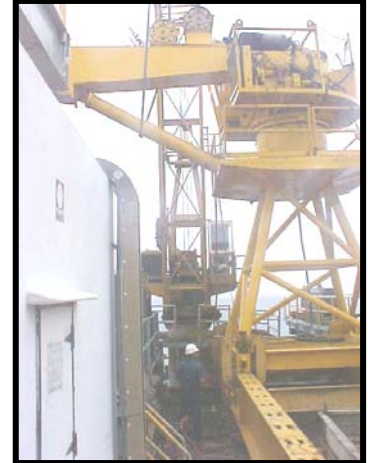
The rig crews were rigging up a tall pedestal crane on an offshore production platform as the first phase of the drilling package rig-up process. The heel section of the boom was secured and pinned and the next task was to install a hydraulic cylinder, which is used to raise and lower the boom. The Driller and Derrickman had successfully removed the transport-securing pin and were lowering the cylinder in place on the turntable clevis with assistance from another crane. At this point the cylinder slipped in its rigging and fell onto a handrail, which protected the pedestal walk around. The handrail was broken from its base and fell 18 feet (5.4 meters) to the deck, taking with it the Derrickman who was tied onto it by his fall protection lanyard. The injured received skull fractures and a broken right arm.

The rigging was not properly applied. Past work practice has dictated the procedure for rigging up the cylinder with a second crane, and rigging that was simply slung underneath to support the cylinder to ease the positioning of the cylinder into the turntable support clevis. As the cylinder was lowered into position, it increased the angle exposed to the slings, causing the slings to slip upward on the cylinder, allowing it to fall.

The Derrickman had tied off his fall protection lanyard to a handrail that was enclosing the pedestal walk-around. Handrails surrounded the platform walk-around, so there was no need for the Derrickman to tie off.

**Perform JSA’s on each task in a job - not the whole job.** Clearly the installation of the boom heel section and then the cylinder are two tasks in the job of installing the crane. After the job is complete, capture lessons learned during the review of JSA and up-date the JSA on file as needed.

**Rig supervisors:** Immediately audit fall protection training on your rig. Spend an equal amount of time talking about tie-off points as you do on wear and care of the harness. Identify individual tie-off points for your lanyards. Provide and clearly mark tie-off points around the rig. A handrail is not an appropriate tie off point for fall protection, as it is designed to withstand only 200 pounds of side loading, where as an appropriate fall protection tie off point is required to withstand 5000 pounds of dynamic loading.

**When rigging loads, use only API recommended hitching techniques.** Improvised slinging will not be a part of our work practice.
