# Safety Alert

ALERT 08 – 09

## UNSECURED LOAD RESULTS IN AN INJURED EMPLOYEE

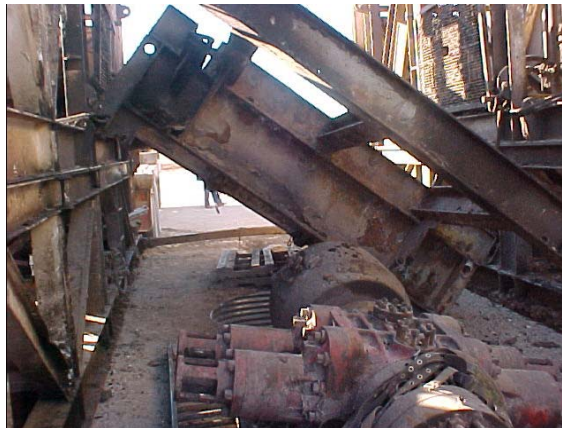
Rig crews utilizing trucks and a crane were in the process of rigging up. The pony subs were set and the top subs stacked. The crane set the first substructure spreader in place, however, the spreader did not set down into the substructure pin ears all the way. At this time the crane line was unhooked from the spreader. This action resulted in an overhead load (i.e., the spreader) not being secured. It is not clear who instructed the crane swamper to disconnect the crane line from the spreader. A gin truck was hooked on to the driller's side substructure at the bottom and onto one side of the load hitch. When the gin truck lifted the substructure it spread the substructure more than expected letting the spreader fall through the substructure to the ground. Two employees were on the ground below the spreader when it fell. They were looking up to see what needed to be done to allow the spreader to set in place so the pins could be installed. One employee was able to move out of harms way. The other employee was struck by the spreader and knocked into the cellar resulting in a severe injury. A cellar cover was not in place.

There was a failure to follow procedures detailed in the "Safe Work Procedures Handbook". The company's handbook states: "**All personnel to stand clear of all overhead work.**"

1. Do not unhook from a suspended load until it is secured. Once secured approval for unhooking must be given by the supervisor overseeing the operation.
2. Top pins should be installed first. This will secure the load before installing the bottom pins from underneath.
3. The company's truck supervisor, rig manager or driller should be supervising rig-up of the substructure assembly. One of these supervisors is responsible for directing **ALL** aspects of the job including authorization for unhooking from the load.
4. A cellar cover is to be installed before assembling the substructure.
5. These incidents will continue to occur unless we **STOP AND THINK**.
6. **ALL** employees have the responsibility to observe fellow crew members **and STOP UNSAFE ACTS IMMEDIATELY** and teach the correct procedure and sequence.
