Safety Alert

From the International Association of Drilling Contractors

ALERT 09 – 10

DAMAGED ELECTRIC CORD RESULTS IN WELDER ELECTROCUTION

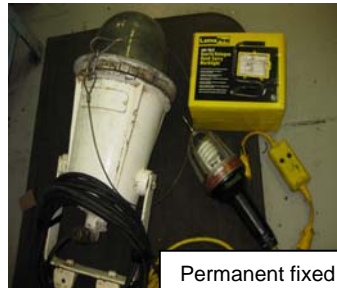
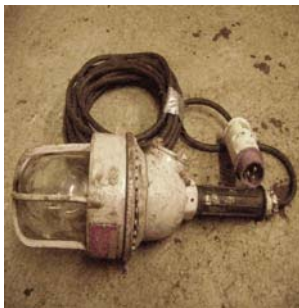
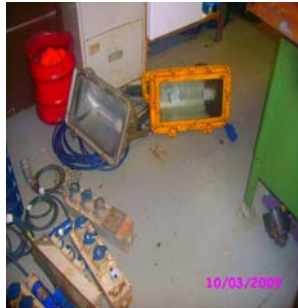
10. **Instructed operations personnel that all the below lights have metallic cases or enclosures and are prohibited as Portable Lighting**

Permanent fixed light not to be used as portable.

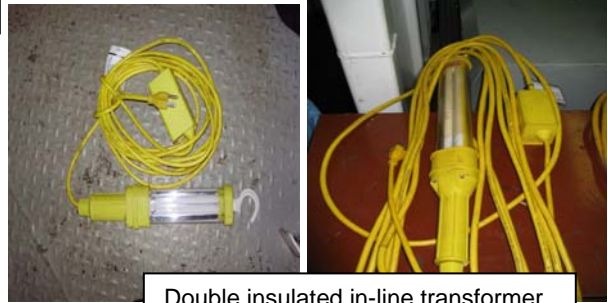
ACCEPTABLE *PORTABLE* LIGHTING

All have plastic enclosure (except air-powered unit)

Air Powered – 24 Volt.

Battery Powered

Double insulated in-line transformer.

1. **Primary Preferred Method: Air-driven**
2. **Secondary Preferred Method: Battery-operated**
3. **Approved (NOT preferred): Low-voltage (50 Volt AC and below) with in-line transformer**
4. **LAST RESORT (must be approved by Rig Manager / Electrical Supervisor prior to use): High-voltage (above 50Vac) must be rated for portable service as well as double insulated**
