Safety Alert

ALERT 10 - 11

CUTTINGS AUGER AMPUTATES LEG OF RIG CREWMEMBER

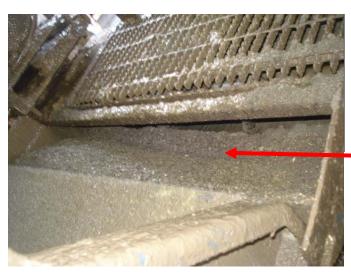
The cuttings auger was installed by a third party. By design, the area between the auger and the shaker was left open to allow the cuttings to fall into the ditch. The remainder of the auger was protected, but the existing hazard was not recognized by the crew or the company who installed the system.

Open area where employee's leg was trapped.

- Instructed operations personnel that all rigs must immediately conduct a hazard hunt on the shaker areas, ensuring that all machinery is effectively guarded. Where deficiencies are identified the machinery should be flagged or locked out and repaired as soon as practicable.
- Instructed rig supervisors to inspect the entire auger system (where applicable) ensuring that no one can access any portion of the auger.
- Rig maintenance personnel or third party auger provider are to provide an emergency shutdown for the auger system (where applicable) so that it can be accessed from any position along the entire length of the auger.
- Corporate HSE personnel will develop procedures for properly guarding of augers and related systems.
