# Safety Alert

ALERT 10 – 25

## WELDING ON A TRUCK TIRE RIM RESULTS IN A SERIOUS INCIDENT

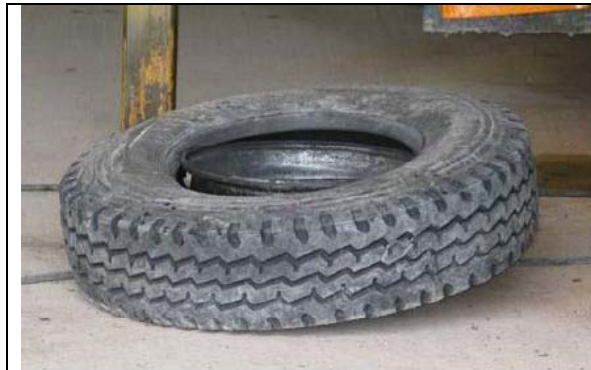
Wheel landed 3 to 4 meters from its original location after hitting the roof

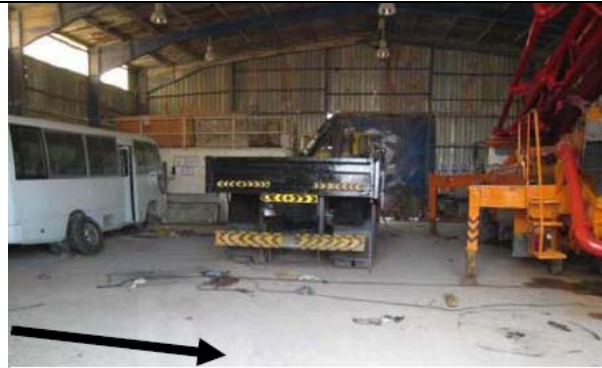
Interior of the Workshop where the incident occurred (arrow tip)

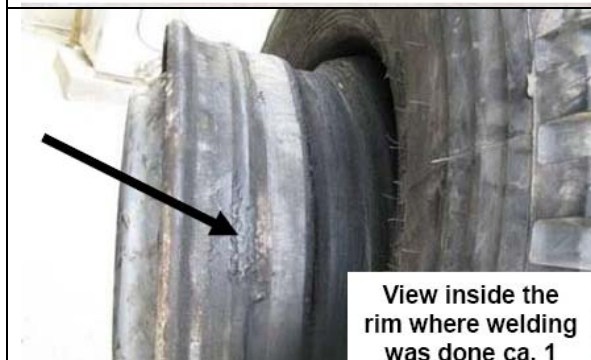
View inside the rim where welding was done ca. 1

- Welding on a single piece rim with a pressurized tire.
- The person in charge / supervisor assigned an unqualified welder to weld on a wheel rim mounted with a pressurized tire.
- Not making use of all required safety equipment, including PPE and tire cages that were only a few meters away.
- Failure to recognize the risks involved in the operation

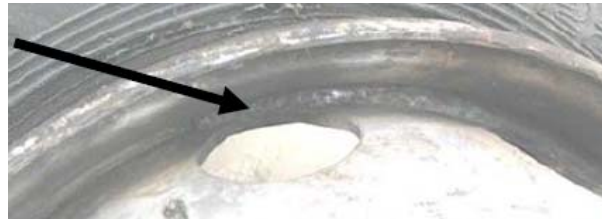
Weld area from hub side

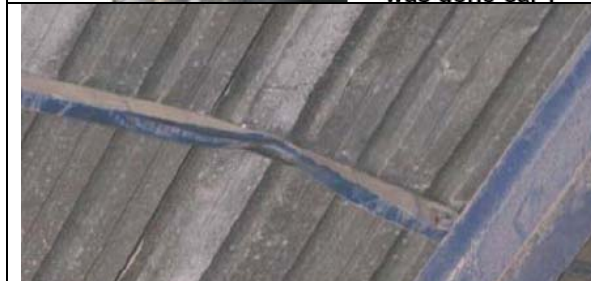
Cross-beam of the roof struck and dented from impact of the wheel (Tyre-Rim Assembly) launched from the floor (ca. 8 mtrs)

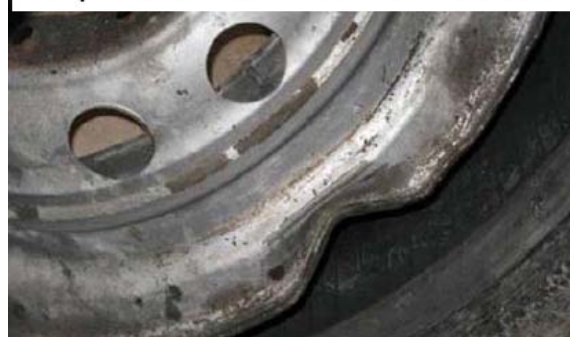
Inside edge of the wheel rim indicating impact when it struck the roof cross-beam
