# Safety Alert

ALERT 02 – 42

## MATERIAL HANDLING INCIDENT

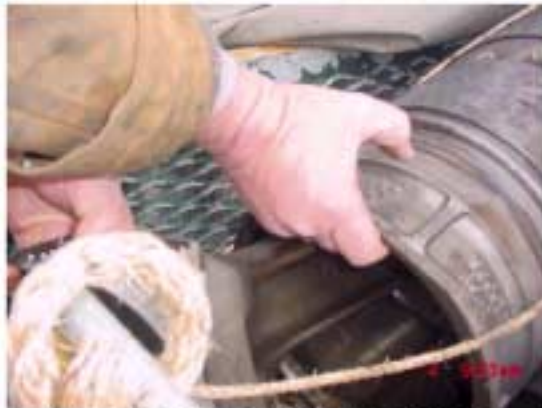
An employee had his left middle finger caught between a connecting rod and the body of a power pack for a diesel engine. The power pack was lying on the engine grating walkway and was being moved from the grating walkway platform to the main deck. The 400-pound power pack was pushed along the floor by two men using their feet to move the power pack approximately 15 feet towards a hatch opening to the main deck. At the opening for the watertight door both men attempted to physically pick up the power pack and lift it approximately 7 inches over the hatchway opening. One of the employees decided to lift the power pack by placing both hands inside the body of the cylinder head. On previous lifts he had placed his hand on the connecting rod of the power pack. He changed his hand position because the connecting rod was turning in a circular fashion making it difficult to control the load. As the men were going through the door, the piston body cleared the 7-inch rise but when the men lowered the piston body the rod caught on the hatch opening catching the employee's left middle finger between the rod and the body of the power pack.

Not recognizing the hazards associated with job. The JSA did mention to beware of pinch points, but didn't identify that putting your hands inside the power pack would be a pinch point. Improper Handling of Materials - need some form of mechanical means when moving an awkward 400-lb. load.

Figure 1: Demonstrates hand placement prior to injury

Instructed Rig and Maintenance Personnel to change the JSA to:

- Identify all pinch points:
- Change the JSA to identify which mechanical means you are using to move the power packs.
- Use a transport box and dolly to move power packs

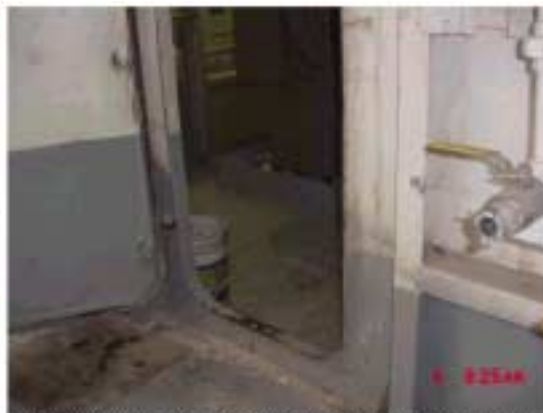
Figure 2: The watertight door that they set the rod down on.
