# Safety Alert

ALERT 03 – 11

## CABLE CAUGHT IN ROTARY HOSE CLAMP RESULTS IN NEAR MISS

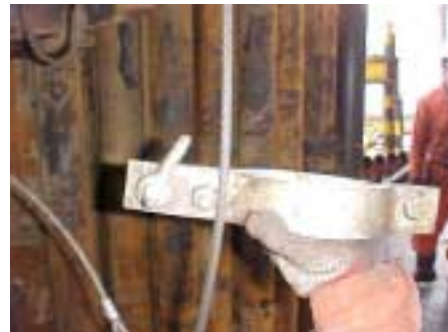
While lowering the block after completion of wire line logging operation, the port aft man-rider winch cable became hooked on the TDS mud safety chain clamp. This action caused increased tension on the cable, breaking the crown sheave swivel retaining pin, side plate and 2 safety slings. The sheave and line dropped 50 feet to just below monkey board level where it got hooked up on the block hang off line. The sheave retaining pin lock nut dropped to the starboard drill floor wind wall roof.

After using the man rider the operator had checked the line and made it tight, but had not noticed that it was caught behind the mud hose clamp, positioned 85 feet above the rig floor. Design of the mud hose clamp which has a protruding bolt that caused a hang-up point for winch line (see picture)

- Revised the JSA for Logging to include a step to check the personnel hoist cable to ensure it is clear of the top drive prior to moving the top drive.
- Modified the clamp in such a way that wire does not get caught or hanged up.
