# Safety Alert

ALERT 03 – 22

## USE OF ROPE & BUCKET TO CATCH SAMPLES RESULTS IN A HAND INJURY

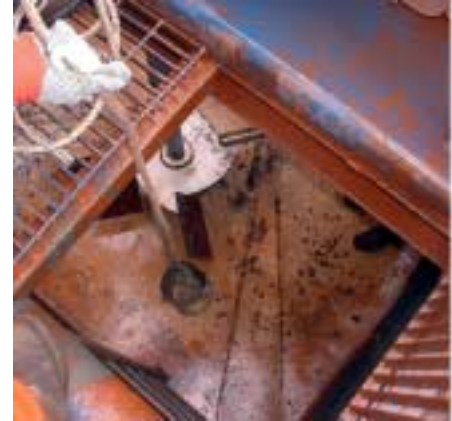
During a cementing job, the slurry was batch mixed in a 100 bbl Batch Mixer with two agitators. The assistant cementer used a rope with a can to take a sample of the slurry inside the tank. The can / rope became wrapped around one of the agitator's shafts. The employee managed to release the rope from his left hand, however the rope was pulled across his right hand, tearing through the glove and causing damage to 3 fingers and his palm. Due to the severity of the injury, his little and ring finger and part of his right hand were amputated.

The pre job inspection did not reveal the absence of a proper sampling outlet. This resulted in the use of a rope and can instead of obtaining the sample from a sampling outlet. In addition, the rotating agitator was close to the access hatch that was used as a sample point. The inside of the batch mixer was dark and the employee could not see the fluid level or the position of the rope and bucket to the rotating agitator. The employee did not receive adequate orientation on the operation of the batch mixer and did not understand the risks involved in this task. Adequate supervision and appropriate risk assessment of the overall job was lacking. Hazard identification process was absent on the rig site, at the base and when manufacturing this batch mixer. There was also non-conformance with the company's Lock Out / Tag Out procedures.

- STOPPED the practice of using a rope to take samples in any vessel with paddles or agitator.
- Instructed units to install proper sampling point on all Batch Mixers or vessels.
- If it is not possible to install a sampling point, the agitators must be shut off and the sample caught using a pole with can attached.
- Implement mandatory use of a hazard assessment and a JSA in all cementing operations (including routine jobs).
- Incorporate lessons learned from incident into company hand/finger awareness training package.
- Requested that a stand down day be held company wide to reinforce the use of risk identification tools and techniques.
- Share lessons learned with all companies that use mixing tanks with agitators i.e. STOP taking samples using the practice of dipping a can into an agitated pit.
