Safety Alert

ALERT 03 – 26

LAYING DOWN CUT-OFF CASING JOINT RESULTS IN A FATALITY

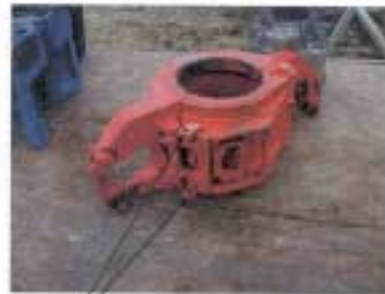
PICTURE OF THIRD PARTY ELEVATOR

The sub contractor's 150 ton side door elevators were certified but did not have the manufacturer's Safety Latch Lock Pin in place. The manufacturer requires the use of a safety latch lock pin on all side door elevators to ensure the elevator is closed properly and cannot open. This incident and past incident history involving this style of elevator indicates that this safety latch lock pin is critical in ensuring that the elevator door is properly closed and secure.

Note: The elevator has the tabs installed as per manufacturer's specification but the safety latch lock pin and safety chain had been removed.

- Prior to the elevator being used for the operation, the supervisor must inspect the elevator to ensure that the safety latch lock pin is in place.
- The elevator must also be function tested to ensure that the door latch, spring and safety latch locking pin operate properly.
- The inspection can be incorporated into the pre-job safety meeting prior to the commencement of the task.
- **If the safety latch lock pin is not in place the elevator must not be used. The safety latch lock pin is the secondary method ensuring the elevator is closed properly.**
