# Safety Alert

ALERT 04 – 04

## LANYARD CAUGHT IN KELLY RESULTS IN A FATALITY

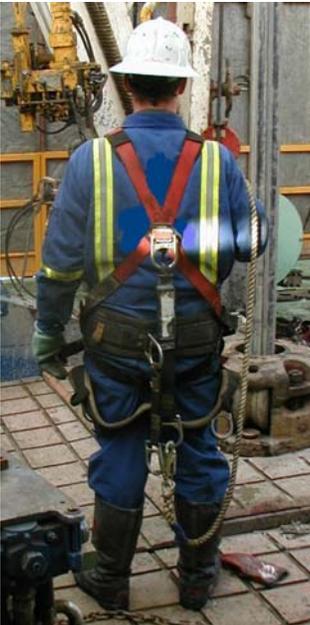
##### *Full body harness and attachments*

A rig worker was fatally injured after his 6-foot lanyard was wrapped around the Kelly bar. The daylight crew were in the process of drilling surface hole. A cable used during slip and cut operations had become unsecured and was hanging inside the derrick. The Motorman volunteered to secure the cable to the derrick girt. The worker was wearing a full body harness with a 6-foot rope lanyard attached to his shock absorber.

- Identify and enforce clear standards associated to working around rotating table. To assist this process complete an individual hazard assessment clearly identifying **danger zone** (distance) and compliance measures.
- Identify and enforce clear standards associated to use of fall protection equipment in and around rotating equipment.
- Work with fall protection training agencies to ensure that procedures for wearing fall protection address hazards associated to moving equipment.
