# Safety Alert

ALERT 04 – 27

## DROPPED OBJECT – AIR TUGGER HOOK

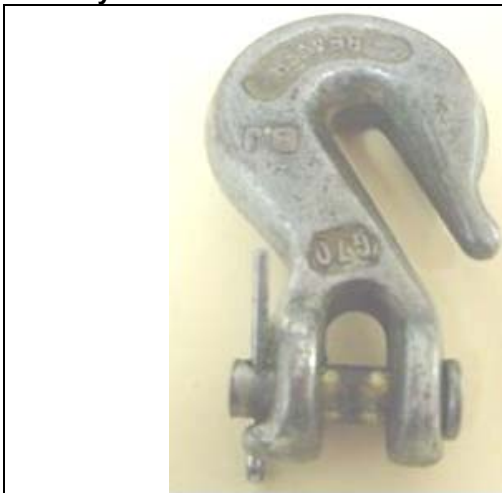
#### Old Style Hook:

The hook from the tubular pull back tigger in the derrick fell to the drill floor while tripping out of the hole. The tigger hook was of a design with a clevis pin through the hook attachment eyes held in place by a cotter pin. The cotter pin had been installed prior to the start of the trip out of the hole. It is assumed that the pin was defective and came away; allowing the clevis pin to back out of the chain loops and allowing the tigger hook to fall to the drill floor. The weight of the hook was approximately 7ozs (210gms) and fell from a height of approximately 90 feet (28m).

1. Design of the hook attachment eyes requiring use of the clevis pin secured by a cotter pin.
2. Visual inspection only conducted prior to use – not physical inspection.

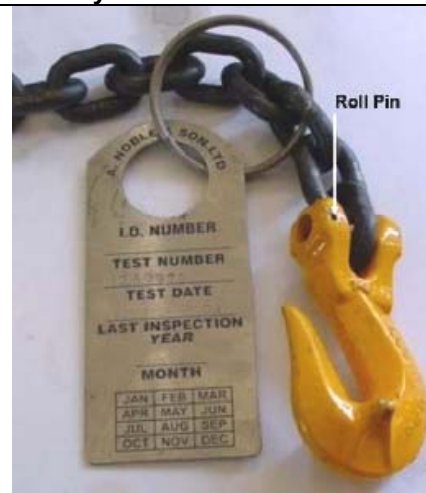
#### New Style Hook to be used:

1. Replaced hook arrangement with new design featuring improved safety features. (see photos). New design has clevis pin through the hook attachment eyes. The securing roll pin can only be inserted from one side and has no external surfaces exposed to possible interference. Removal of the attachment pin can only be achieved by first driving out the roll pin and then driving out the clevis pin.
2. Update JSA to include physical inspection of equipment prior to use.
