Safety Alert

From the International Association of Drilling Contractors

ALERT 04 – 38

JOINT OF DRILL PIPE FALLS TO RIG FLOOR

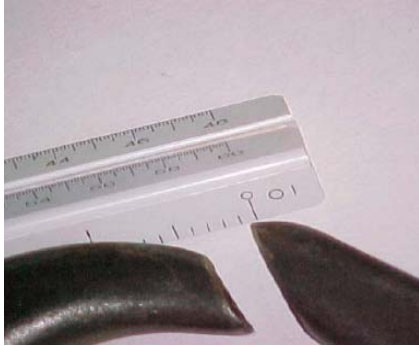
Figure 2 = 0.3 inch

Although not a contributing factor in this incident, the investigation revealed that the locking safety hook was worn beyond the manufacturer’s maximum clearance. A copy of the manufacturer’s inspection data sheet for Maximum In-Service Clearance is shown. (See Figure 1) Figure 2 shows over 0.3” or just under 3/8” opening between the latch and the body of the hook. According to the manufacturer, the maximum allowable clearance between the body and the latch on this 3/8” hook is 0.09” or 3/32”.

1. When using a locking safety hook the employee shall visually inspect prior to use and ensure that the hook is latched and locked prior to lifting the load.
2. Inspect all locking safety hooks immediately and remove from service all hooks that have a gap between the hook and the latch larger than specified by the manufacture.
3. Include all locking safety hooks in the rigs lifting gear register and ensure all lifting appliances are inspected in accordance with the manufacturer recommendations.
4. A copy of the attached inspection data sheet showing maximum allowable clearance for locking safety hooks shall be available on board the rig.
5. Existing (old style) Locking Safety Hooks currently in use be replaced as they become unserviceable with one that has side safety guards to keep the latch from accidentally opening if hit or bumped. (See figure 4 attached.)

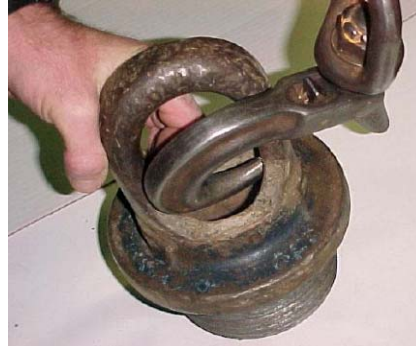
Figure 3

The employee indicated that he heard the hook close but did not see the locking safety hook close around the lift cap. Based on that, the assumption is made that the hook was never latched around the lift cap. It probably closed on the lift cap and never locked; thereby the lift cap was not sitting in the throat, but on the tip of the hook. (See Photo in Figure 3) The twisting motion when the employee attempted to remove the protector from the joint of pipe resulted in the lift cap twisting out of the hook tip and falling to the floor and across the derrick.

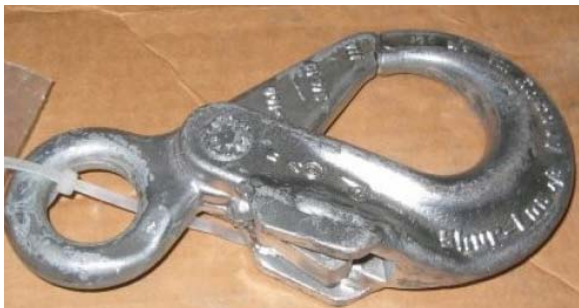
Figure 4 Safety locking hook with safety guards.
