# SAFETY ALERT

## EMPLOYEE STRUCK BY DRILL LINE WHEN THE WIRE ROPE GRIP (SNAKE) PARTED ALERT 1-20

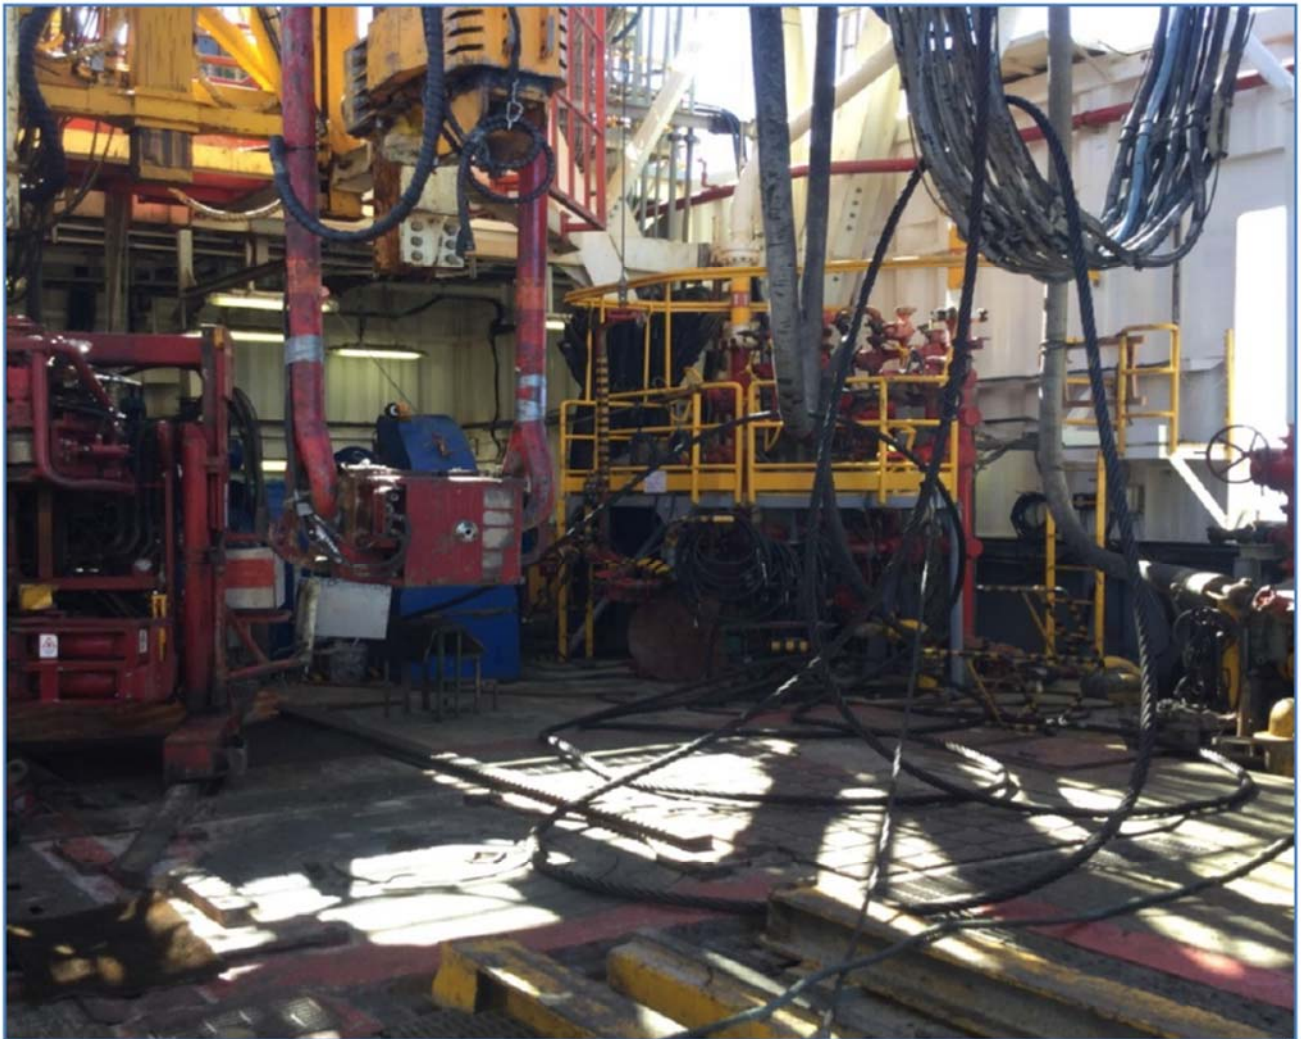
The drill crew was in the process of changing out the 2" drill line on the rig floor and as the Driller was picking up the draw works to remove the slack from the drill line, the wire rope grip "snake" parted, and the drill line fell to the rig floor striking a Floorman. The Floorman sustained injuries to his ribs and back as a result of being struck by the drill line.

Drill line position after wire rope grip failed

- Going forward, the use of wire rope snakes with *drill lines* will require a risk assessment and MOC approved by a Vice President.
- Investigate the use of alternative to the current approved wire rope grip ‘snake’ for all wire sizes used.
- Wire rope grips will be taken out-of-service and discarded after one use.
- The rig floor will be cleared of personnel while the drill line is being pulled by the drawworks or line spooler.

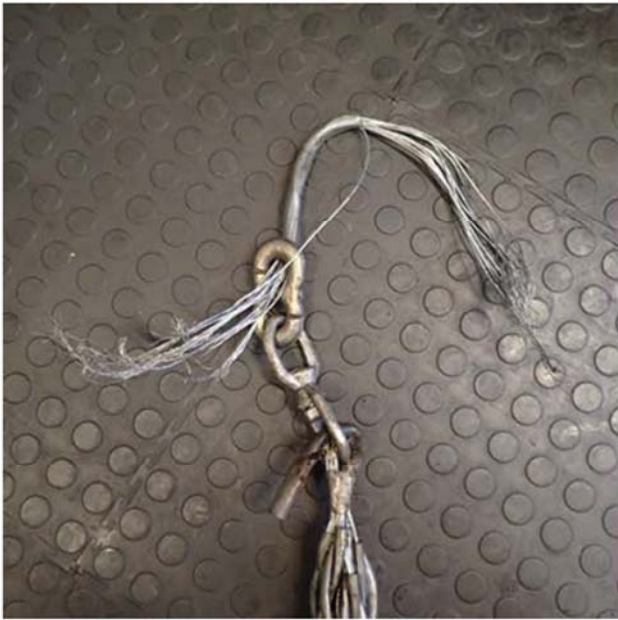
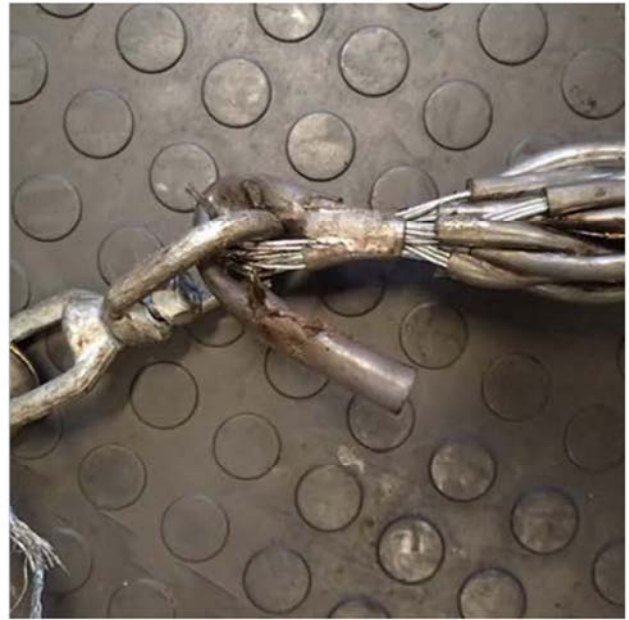
Failed components of the wire rope grip

- The drill line wire rope grip (Snake) was overloaded past its breaking strain causing it to fail and drop to the rig floor.
- Personnel were not in an area that protected them from the falling drill line.
