SAFETY ALERT

BACK INJURY CAUSED BY LIFTING SLINGS

Alert 2-20

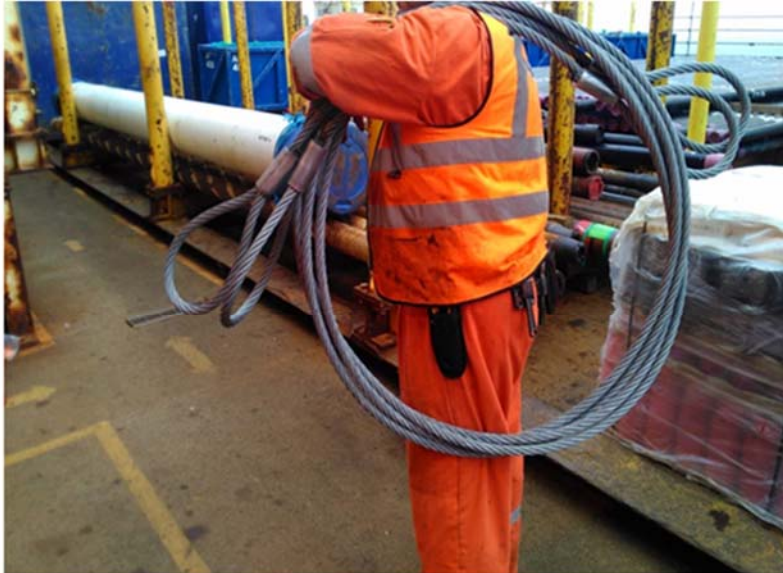
The task was to prepare 4" Heavy Weight Drill Pipe for transfer from V door to pipe deck. The Deck Foreman requested one of the deck crew to bring 2 transit slings from the north side of the pipe deck to the bottom of the V-Door. The IP lifted the 2 slings, bundled together onto his right shoulder (see image below) and proceeded to walk toward the bottom of the V-Door. After walking approximately 3 – 5 metres he felt a sharp pain in his back and slid the slings from his shoulder onto the deck. The Deck Foreman asked another member of the crew to escort the IP to the medic. After a short distance the IP had to stop as he was in too much pain to move any further. Emergency response team (ERT) was summoned to take the IP to the sick bay on a stretcher. The IP was subsequently medevac'd.

- The transit slings normally used for this task were not on-board.
- The heavier slings were the only transit slings available at the time.
- No one questioned the weight of the transit slings.
- The actual weight of slings used offshore is not widely known nor identified in procedures or risk assessments.

- Sling weight campaign to be developed and communicated
- Procedures and risk assessments to be up-dated to include sling weights
- Manufacturers should be approached to discuss feasibility of actual sling weights to be clearly marked on slings
