Deepwater Horizon Accident Investigation Report

September 8, 2010

Analysis 5A. Well Integrity Was Not Established or Failed

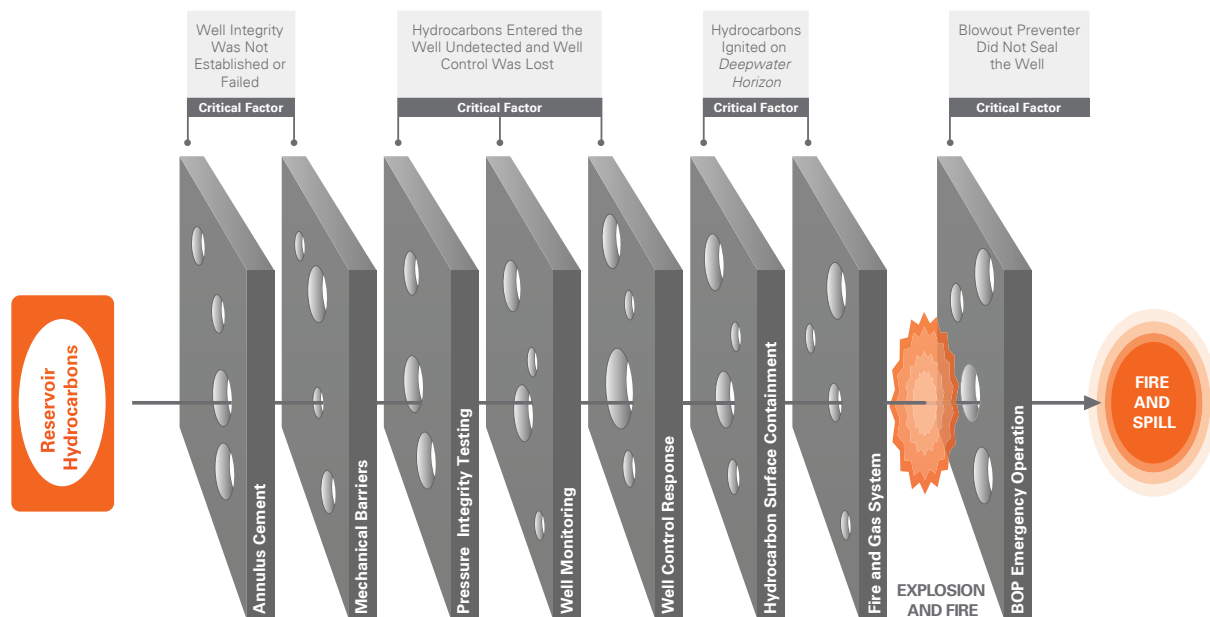
Figure 1. Barriers Breached and the Relationship of Barriers to the Critical Factors.

1. The annulus cement barrier did not isolate the hydrocarbons.
2. The shoe track barriers did not isolate the hydrocarbons.
3. The negative-pressure test was accepted although well integrity had not been established.
4. Influx was not recognized until hydrocarbons were in the riser.
5. Well control response actions failed to regain control of the well.
6. Diversion to the mud gas separator resulted in gas venting onto the rig.
7. The fire and gas system did not prevent hydrocarbon ignition.
8. The BOP emergency mode did not seal the well.

In *Figure 1*, the eight blocks represent the defensive physical or operational barriers that were in place to eliminate or mitigate hazards. The holes represent failures or vulnerabilities in the defensive barriers. The eight key findings are represented by the holes that lined up to enable the accident to occur.

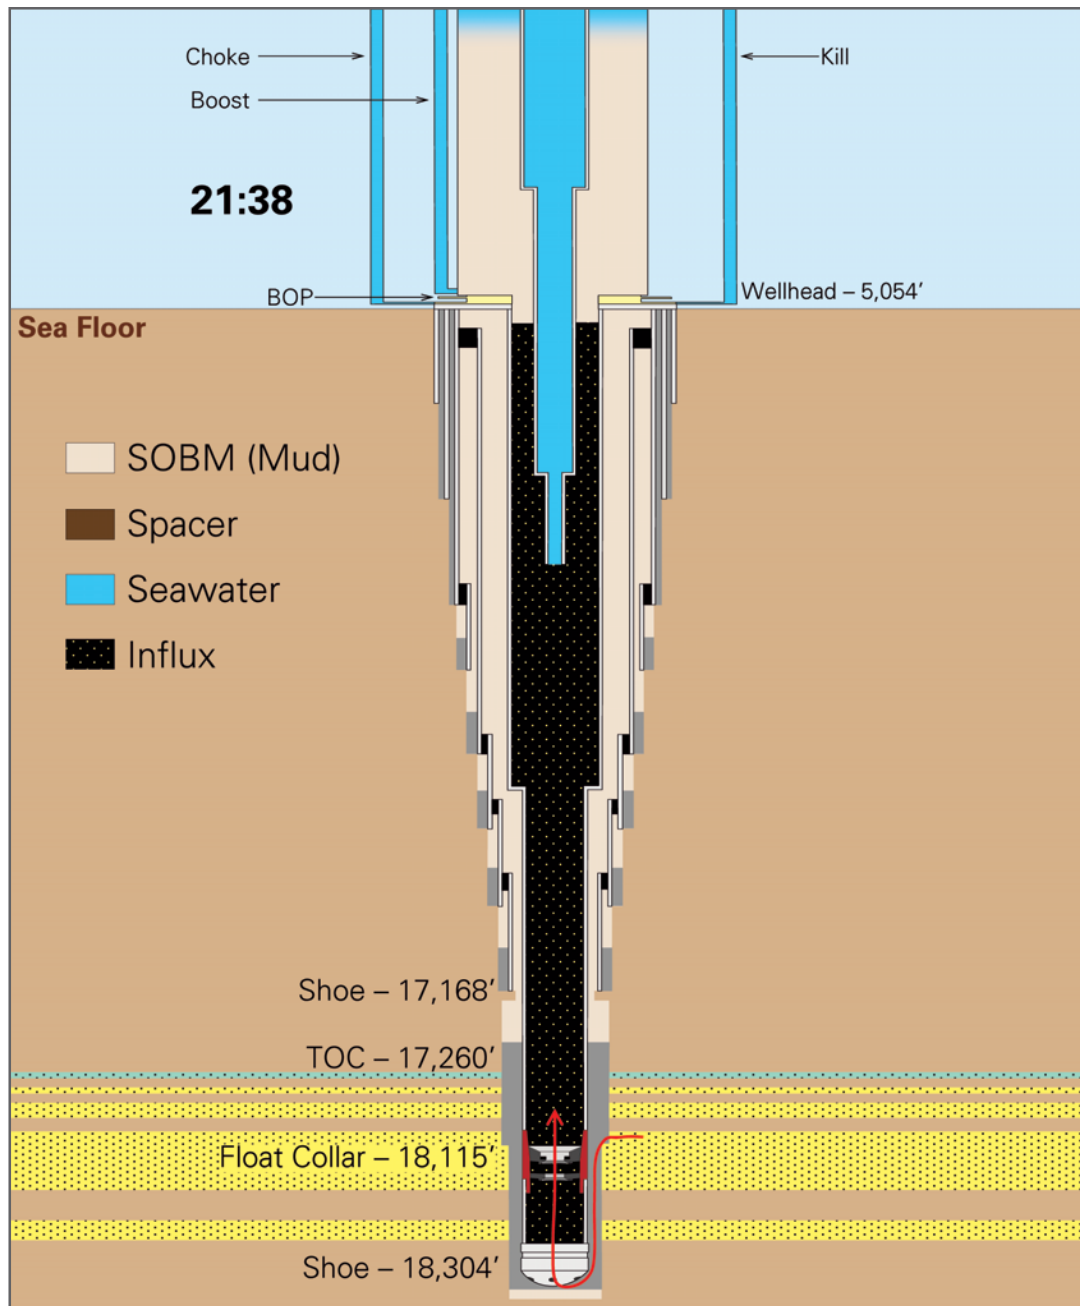
Figure 4. Hydrocarbons Entering the Riser.

Analysis indicates that the first indications of flow from the well could be seen in the real-time data after 20:58 hours. The rig crew and mudloggers either did not observe or did not recognize indications of flow until after hydrocarbons entered the riser at approximately 21:38 hours. The first well control response likely occurred at 21:41 hours.

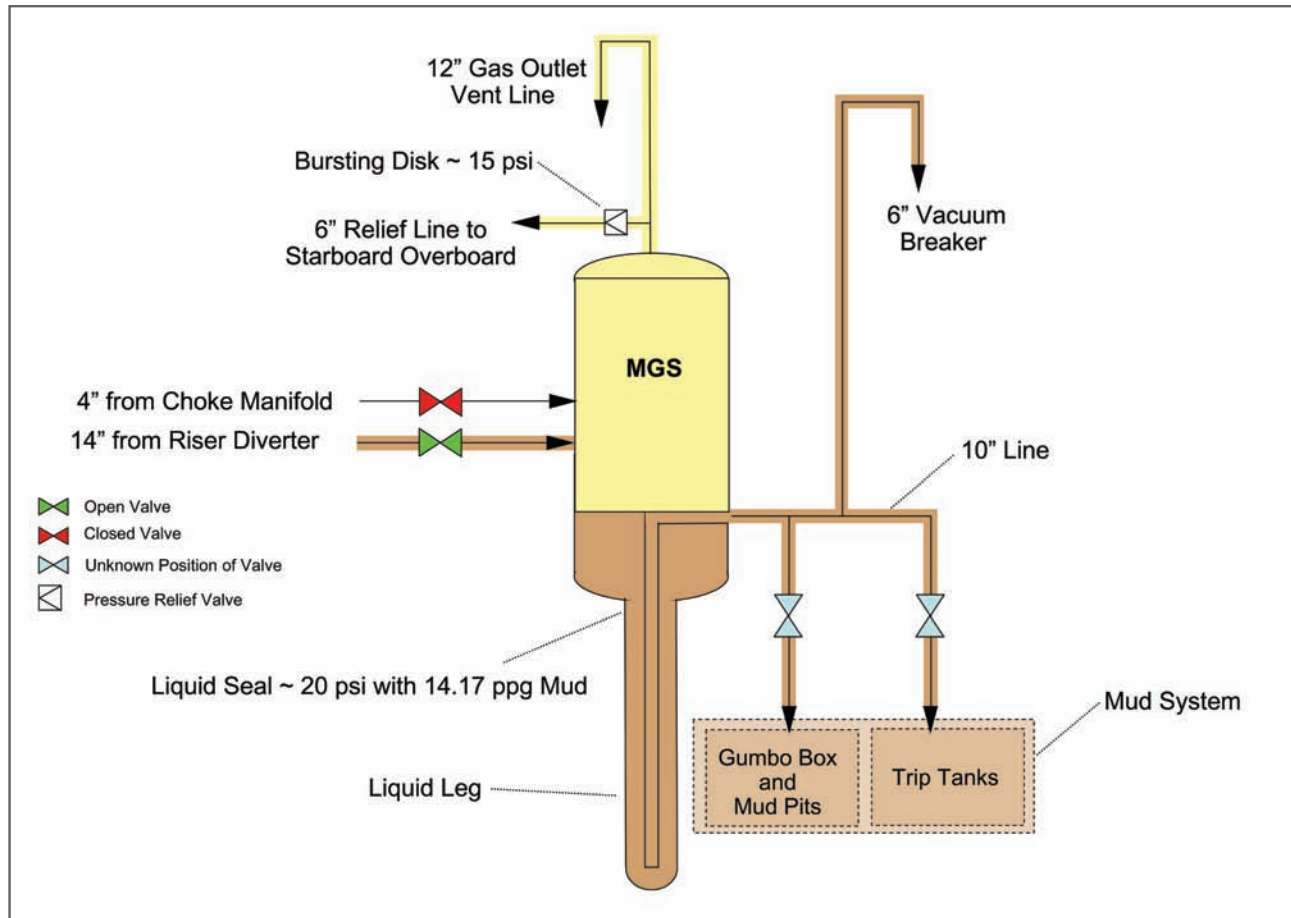
Figure 5. Mud Gas Separator.

The diversion of fluids overboard, rather than to the MGS, may have given the rig crew more time to respond and may have reduced the consequences of the accident.

Transocean's shut-in protocols did not fully address how to respond in high flow emergency situations after well control has been lost. Well control actions taken prior to the explosion suggest the rig crew was not sufficiently prepared to manage an escalating well control situation.

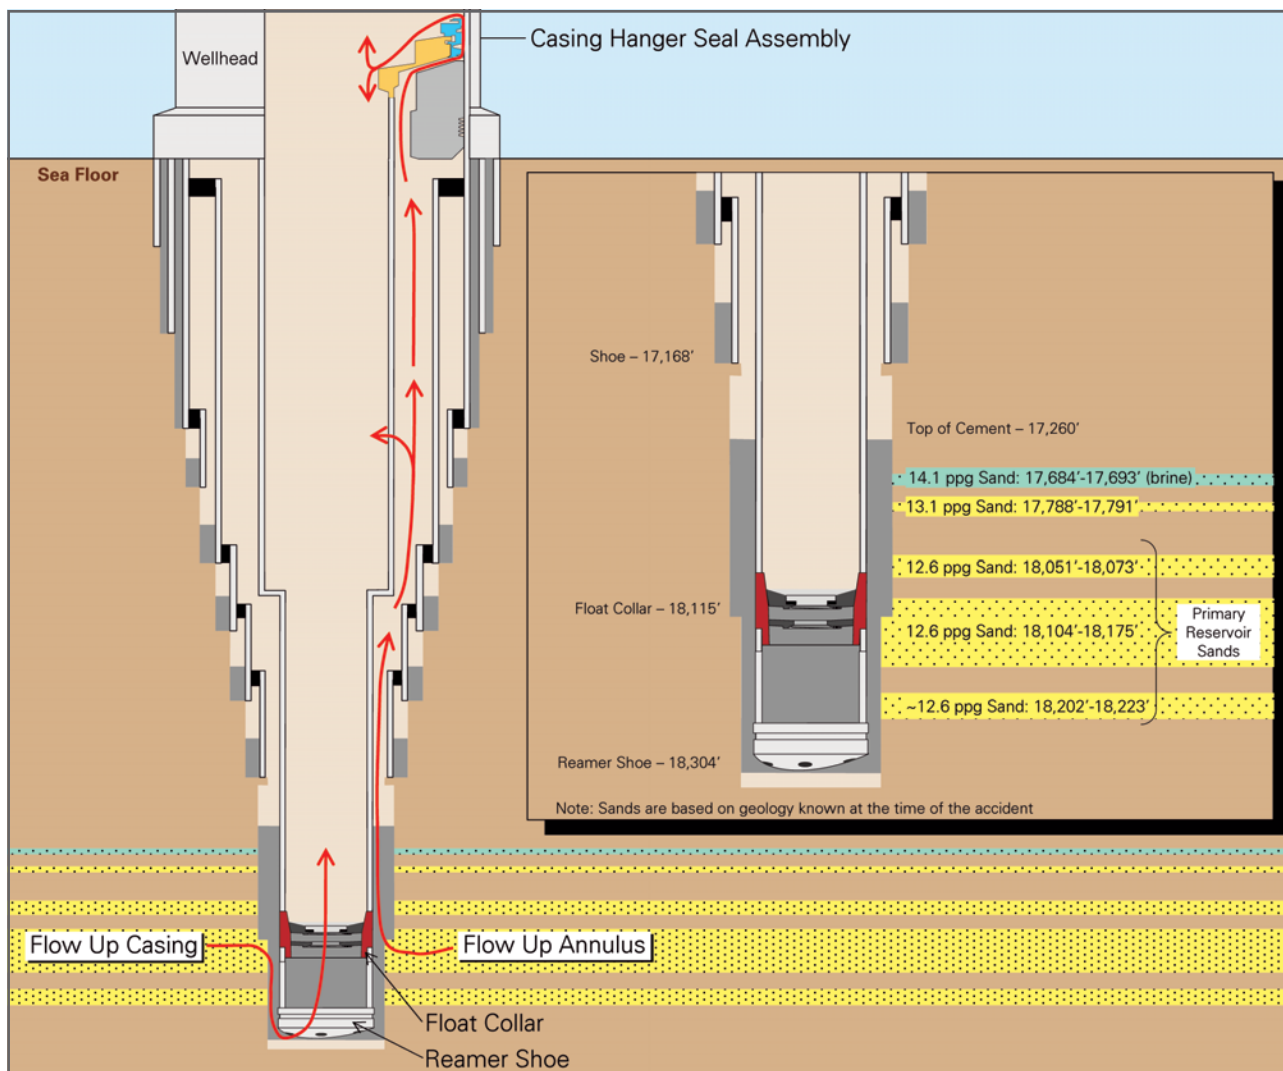
Figure 1. Hydrocarbon Zones and Potential Flow Paths.

The annulus cement barrier failed to prevent hydrocarbons from entering the annulus after cement placement. The investigation team assessed possible failure modes and paths that led to hydrocarbon migration from the formation into the wellbore. (Refer to Figure 1.)

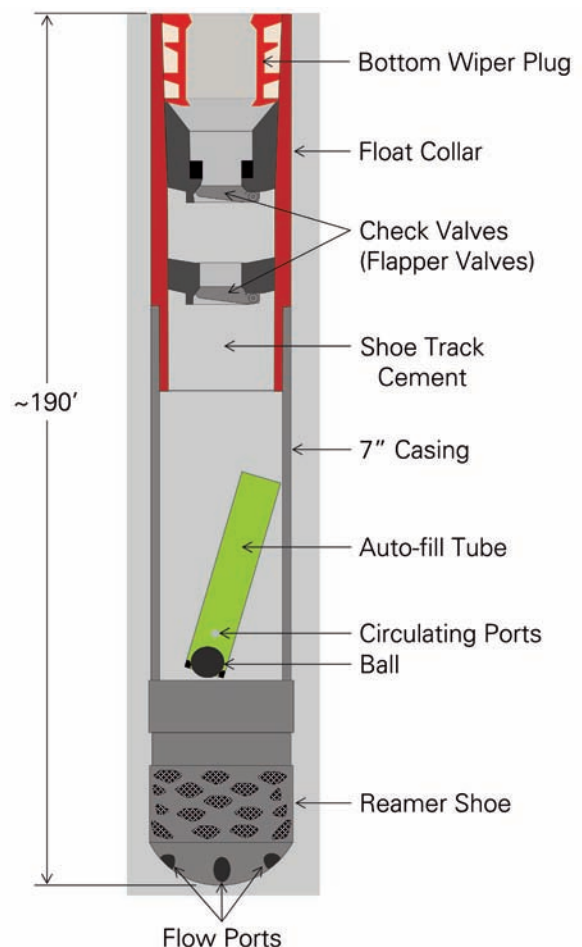
Figure 4. Shoe Track.

Based on available evidence, hydrostatic pressure calculations, OLGA® well flow modeling and analysis of data from the Macondo well static kill on August 4, 2010, hydrocarbons entered the casing through the shoe track. Therefore, the shoe track cement and the float collar must have failed to prevent this ingress. The investigation team has not

established whether this failure was attributable to the design of the cement, contamination of the cement by mud in the wellbore, commingling of cement with nitrogen due to nitrogen breakout from the foam cement slurry, swapping of the shoe track cement with the mud in the rathole (bottom of the well), or some combination of these factors.

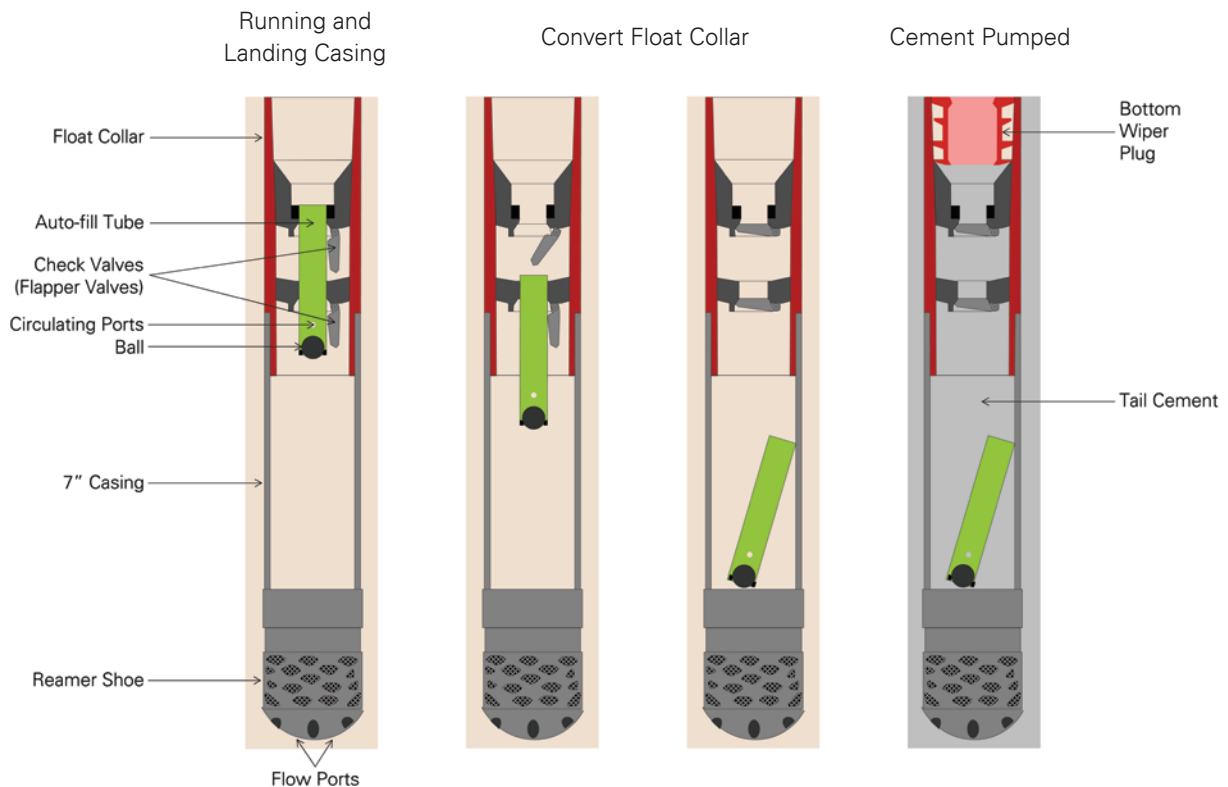
Figure 5. Float Collar Conversion.

At the time this report was written, lab tests were being conducted to determine whether the rush of fluids converted the float collar when the bottom wiper plug's burst disk ruptured or when the plugged shoe was cleared. Preliminary model results indicate that conversion most likely occurred in either case.

The BP Macondo well team interpreted the float collar testing after cement placement as successful. This was further documented in the Halliburton post-job report, which indicated that the float collar was holding backpressure. (Backpressure is the difference between hydrostatic pressure in the annulus and hydrostatic pressure inside the casing, which results from different fluid densities and heights.) However, the investigation team concluded that, with the 38 psi backpressure predicted in the Halliburton April 18, 2010, OptiCem™ program, the backpressure test that was conducted was not a reliable indicator that the float collar sealed.

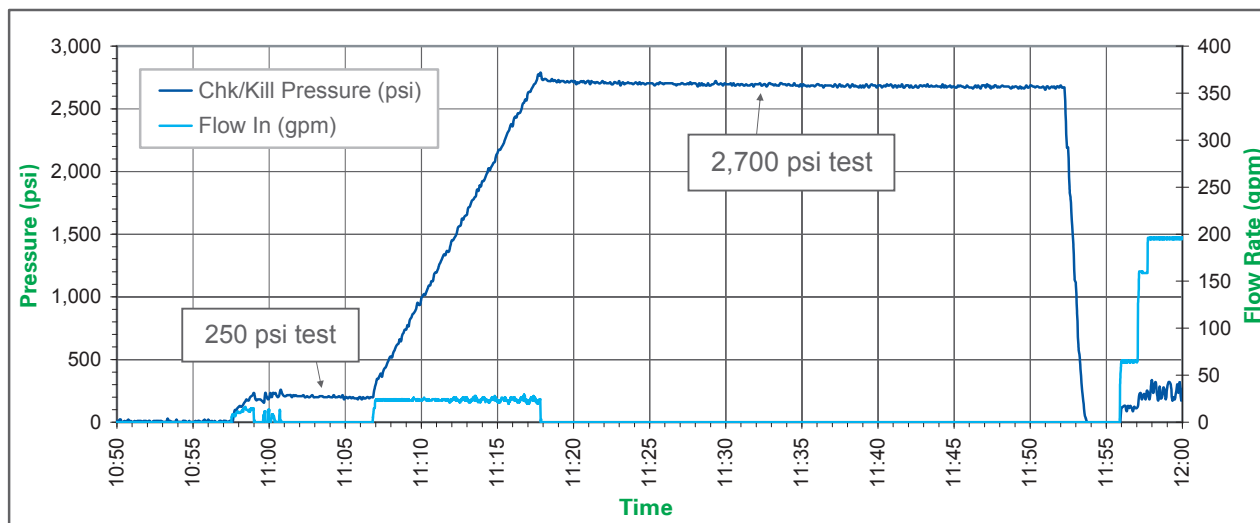
Figure 1. Positive-pressure Test (Real-time Data).

First, after closing the blind shear rams (BSRs) in the BOP, wellbore pressure was increased through the kill line to 250 psi and held for 5 minutes. Second, after no leaks were observed, wellbore pressure was increased to 2,700 psi and held for 30 minutes. The rig crew determined that the test was successful after the observed pressure did not decline more than the criteria specified by the MMS (no more than 10% decline in 30 minutes). The investigation team's review of the test data confirmed that the test was successful. *Figure 1* shows the successful pressure test.

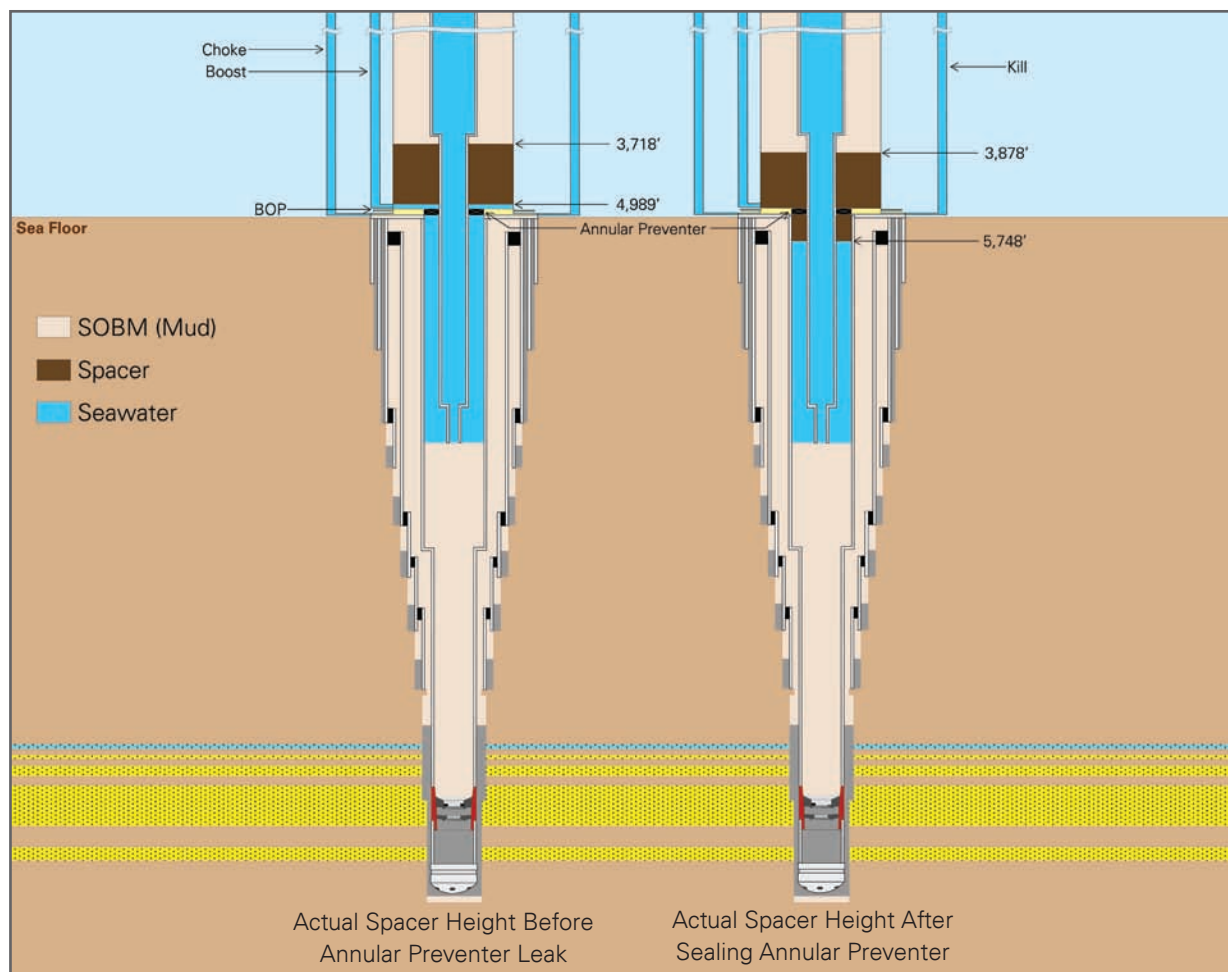
Figure 2. Spacer Placement.

- During the initial attempted negative-pressure test on the drill pipe, the annular preventer was closed, but it failed to seal on the drill pipe, resulting in approximately 50 bbls of spacer leaking past the annular preventer into the BOP during the bleed-off of drill pipe pressure. The investigation team believes that the spacer or spacer/seawater interface was across the BOP during the negative-pressure test procedure. (Refer to *2.3 Opened the Drill Pipe to Bleed Pressure* of this analysis.) The bottom of the spacer, therefore, was not above the upper annular preventer as intended. *Figure 2* shows the actual spacer placement before and after sealing the annular preventer.

- The presence of the spacer across the kill line inlet could have complicated the interpretation of the negative-pressure test. (Refer to *2.5 Continued the Negative-pressure Test on the Kill Line* of this analysis for a discussion of the anomalous pressure readings during the negative-pressure test.)

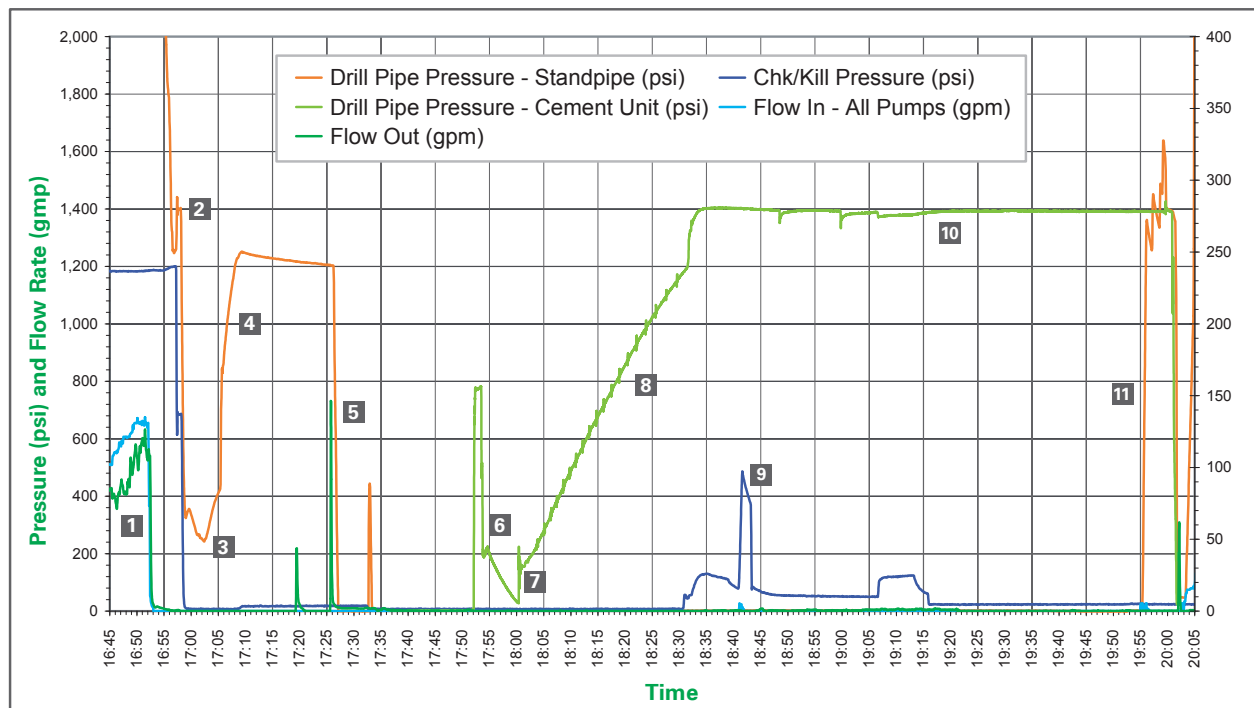
A successful negative-pressure test is indicated by no flow from either the kill line or the drill pipe; however, there was 1,400 psi on the drill pipe, an indication of communication with the reservoir.

| <p>1 Spacer displacement complete; mud pumps stopped.</p> <p>2 Annular preventer closed; attempt to bleed drill pipe pressure to zero.</p> <p>3 Drill pipe pressure decreases to only 273 psi; annular preventer leaking.</p> <p>4 Drill pipe pressure increases as annular preventer leaks; hydraulic closing pressure increased to seal annulus.</p> <p>5 Drill pipe pressure bled to zero for negative-pressure test.</p> <p>6 Decision made to conduct negative-pressure test via kill line; kill line opened; 3 bbls to 15 bbls bled to cement unit.</p> | <p>7 Shut in kill line at cement unit, drill pipe pressure starts to increase.</p> <p>8 Drill pipe pressure slowly increases to 1,400 psi.</p> <p>9 Fluid pumped into kill line to confirm full; kill line opened to mini trip tank for monitoring.</p> <p>10 Discussion ongoing about 'annular compression' and 'bladder effect' while monitoring kill line; drill pipe pressure static at 1,400 psi.</p> <p>11 Negative-pressure test concluded, declared a success; preparation made to continue displacement.</p> |

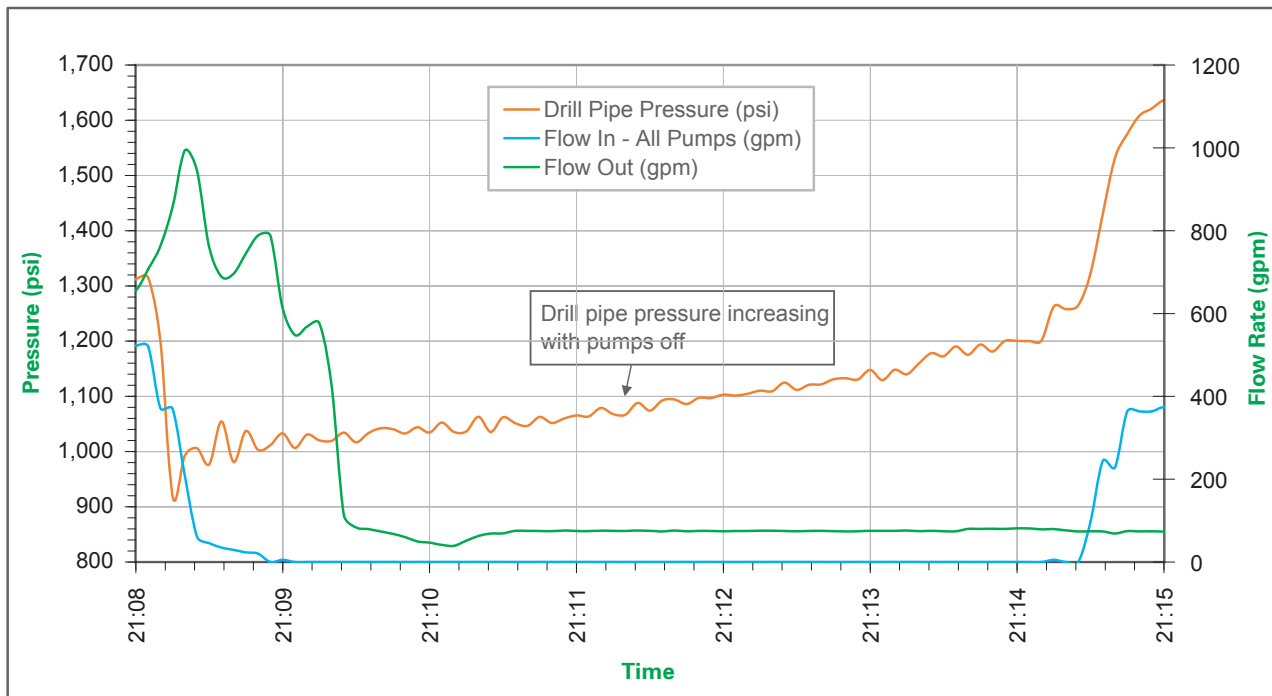
Figure 9. Pressure Increase During the Sheen Test (Real-time Data).

- The drill pipe pressure continued to increase from 1,017 psi at 21:08 hours to 1,263 psi at 21:14 hours. (Refer to Figure 9.) Modeling indicated this pressure increase was caused by 14.17 ppg mud rising above the stinger in the annulus. In addition, modeling suggested that this pressure increase was indicative of flow through the shoe track at a rate of approximately 9 bpm. (Refer to *Appendix G. Analysis Determining the Likely Source of In-flow* for the detailed analysis.)

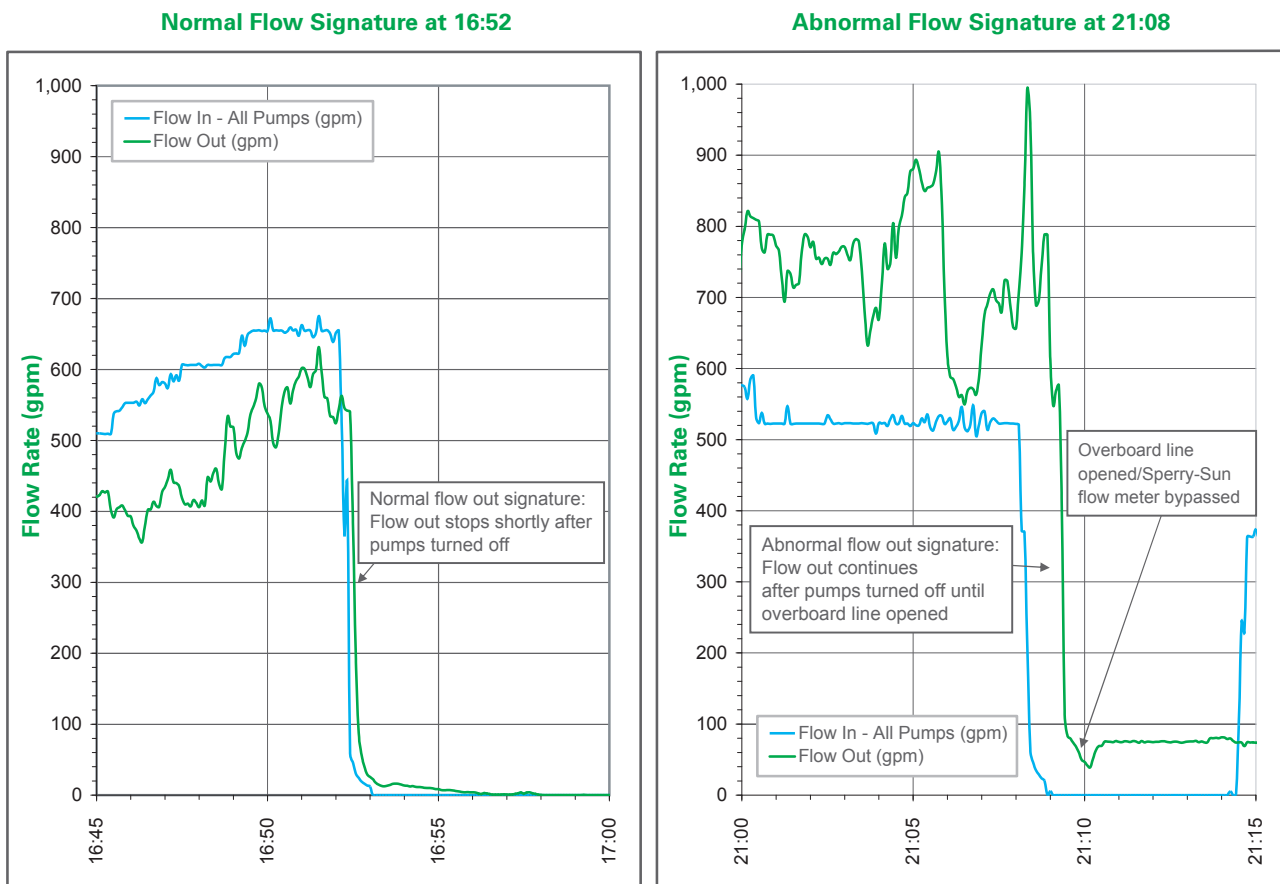
Figure 10. Normal Versus Abnormal Flow Out Signature as Pumps Shut Off (Real-time Data).

- The investigation team compared the flow out signature (i.e., the length of time it took the flow meter sensor to indicate zero flow after shutting the pumps off) to a time when the well was known to be stable. (Refer to Figure 10.) A distinctly different signature was observed at that time, indicating that the well was flowing.

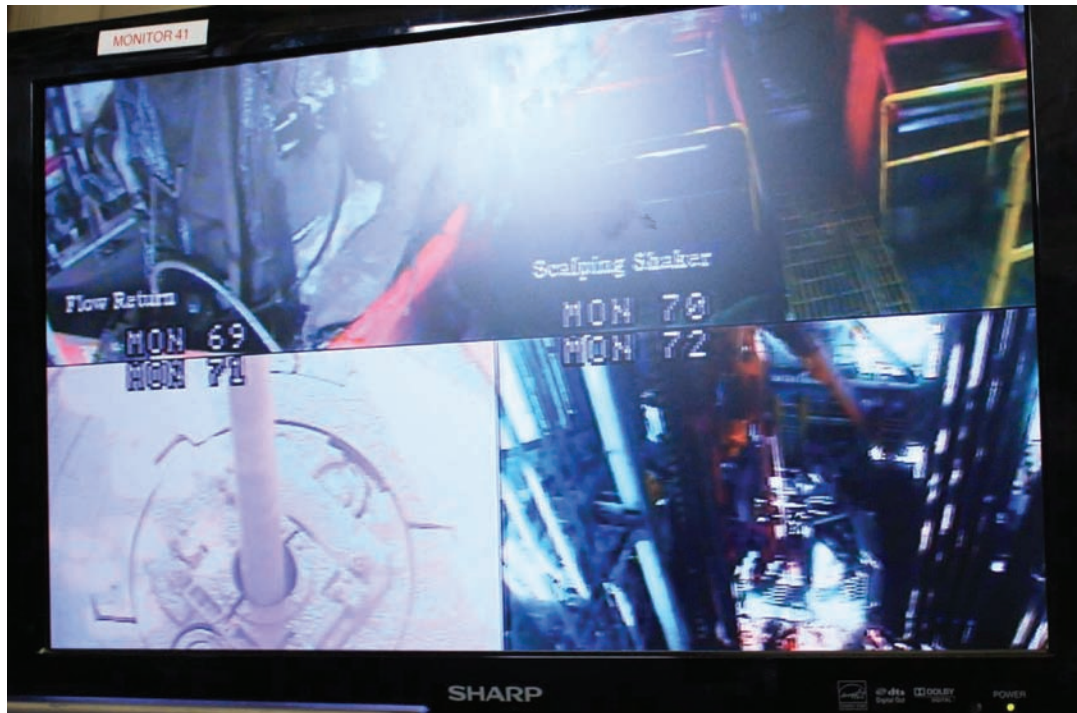
Figure 12. Typical Video Camera Displays in the Driller's Cabin (not *Deepwater Horizon*).

In addition, display screens should have provided visual indication to the driller (through video cameras) until the flow path was changed to the overboard line. When the flow path was diverted overboard, visual indication of flow on the display screen was no longer available. (Refer to Figure 12 for an example of display screens that are available to the driller.)

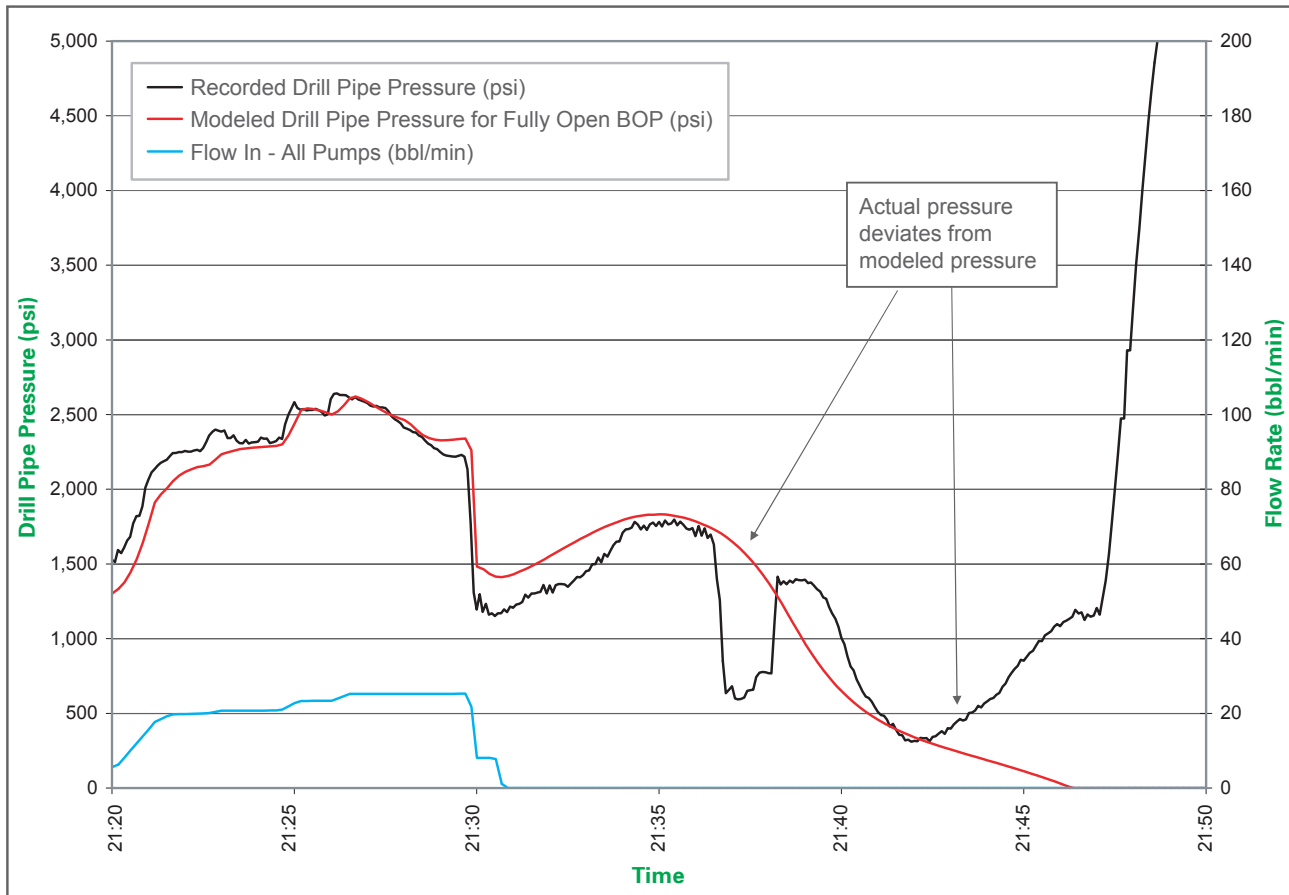
Figure 14. OLGA® Well Flow Modeling for Flow Condition with an Open Annular Preventer.

- As mentioned previously, at approximately 21:33 hours (approximately 21:30 hours per MBI testimony), the chief mate observed the toolpusher and the driller discussing 'differential pressure' on the well. This coincided with the real-time data showing the drill pipe pressure increasing at this time.
- The OLGA® well flow modeling predicted the pressure responses from 21:31 hours to 21:42 hours fairly accurately, with the exception of the sudden pressure changes shown in the real-time data from 21:36 hours to 21:38 hours. (Refer to Figure 14 for specific readings.)

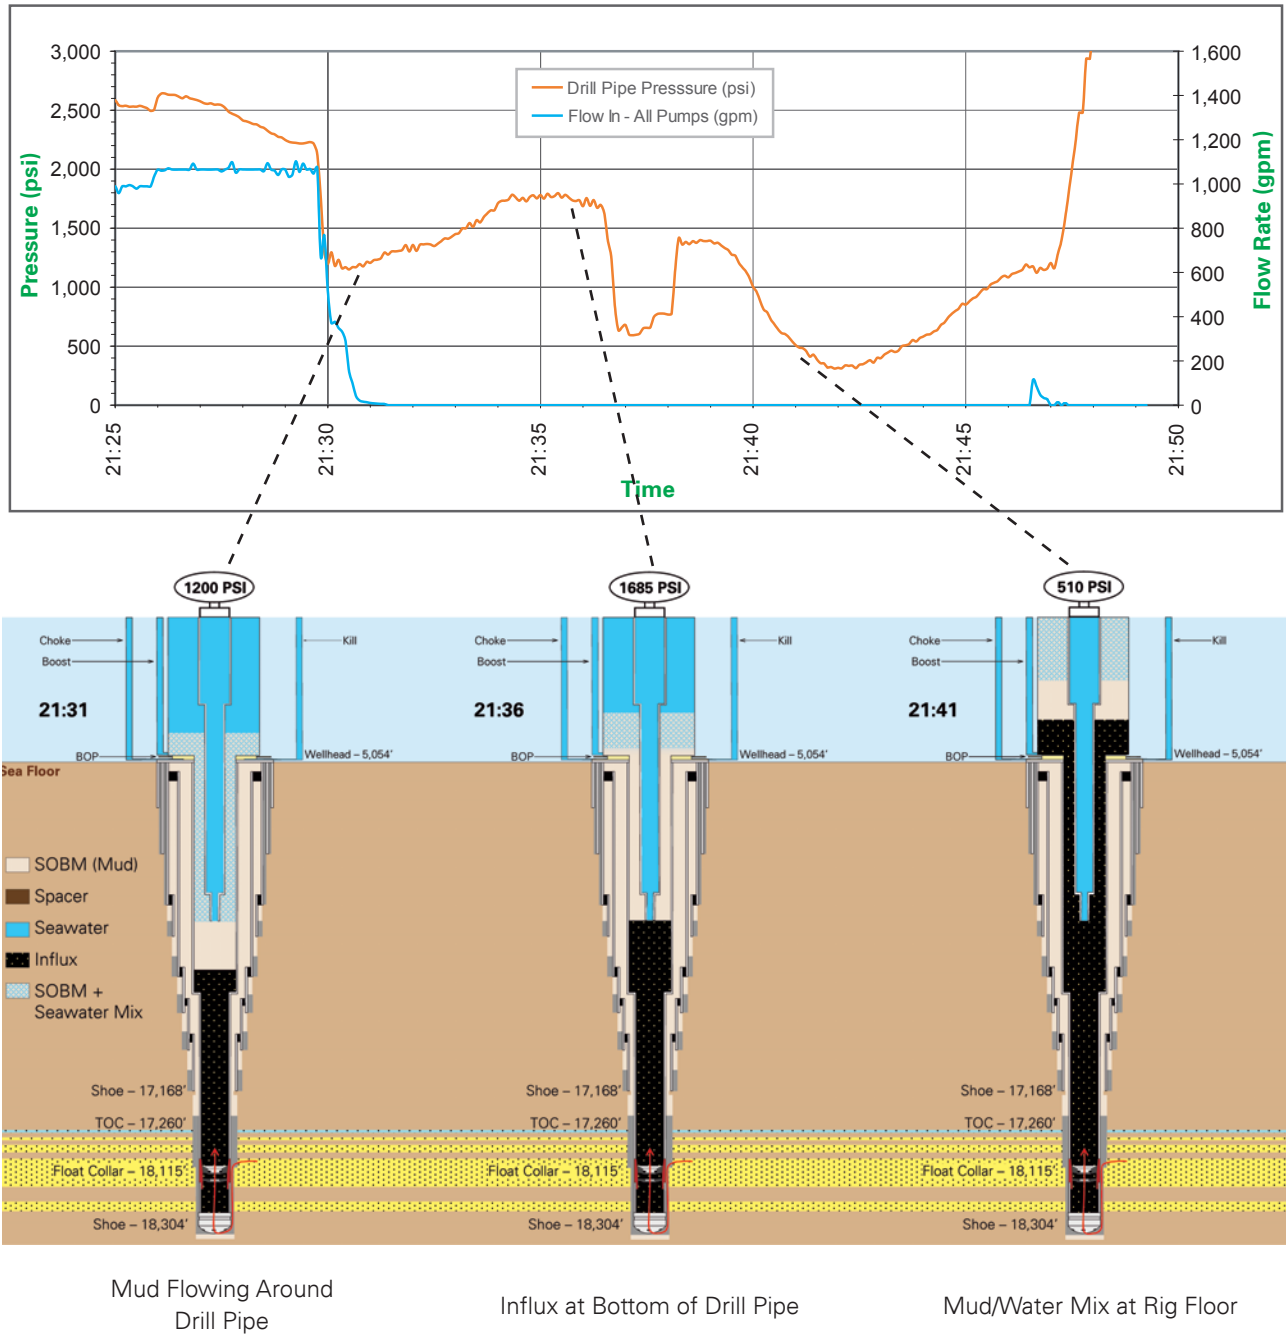
Figure 16. Modeled Pressure Responses Resulting from Hydrostatic Changes in the Wellbore.

- The rig crew may have conducted this bleed-off when they were investigating the 'differential pressure.' This action would not be consistent with a rig crew responding to a recognized well control condition.
- Other than the sudden pressure changes between 21:36 hours and 21:38 hours (interpreted to be the bleed-off of the drill pipe pressure), the drill pipe pressure increased until 21:35 hours as 14.17 ppg mud rose above the stinger and then declined after that as hydrocarbons rose above the stinger.
- Modeling indicated that this fluctuation was consistent with the change in fluid densities (spacer, seawater, mud and hydrocarbons) moving through the various cross-sectional areas in the well. *Figure 16* illustrates the hydrostatic changes occurring in the well and the corresponding pressure responses.

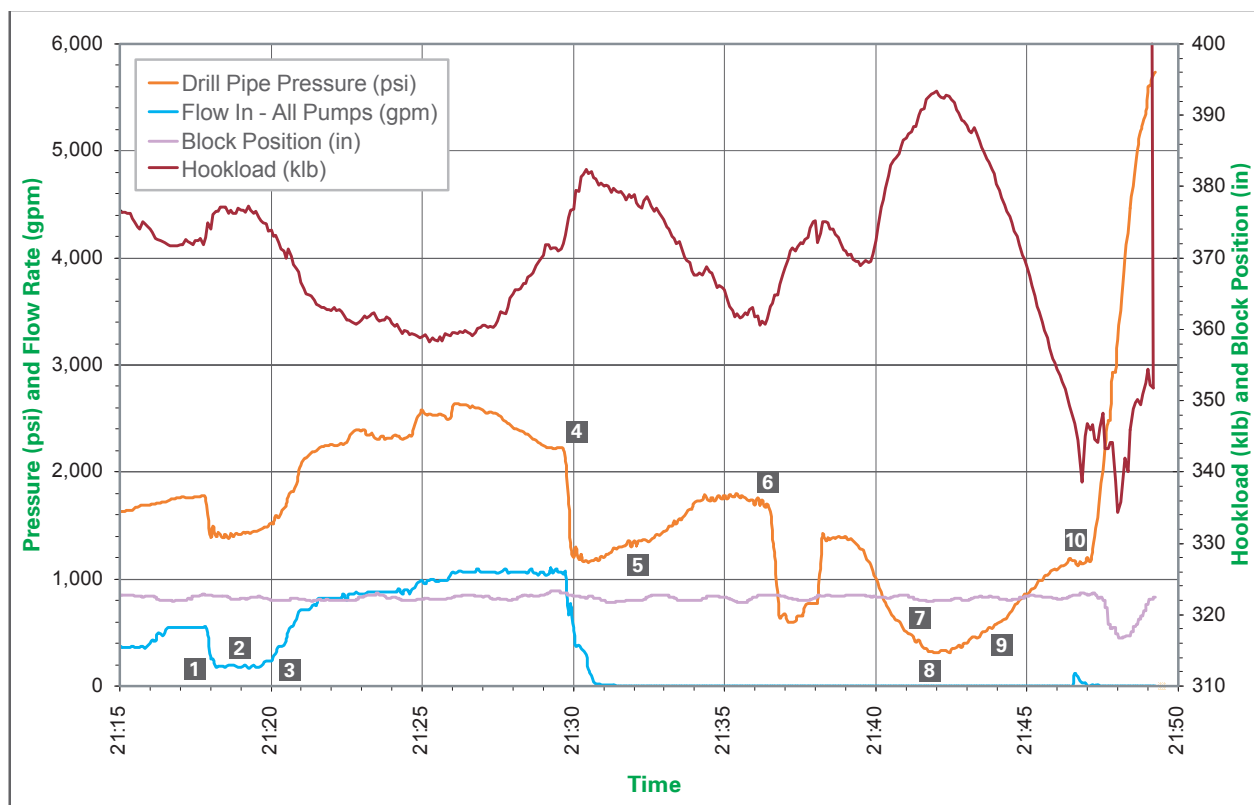
Figure 17. Interpretation of Well Control Response (Real-time Data).

- Analysis shows that to create the pressure increase observed on the drill pipe from 21:42 hours to 21:47 hours, the annular preventer was over 99% closed (but not fully sealed) around the drill pipe. If the annular preventer was fully closed and sealed during this time period, the pressure increase would have been more immediate. (Refer to *Analysis 5D. The Blowout Preventer Did Not Seal the Well* of this section for a detailed explanation.)

- One of two possible actions would have caused the rapid pressure increase to 5,730 psi from 21:47 hours to 21:49 hours:
 - The rig crew possibly first closed an annular preventer and then closed a VBR in accordance with Transocean’s protocol for handling well control events.

- The rig crew possibly first closed an annular preventer and then increased its closing pressure to create a seal.

- 1 Pressure relief valve on pump #2 opens; toolpusher called to rig floor.
- 2 All pumps shut down except boost pump.
- 3 Assistant driller called to pump room.
- 4 Pumps shut off.
- 5 Toolpusher and driller discuss 'differential pressure.'
- 6 Opening of 4" surface line to bleed pressure.
- 7 Mud/water flows onto rig floor and then unloads through the derrick.
- 8 Diverter and annular preventer activated; diverted to mud gas separator.
- 9 Well site leader and senior toolpusher receive calls from rig floor; annular preventer attempting to close.
- 10 BOP sealing.

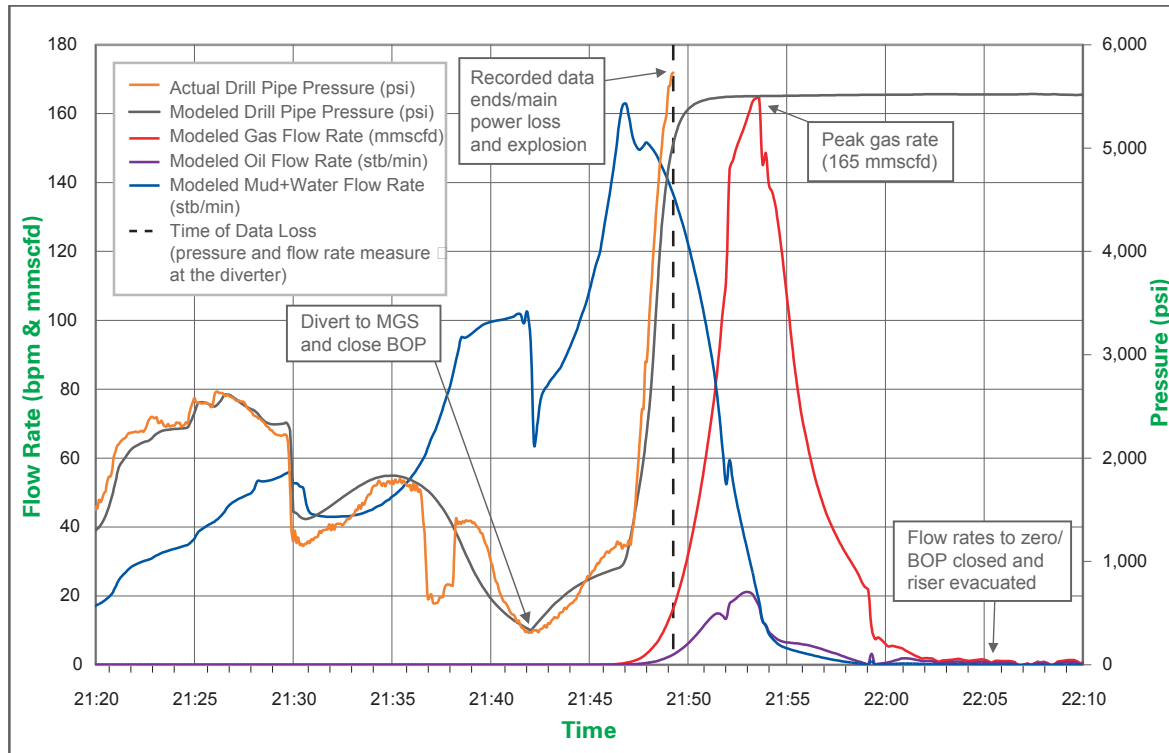
Figure 1. OLGA® Well Flow Modeling Prediction of Fluid Outflow from the Riser.

Figure 1 shows the predicted flow rates of mud/water, gas and oil. At approximately 21:46 hours, the gas reached the surface, and over a 5-minute period the flow of gas increased to more than 140 mmscfd. Simultaneously, the flow of mud and water to the surface reduced from 140 bpm to 20 bpm. The modeled timeline of flow to the surface aligns with eyewitness accounts described in *Table 1*.

Based on the assumption that the BOP remained closed and sealed around the drill pipe, *Figure 1* shows that predicted flow tails off approaching 22:00 hours, though it is evident from the actual event that this did not occur. (Refer to *Appendix W. Report–Dynamic Simulations Deepwater Horizon Incident BP.*) The failure modes that may have allowed the flow to continue are described in *3.5 Sustaining the Flow Following the Closure of the BOP* of this analysis.

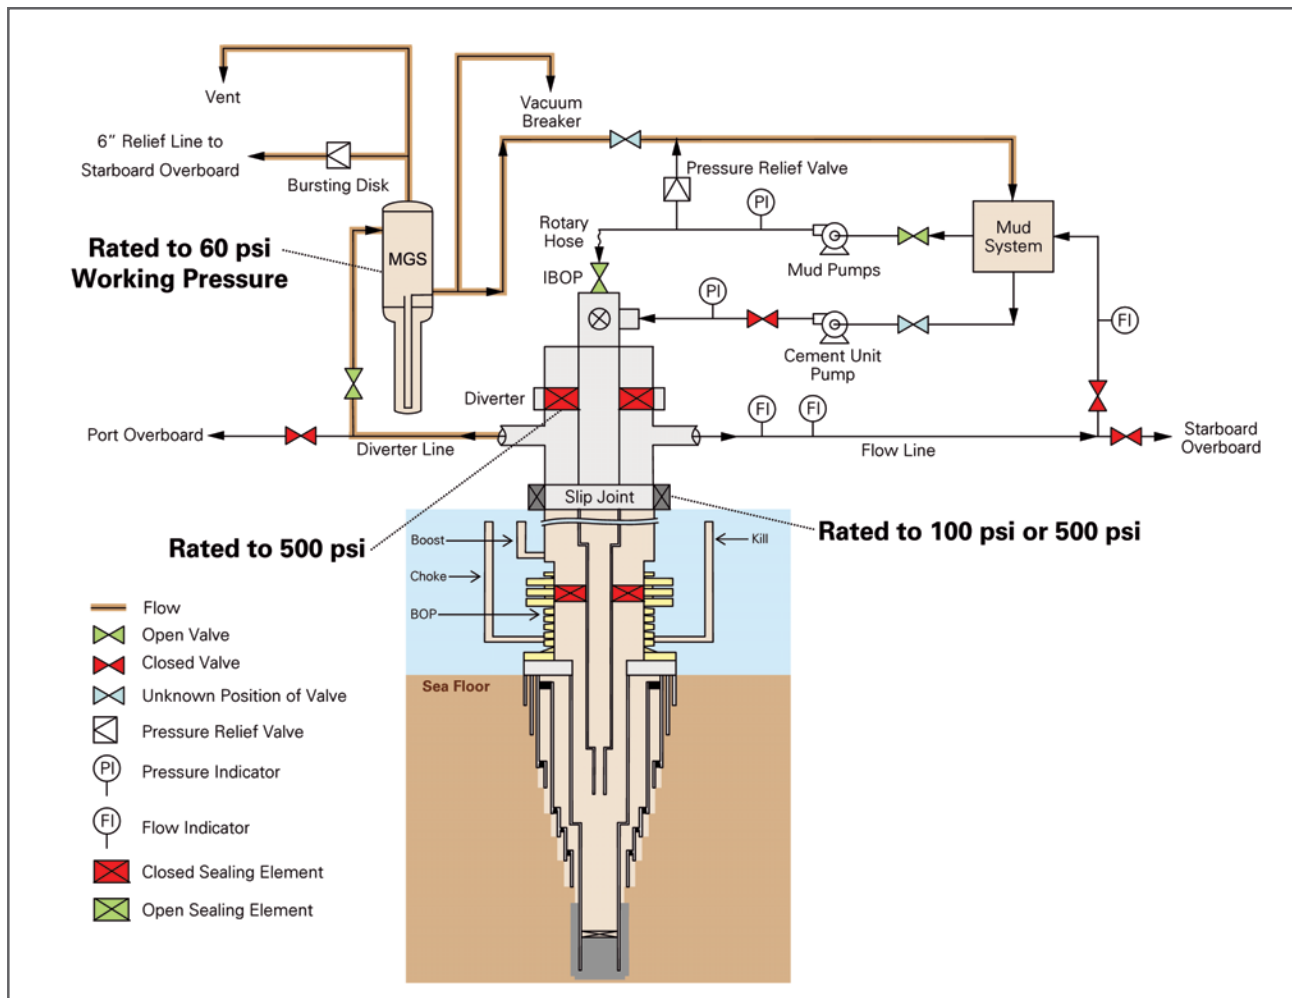
Figure 2. Simplified Process Flow Diagram of Selected *Deepwater Horizon* Surface Equipment.

Based on these modeled pressures, it appears that some of the surface equipment could have begun to fail and release hydrocarbons. (Refer to Figure 2.) The two most vulnerable pieces of equipment were the MGS vessel, which was rated for 60 psi; and, if selected in low-pressure mode, the riser slip joint seal, which was rated for 100 psi.

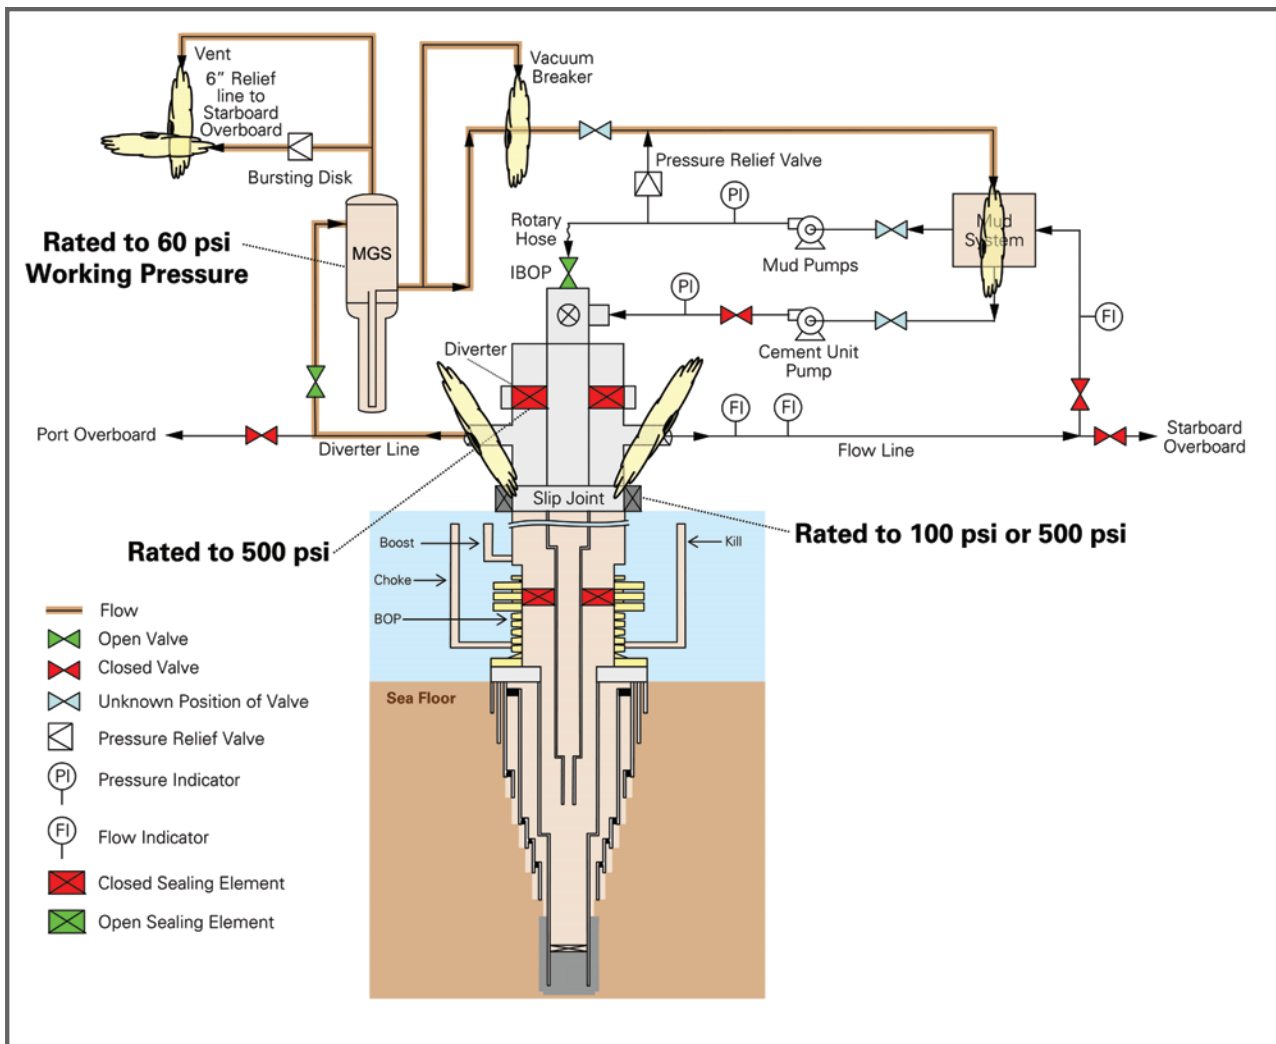
Figure 8. Schematic of Postulated Hydrocarbon Release Locations.

The case presented in this analysis assumes that the 12 in. MGS vent and the 10 in. MGS liquid outlet to the gumbo box, the riser slip joint seal, the MGS 6 in. bursting disk and the 6 in. MGS vacuum breaker vent were all open flow paths. *Figure 8* is a simplified illustration of these open flow paths.

Other scenarios, such as a closed MGS liquid outlet and no equipment failures (all fluid flowing out of the 12 in. MGS vent) or a catastrophic failure of the MGS vessel were possible, but the investigation team believes that these other scenarios would not substantially alter the net effect of the initial gas release.
