Deepwater Horizon Accident Investigation Report

September 8, 2010

Analysis 5A. Well Integrity Was Not Established or Failed

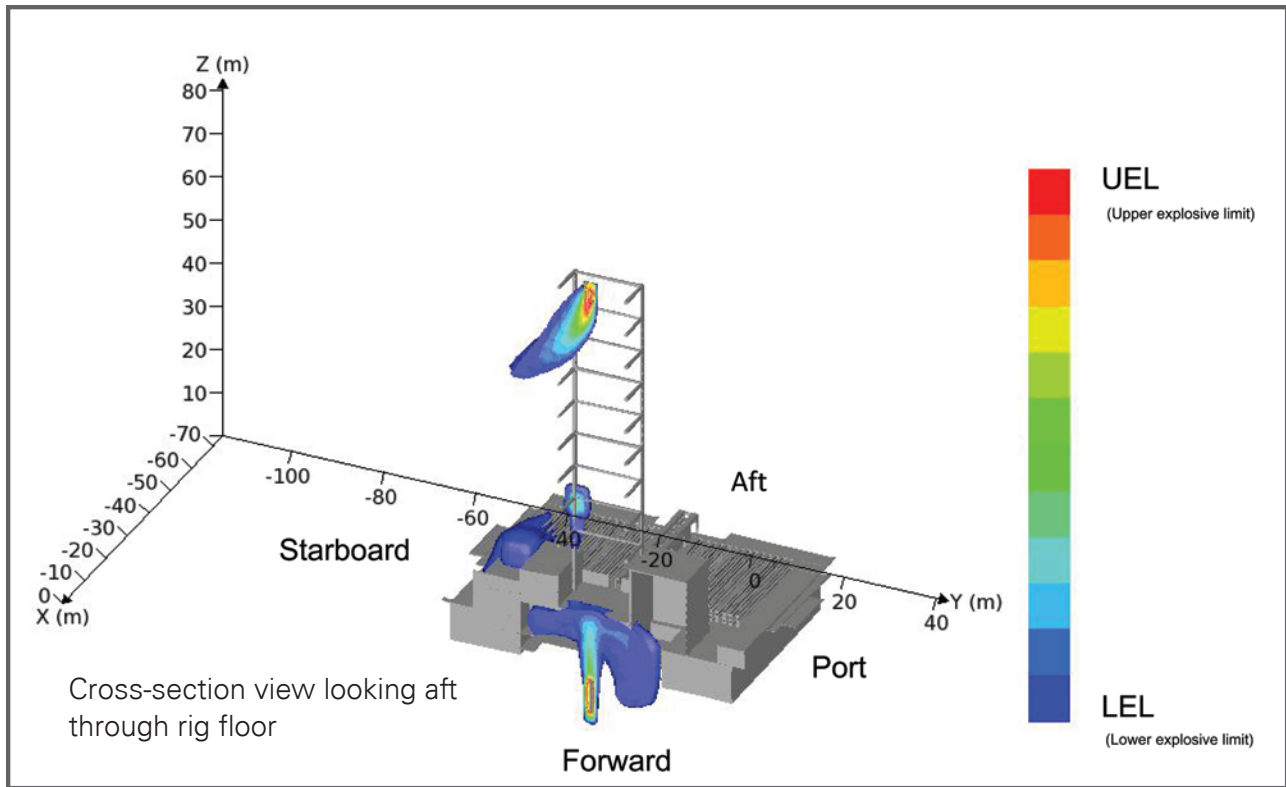
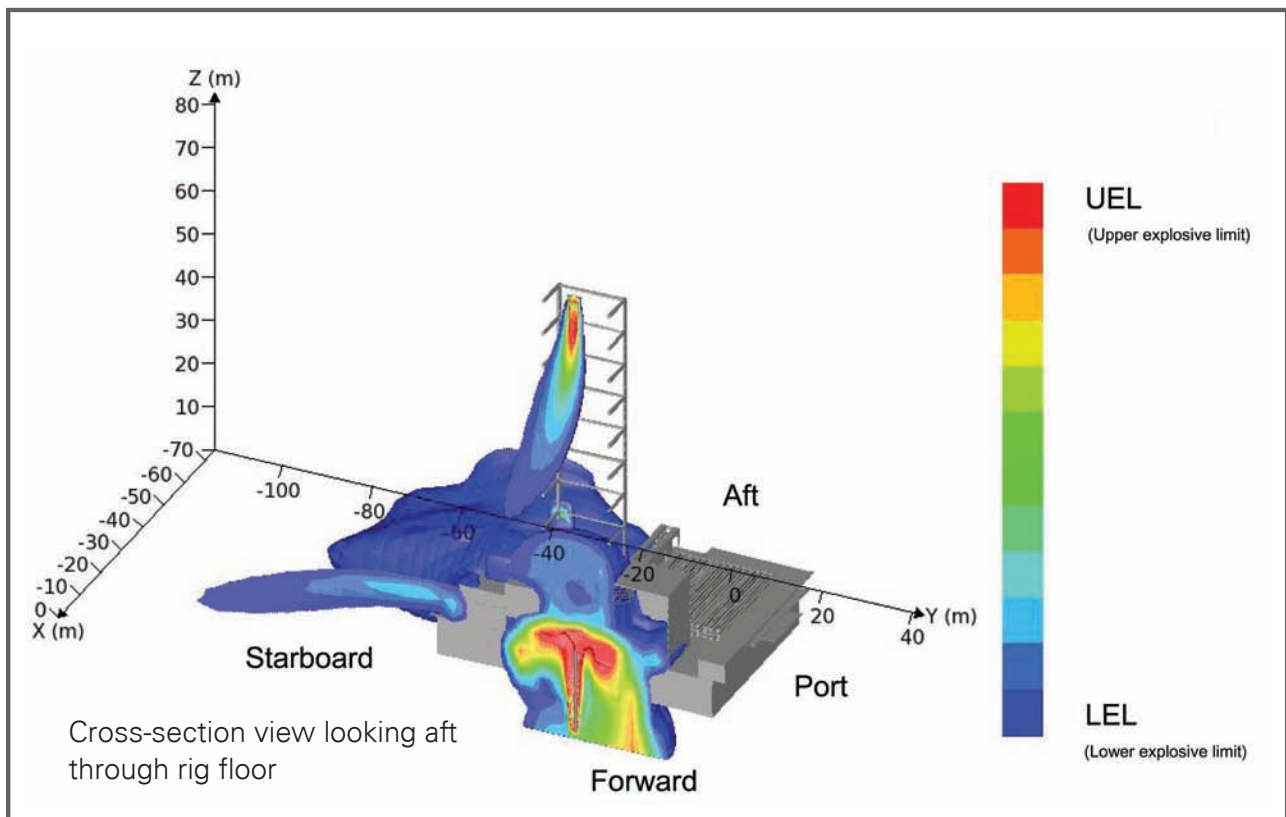
The graphics in *Figure 9* and *Figure 10* show the modeled outcomes of gas rapidly dispersing across the drilling rig. Gas could have also migrated into enclosed spaces under the deck through the mud system or through the HVAC supply fans for the engine rooms.

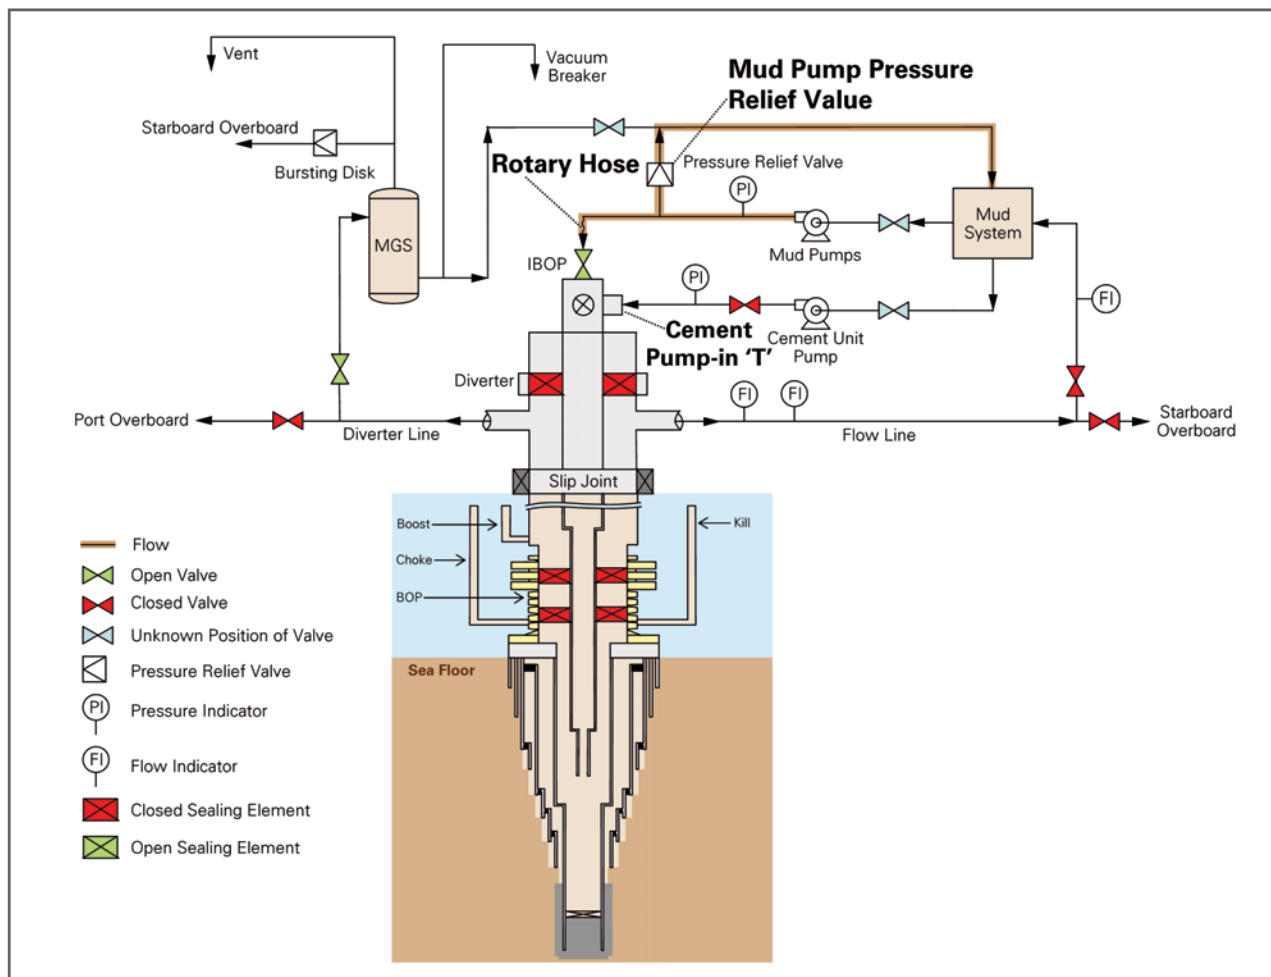
Figure 11. Relevant Surface Equipment Downstream of the IBOP at ~21:47.

It was important to clarify the position of the internal blowout preventer (IBOP) valve, as this determines the number of potential flow paths to the surface if the BOP had closed and sealed. The simplified process flow diagram in *Figure 11* shows that there were two pressure indicators (PIs), each of which was recorded via the real-time data system. One PI measured drill pipe pressure from upstream of the IBOP, and one measured drill pipe pressure from downstream of the IBOP.

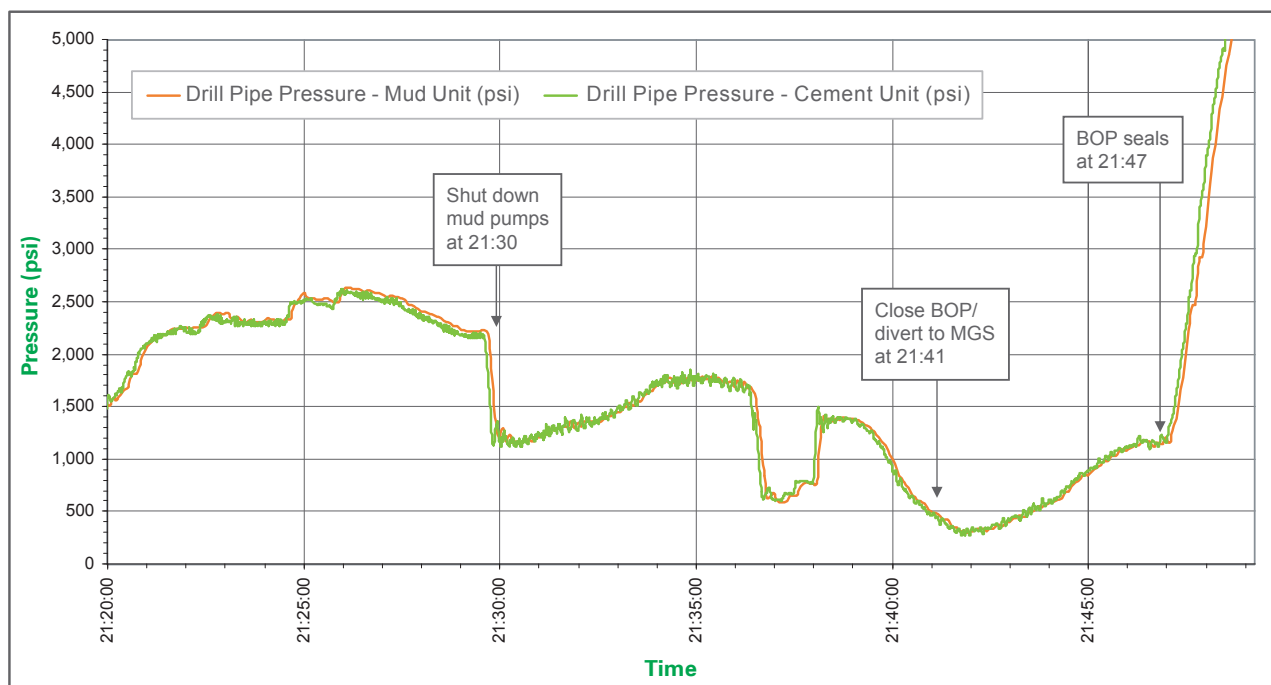
Figure 12. Drill Pipe Pressure Measured at Cement Pump PI and Mud Pump PI.

Figure 12 shows the pressure trend data from each of the PIs during the 30 minutes prior to the loss of power and the explosions. The fact that the trends tracked almost identically over a significant range of changing pressures indicates that the IBOP must have been open.

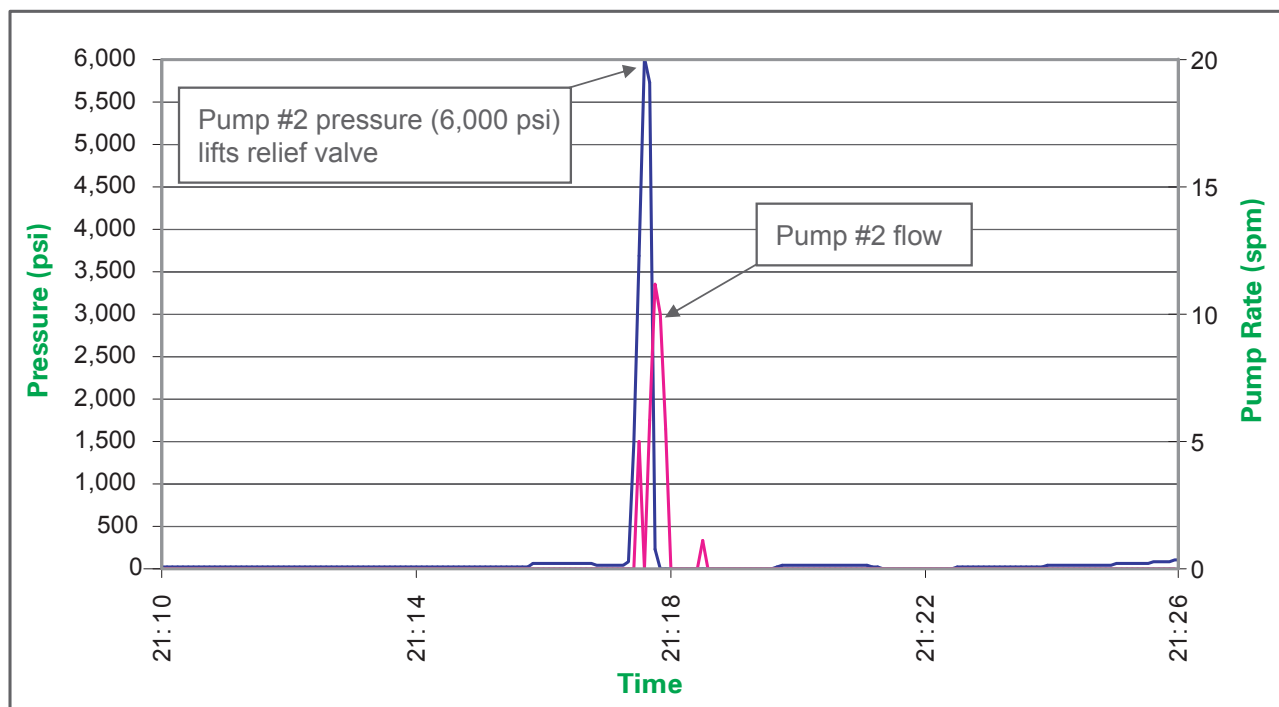
Figure 14. Mud Pump #2 Pressure Plot Showing Lift Pressure of PRV.

- Mud pump #2 was tested to 5,800 psi during the negative-pressure test procedure at 15:17 hours.
- While trying to start mud pump #2 at 21:17 hours, the pressure increased to 6,000 psi.

The investigation team believes that mud pump #2 was started against a closed discharge valve at 21:17 hours and the PRV lifted.

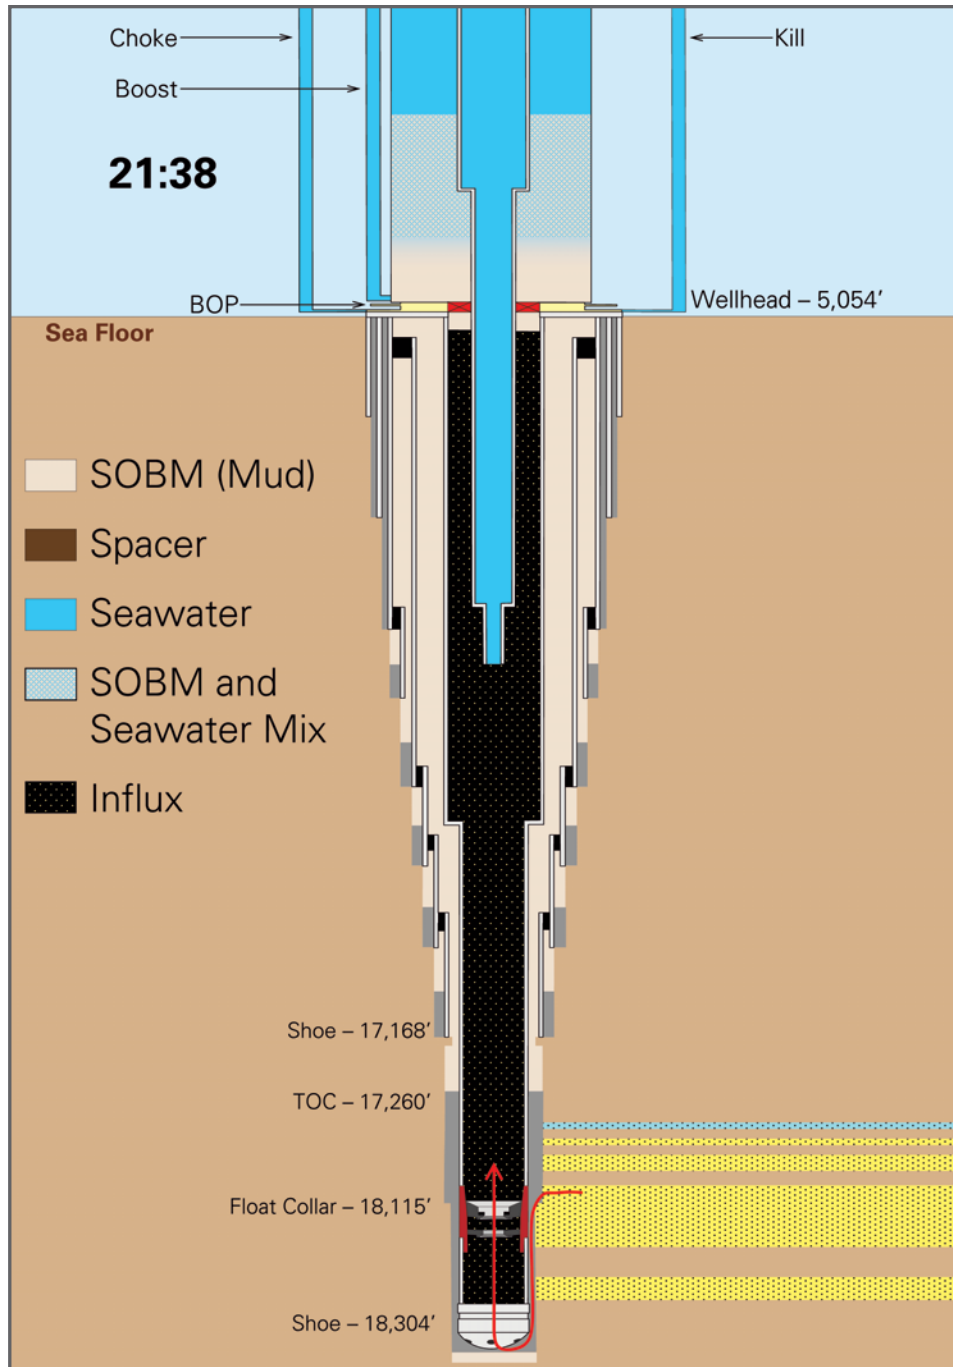
Figure 15. Illustration of Wellbore and Position of Hydrocarbons at 21:38 Hours if BOP Was Closed.

Figure 15 shows a view of the different fluids across the wellbore at 21:38 hours, if the BOP was closed, and illustrates that hydrocarbons would probably have been located below the BOP at that time. In the figure, a sharp interface among different fluids is shown for simplicity of illustration. In reality, there would have been varying degrees of fluid mixing.

The simulations have been proven to be quite sensitive to the net pay assumption. Therefore, the time of 21:38 hours, when hydrocarbons were assumed to be just below the BOP, could be off by 1 or 2 minutes.

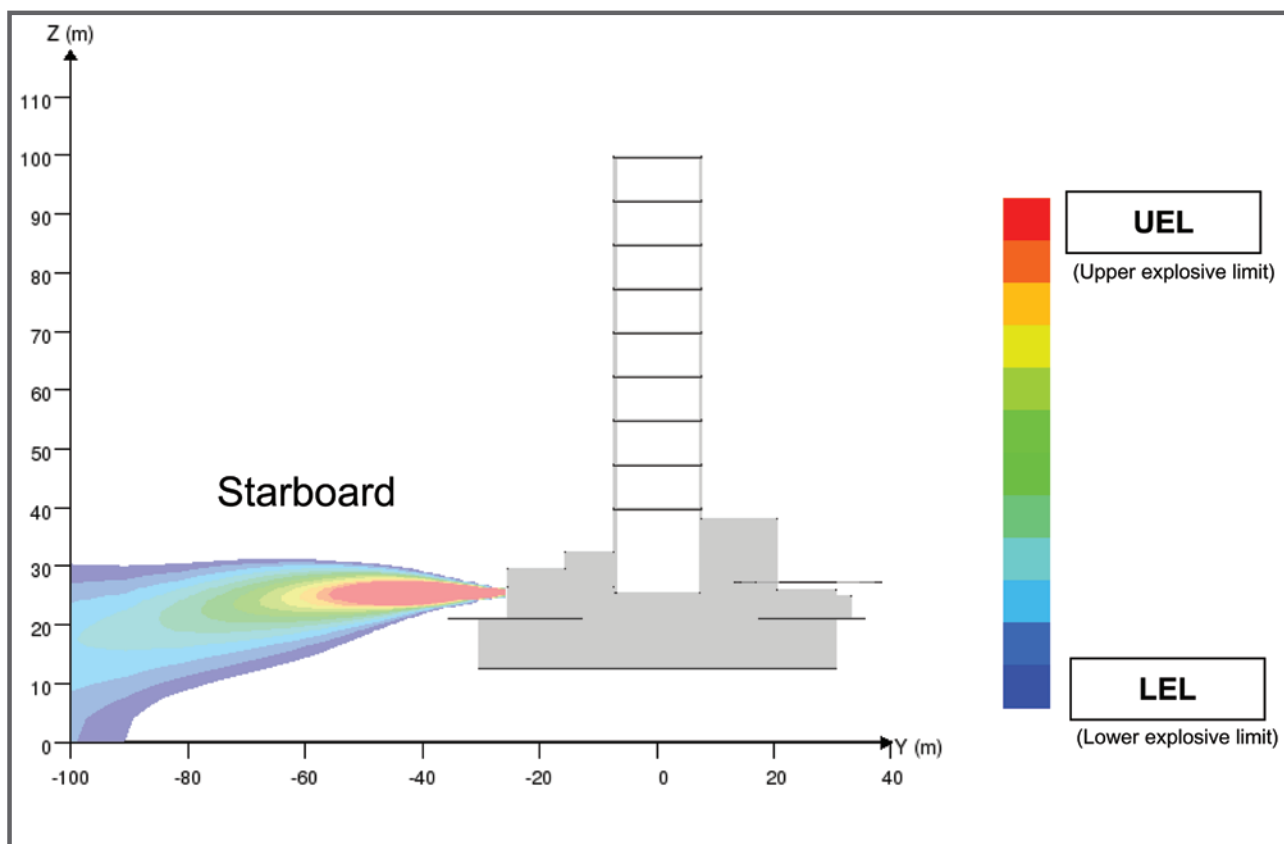
Figure 16. Vapor Dispersion Case for Diverting to the Starboard Diverter.

The investigation team has also concluded that if the well had been lined up to the starboard diverter rather than the MGS, the majority of the gas would have been diverted safely overboard. The pressure increase during the blowout may still have caused a failure of the riser slip joint seals, which would have allowed gas onto the rig floor through the moon pool. However, the majority of the gas would probably have vented through the starboard diverter, reducing the likelihood of hydrocarbons reaching an ignition source and may have reduced the consequences of the event.

Figure 16 shows the likely vapor dispersion pattern based on the orientation of the rig and the prevailing wind conditions on the evening of the accident.

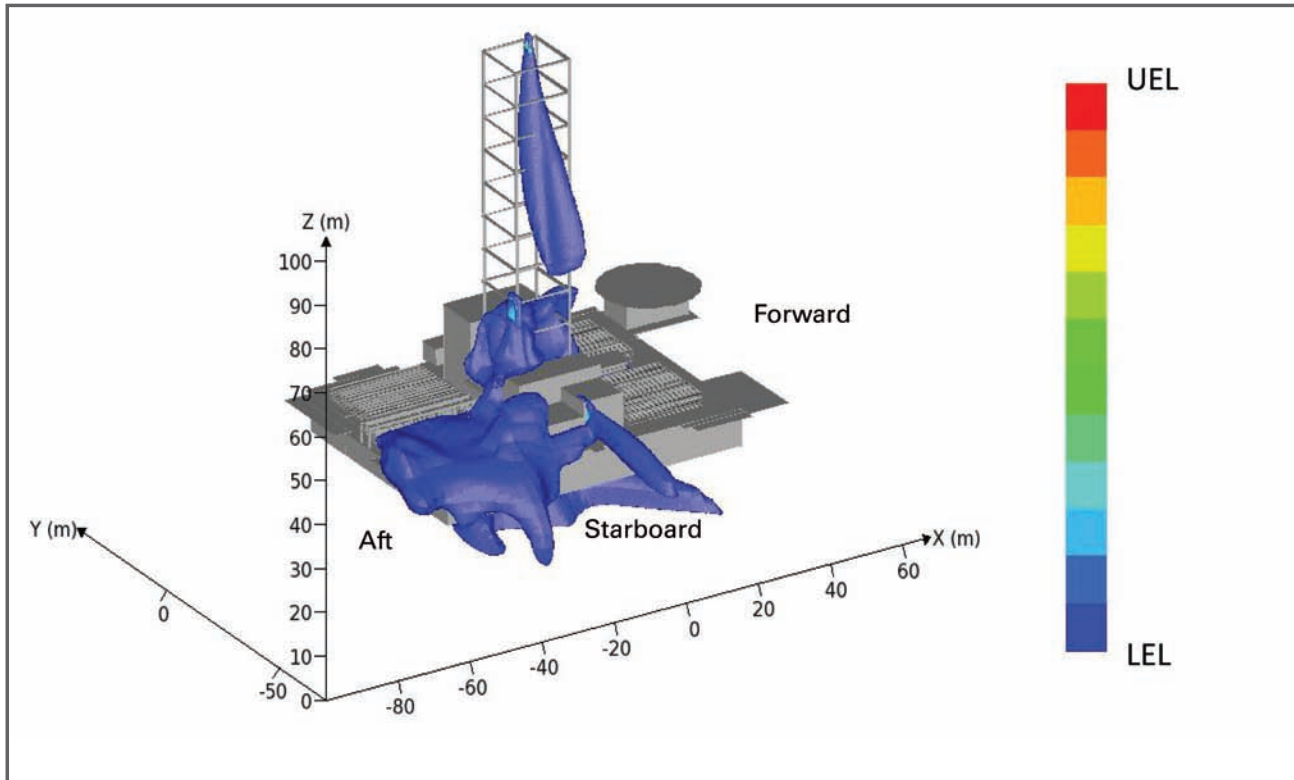
Figure 22. Vapor Dispersion Aft Deck—190 Seconds.

Although the F&G system visual and audible alarms were automatically triggered upon gas detection, there were no automated actions to close the fire dampers or shut down the engine room ventilation fans. *Figure 22* shows the modeled vapor dispersion cloud across the aft main deck 190 seconds after gas reached the surface. Gas would probably have reached the engine room HVAC fans and been transferred into the enclosures for engine rooms #3, #4, #5 and #6.

A review of personnel injury locations (including fatalities) and facility damage accounts suggested that one likely epicenter of the explosion was in the starboard aft quadrant; this corresponded to the area of the rig containing engine rooms #3 and #6 (the running engines) and the mud pump rooms. The initial vapor release probably reached the HVAC intakes in this area. (Refer to Figure 22.)

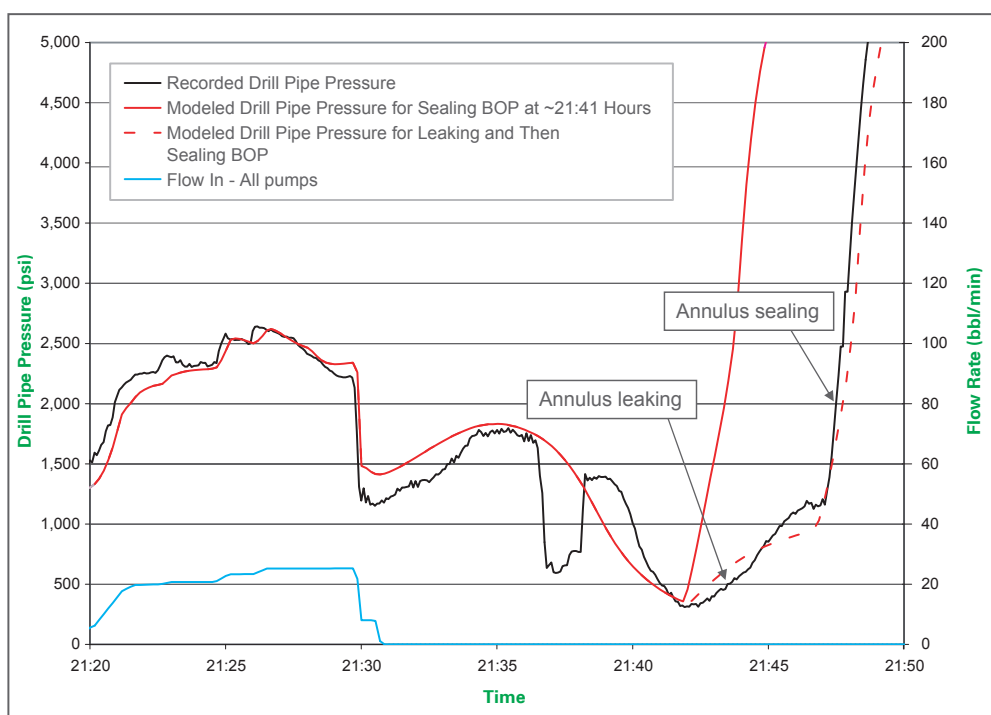
Figure 1. Drill Pipe Pressure—OLGA® Well Flow Modeling of Drill Pipe Pressure for a Closing BOP Versus Recorded Data.

The recorded surface data, from approximately 21:41 hours to 21:49 hours on April 20 (the time at which Sperry-Sun real-time data stopped transmitting), is critical to understanding the BOP operation prior to the explosions. The data suggests that the normal mode of BOP operation sealed the annulus less than 2 minutes prior to the loss of data transmission just before the explosions. (Refer to 6. *Modes of BOP Operation* of this analysis, which provides a discussion of BOP normal and emergency modes of operation.) The BOP closed, but it was slow to seal. Based on the evidence and analysis to date, it is not certain which BOP components were operated to seal the annulus prior to the explosions. It is likely that a variable bore ram (VBR) eventually sealed the annulus.

As established in *Analysis 5B.*, the rig crew activated the BOP at approximately 21:41 hours. *Figure 1* shows the results from the OLGA® well flow modeling of the BOP as activated at 21:41 hours and closing and sealing the annulus in 30 seconds (solid red curve). (Refer to *Appendix W. Report—Dynamic Simulations Deepwater Horizon Incident BP*) However, the recorded drill pipe pressure (solid black curve) indicates that the annulus was sealed approximately 5 minutes later than the OLGA® well flow modeling predictions. Further OLGA® well flow modeling of the BOP closing in 30 seconds, but allowing leakage past the annular preventer for 5 minutes before fully sealing the annulus, resulted in a drill pipe pressure (dashed red curve) that closely followed the recorded pressure. This analysis indicates that the BOP closed within the expected time, but it did not fully seal for another 5 minutes.

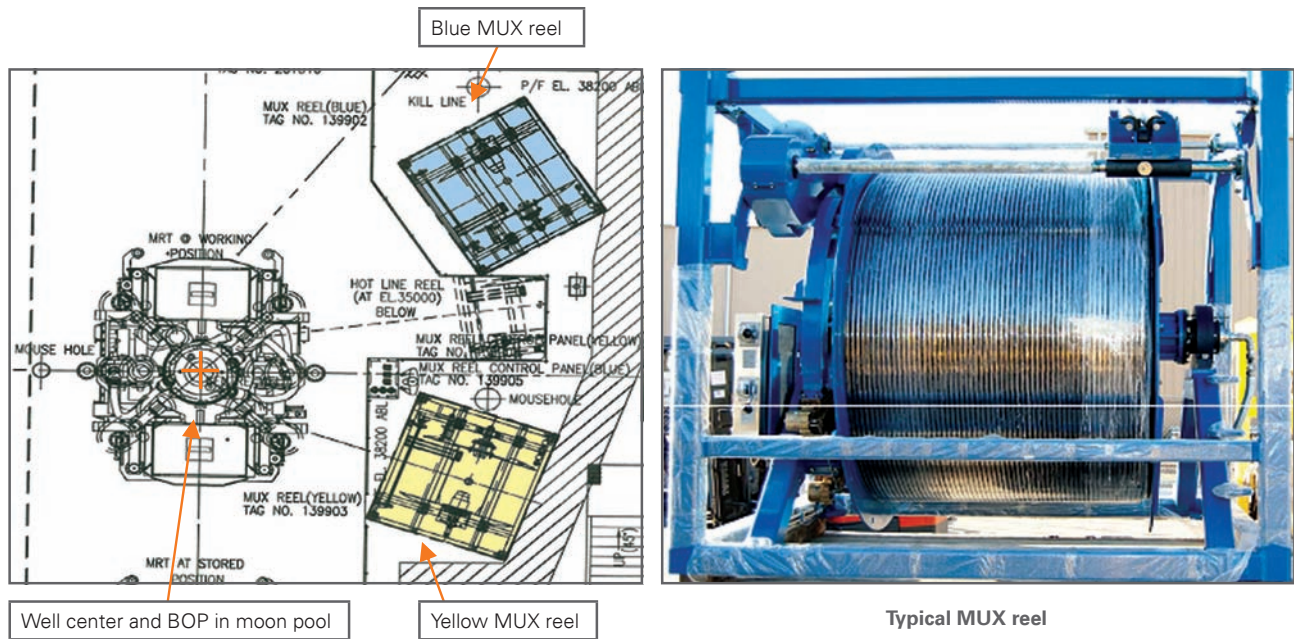
Figure 6. Moon Pool Layout Showing the Location of Blue and Yellow MUX Reels.

The MUX reels were located in the moon pool area within the explosion and fire zone. (Refer to Figure 6.) Since the MUX cables were not protected against explosions or fire, it is very likely that the early explosion and fire damaged the MUX reel slip rings and the cables to the extent that the communication line and electrical power required to initiate the high-pressure BSR and EDS functions were no longer available.

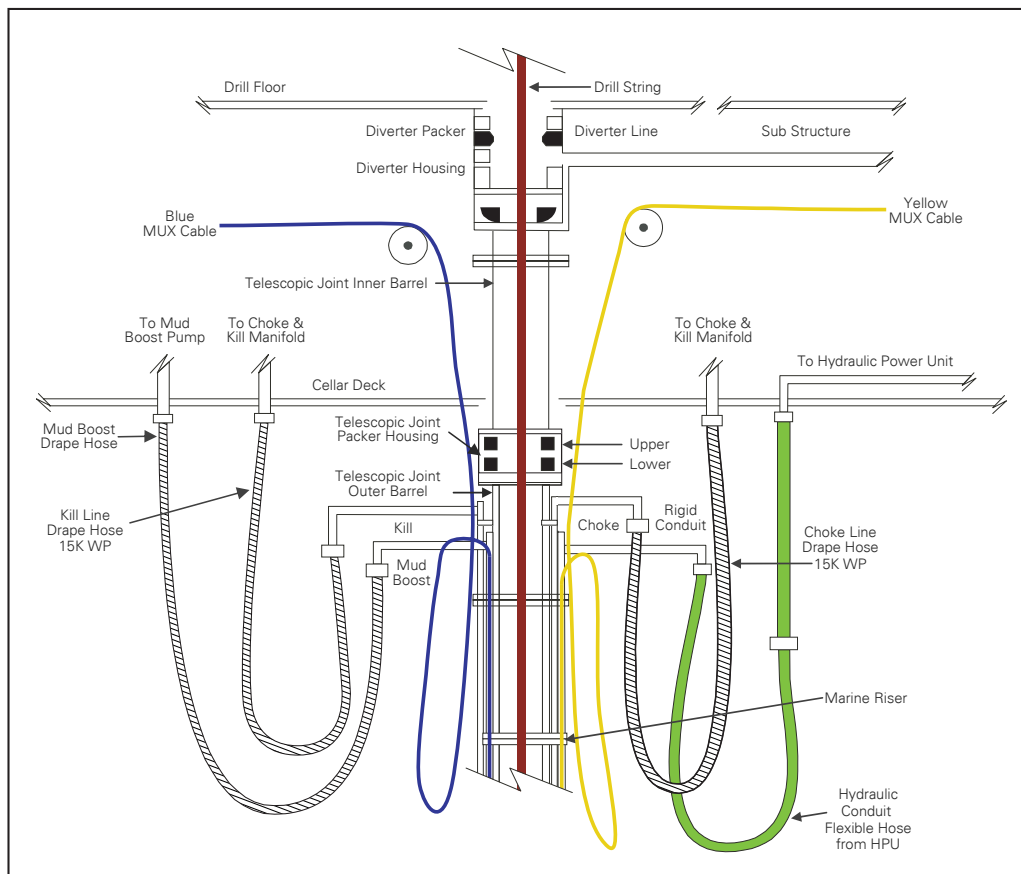
Figure 7. Typical Configuration of Flexible Hoses in the Moon Pool. (Hydraulic conduit flexible hose is shown in green).

The AMF sequence is initiated when electrical power, communications and hydraulic pressure are lost to both pods. To initiate an AMF, all three services must fail (i.e., after damage to the MUX reels or cables and to the hydraulic conduit, caused by explosions and fire). As indicated in 3.1 of this analysis, the MUX cables, which carry electrical power and communications, were vulnerable to explosion and fire damage. Though the hydraulic conduit flexible hose was less vulnerable to damage than the MUX cables, it was located close to the MUX cables in the moon pool and could have been damaged by the explosions and fire. (Refer to Figure 7.)

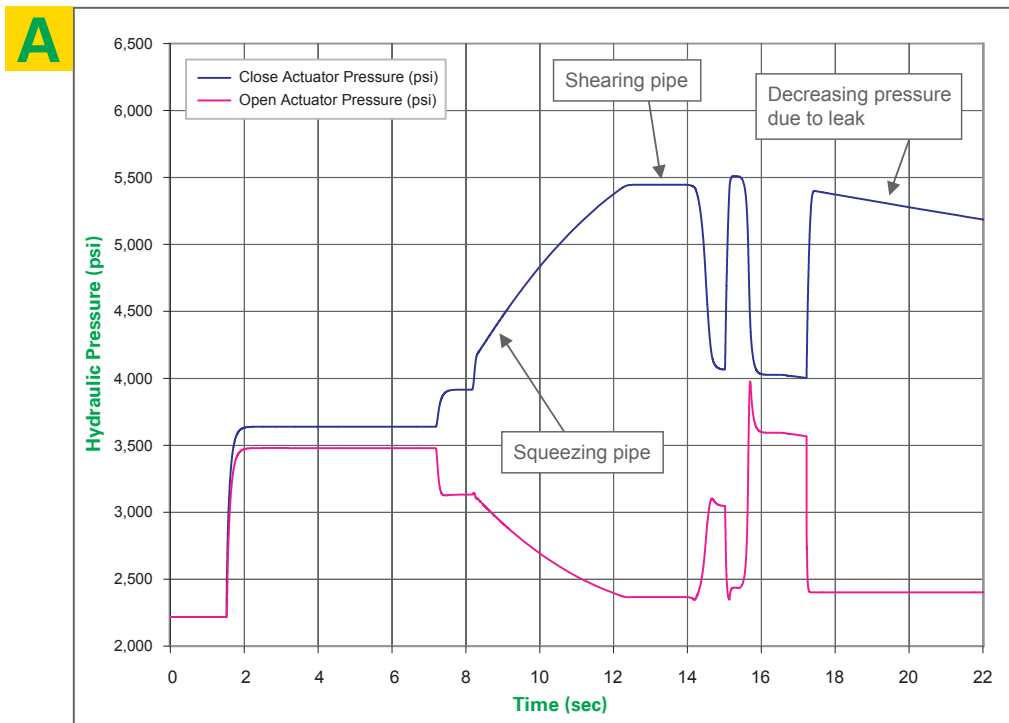
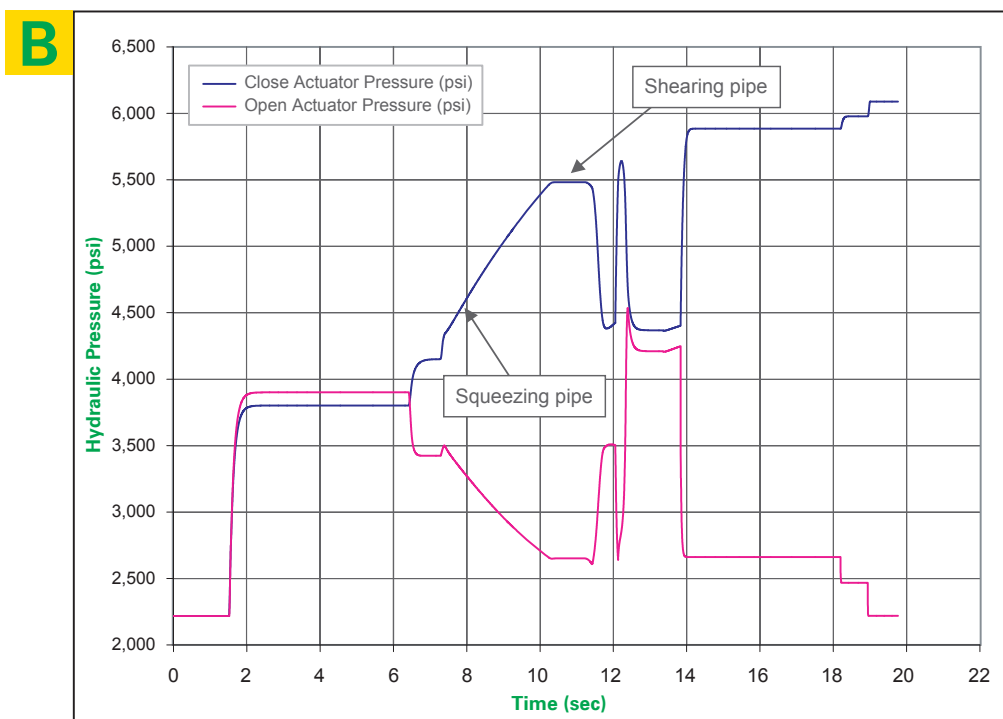
Figure 11. Hydraulic Analyses of BSR Closure Response (at a Wellbore Pressure of 3,000 psi and 5,000 ft. WD) **(A)** With and **(B)** Without a Leak in the ST Lock Hydraulic Circuit. (All pressures include hydrostatic head at the sea bed.)

Figure 11 shows the responses of the BSR with and without a leak in the ST lock hydraulic circuit. The analysis assumes a pipe shearing pressure derived using Cameron's formula for 5 1/2 in., 21.9 ppf, S-135 pipe at a wellbore pressure of 3,000 psi. *Figure 11(B)* illustrates that without a leak, there was sufficient pressure to shear and seal the drill pipe. In comparing *Figure 11(A)* and *Figure 11(B)*, the impact of a leak is seen to increase the time it takes to build up hydraulic pressure in the actuator to be able to shear the pipe (12.5 seconds versus 10.5 seconds). However, even with the presence of the leak, sufficient hydraulic pressure was achieved to complete the shearing operation. With the leak, the overall shearing operation would have taken 17 seconds to complete, whereas without a leak, shearing operations would have finished in 14 seconds.

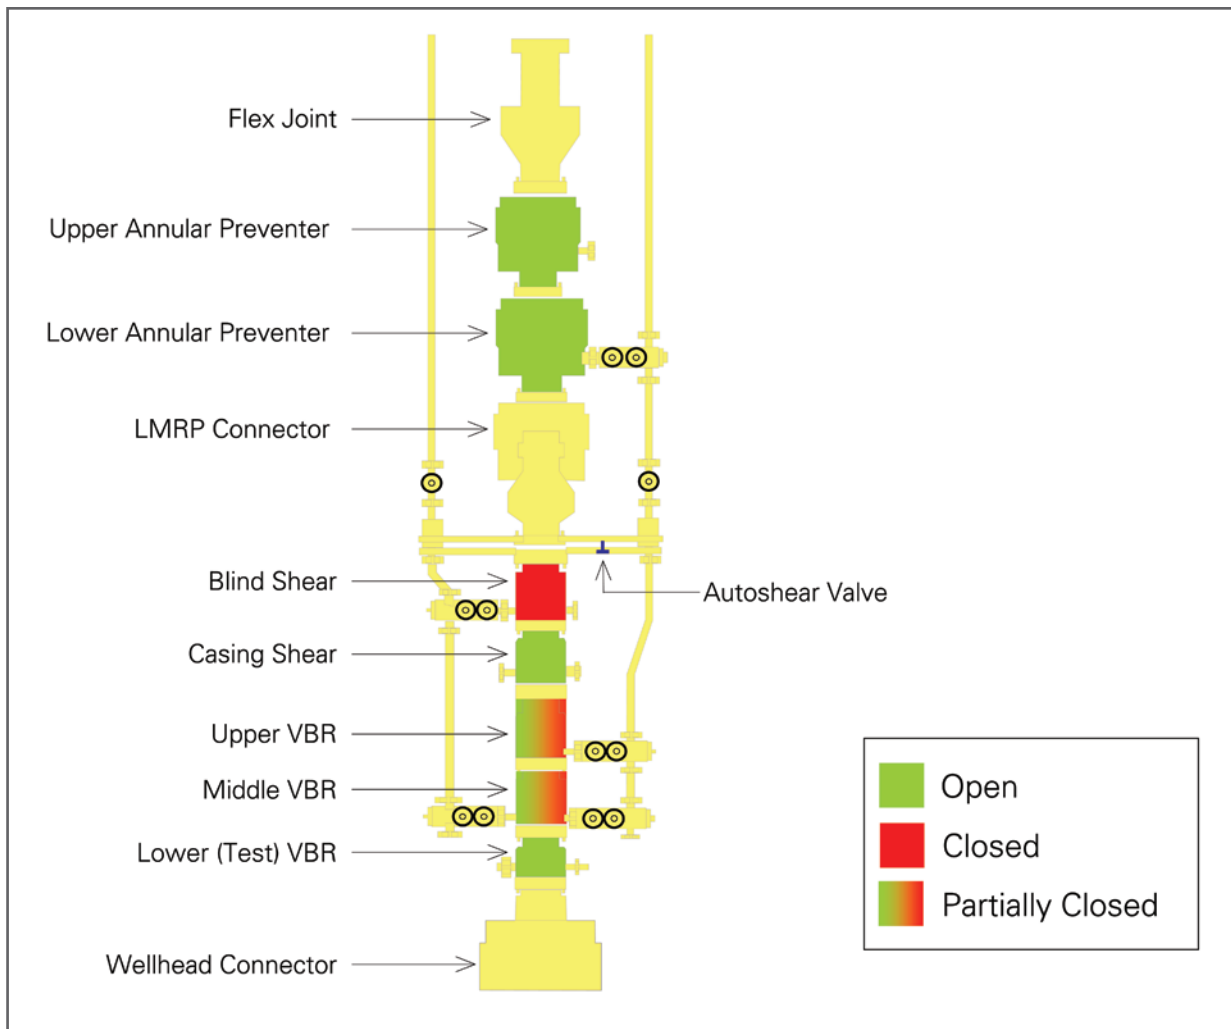
Figure 13. Likely Status of BOP Rams Immediately After Autoshear Initiation.

Based on these findings, the investigation team concluded that the upper, and possibly the middle, VBRs were likely closed by the rig crew.

Figure 13 shows the likely status of the BOP rams immediately after the initiation of autoshear.

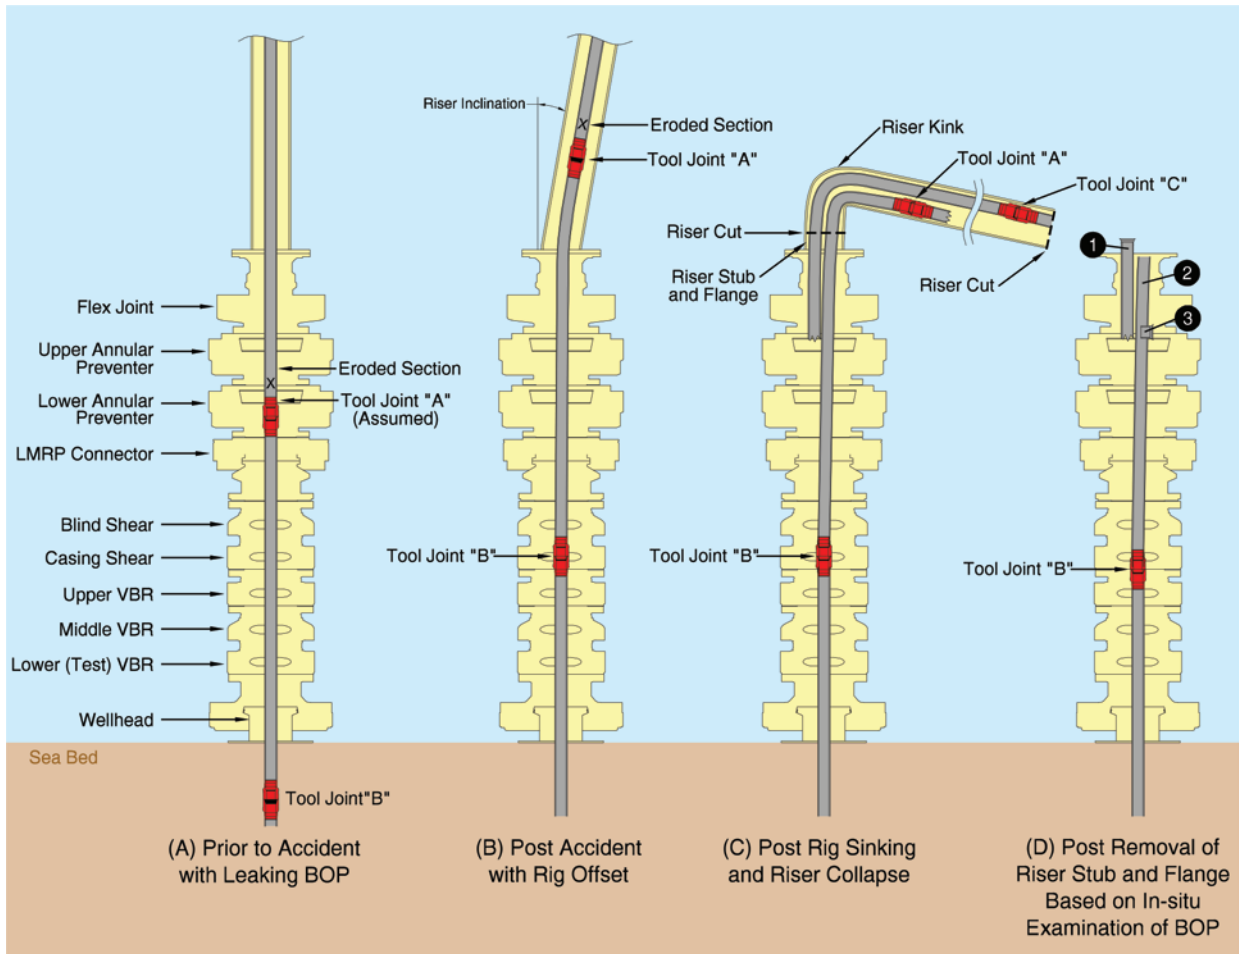
Figure 15. A Schematic of Drill Pipe Configuration Across the BOP Over Time.

The investigation team determined that this erosion may have occurred when the section of pipe was in the BOP, where it experienced extremely high flow velocities during the leaking of a ram or annular preventer, indicating that this section of drill pipe was continuous through the BOP. The approximately 22 in. long erosion zone could suggest that the erosion event took place in an annular preventer.

Assuming the erosion took place at the lower annular preventer, the right-hand pipe must have moved by approximately 25 ft. This could have happened as the rig drifted off location after power was lost. (Refer to time period [B] in Figure 15.) The metocean records indicate that the current velocity at sea level at the time of the accident could have been above 0.69 ft./sec. The investigation team did not have access to the vessel's hydrodynamic characteristics in order to perform a drift-off analysis of the rig. However, it is likely that a current of this magnitude would have caused the vessel to drift off after the power was lost at approximately 21:49 hours.

For the drill pipe to have moved upward by 25 ft., the next tool joint down the drill string (Tool Joint "B" in Figure 15 with an outside diameter of 7 in.), would have had to pass through the middle and upper VBRs. This could indicate that the ST locks were not operated when the rig crew likely attempted to close the VBRs, and the rams allowed the pipe to move upward through the BOP.

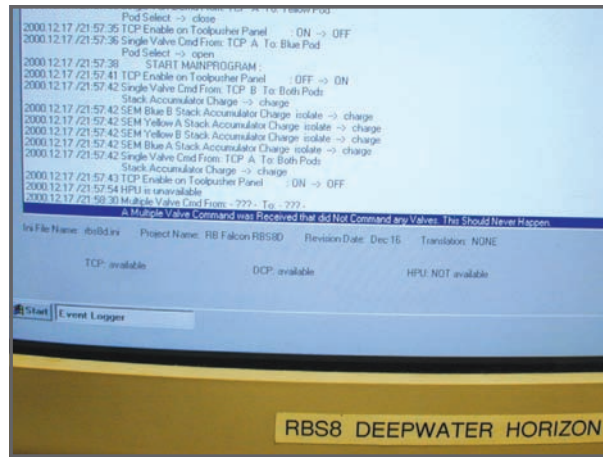
Figure 19. Photographs of *Deepwater Horizon* BOP TCP and Event Logger.

Diagnostics of the BOP control system were available to the rig crew and subsea personnel through an alarm indication system and an event logger. (Refer to Figure 19.) The alarm system was integrated into the driller's control panel and into the TCP. The event logger was located in the subsea workshop, and it may never be recovered.

The control system was capable of identifying the coil defects in solenoid valves 103 and 3A in the yellow pod and logging them in the event logger. A failure mode effects and criticality analysis (FMECA) performed as part of a BOP assurance analysis of *Deepwater Horizon* BOP stack identified this failure mode. As stated in the FMECA report, when this failure is detected, the mitigation is "Switch to alternate pod, secure well and pull LMRP."

The charge level of the batteries for the AMF sequence could not have been monitored on the surface while the BOP was deployed subsea. If the battery voltage was not checked on the surface prior to the BOP deployment, there would have been no means of determining the charge on the batteries once the BOP was deployed.

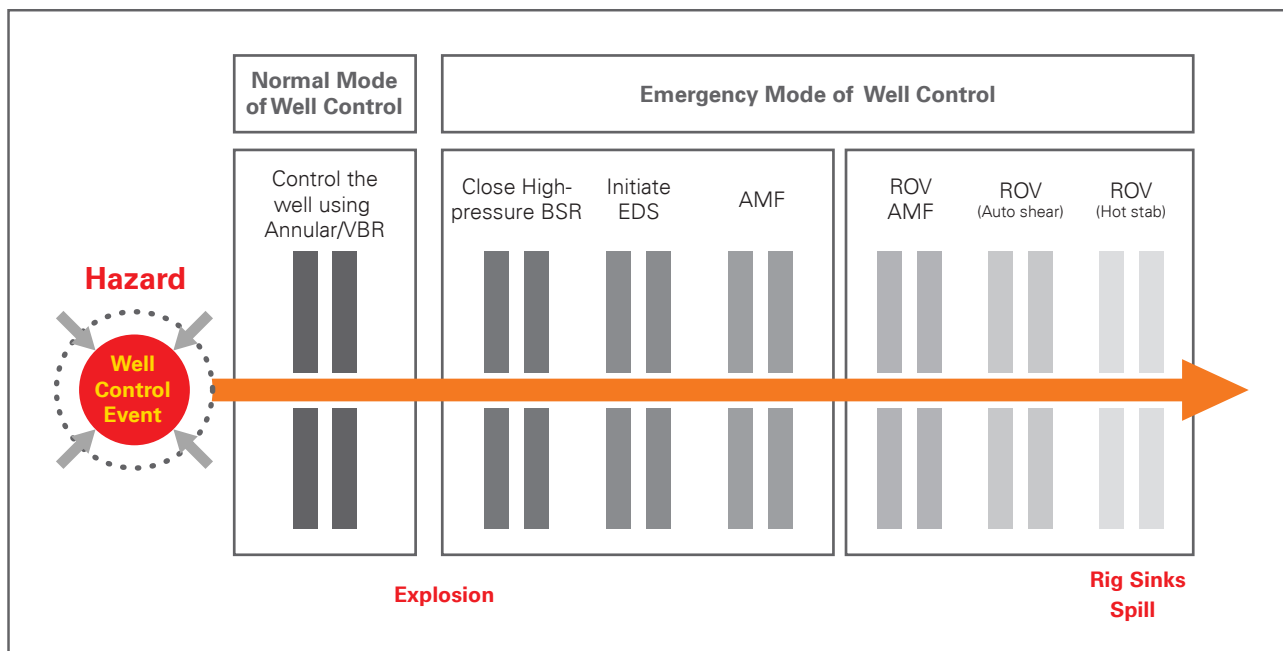
Figure 20. BOP Well Control Modes of Operation.

There were six possible methods of closing the BSR in emergency mode that pertain to this accident (refer to Figure 20):

- **EDS function (crew-initiated):** initiated by rig personnel from a control panel on the rig. EDS was primarily designed to mitigate the risk of losing containment as a result of the dynamic positioning system not being able to keep the rig on station. This function also requires at least one operational control pod and associated MUX cable. The sequence activates the high-pressure BSR. All three sets of accumulators provided hydraulic power for this activation of the high-pressure BSR. Witness accounts indicated that the subsea supervisor initiated this function from the TCP, but it would have been unsuccessful because the MUX cables had already been rendered inoperable due to the explosions and fire.

- **AMF:** an automatic means of closing the high-pressure BSR when electrical power, electronic communication and hydraulic pressure are all lost. AMF is designed to mitigate the risk caused as a result of catastrophic failure of the riser with the resultant reduction of hydrostatic head of mud in the riser to seawater hydrostatic head. This function had to be manually armed by rig personnel from the BOP control panel and required at least one operational control pod. The accumulators on the BOP stack were the only source of hydraulic power for this function. The investigation team concluded that the AMF very likely did not function due to the condition of critical components in the control pods.

- **ROV-initiated AMF:** a simulation of AMF conditions to close the high-pressure BSR by using an ROV to cut power/communication and hydraulic lines at the LMRP. This was attempted hours before the rig sank, but the investigation team concluded that the AMF very likely did not function due to the condition of critical components in the control pods.

- **ROV-initiated autoshear:** a simulation of the autoshear condition to close the high-pressure BSR by using an ROV to cut through the autoshear activation rod. Autoshear is designed to mitigate the risk of loss of containment as a result of an inadvertent disconnect of the LMRP from the BOP stack. The accumulators on the BOP stack were the only source of hydraulic power for this function. This ROV-initiated autoshear was attempted hours before the rig sank, and the investigation team concluded that the autoshear appeared to close the high-pressure BSR, but failed to seal the wellbore.

- **ROV-initiated BSR:** closure of the BSR by ROV hot stab using an ROV seawater pump or utilizing a separate hydraulic power supply provided by a bank of accumulators on the sea bed. This function required sufficient hydraulic power available from the ROV pump or bank of accumulators. Various attempts were made to close the BSR by ROV hot stab intervention prior to and after the rig sank, but all failed to seal the wellbore.

The rig crew attempted the normal mode of BOP system operation (using an annular preventer and possibly a VBR) prior to the accident. The emergency mode of well control shown in *Figure 20* relates to the period after the accident, but only the ROV hot stab intervention continued after the rig sank.

The effectiveness of the emergency system methods of operation available to rig personnel to isolate the wellbore was lost due to damage resulting from the explosions.

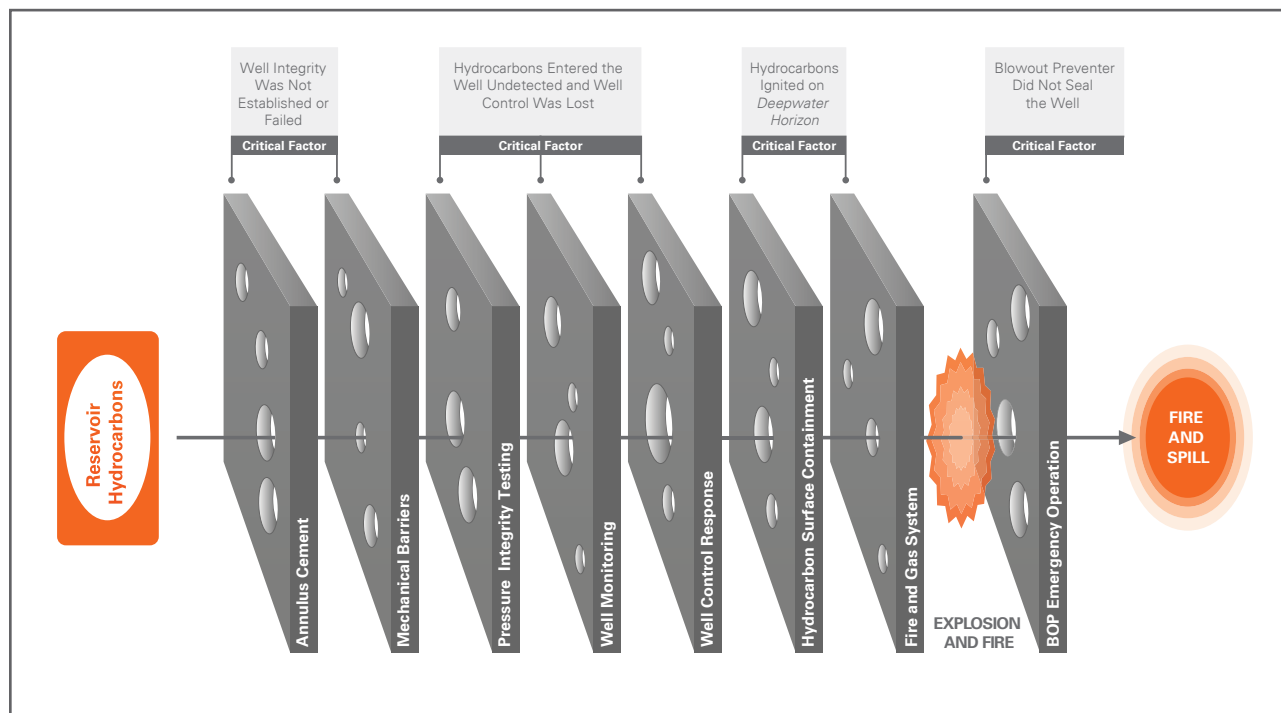
Figure 1. Barriers Breached and the Relationships of Barriers to the Critical Factors.

The purpose of these recommendations is to enable prevention of similar accidents occurring in the future by strengthening the defensive physical or operational barriers needed to eliminate or mitigate hazards. (Refer to Figure 1.) The recommendations are intended to provide a basis for the consideration of actions that can be implemented by both BP and by the contractor community that provides critical services and products to BP's exploration and production operations.
