Safety Alert

ALERT 01-11

NEAR MISS STICKING BOP CONTROL VALVE

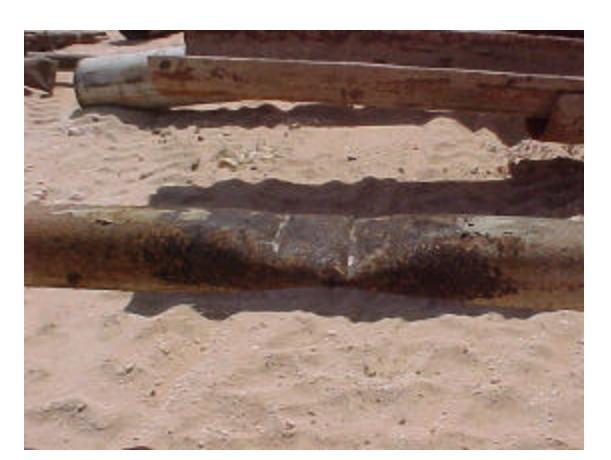
While function testing the BOP's from the Toolpusher's remote panel it was noticed that the shear rams had closed without manually activating the BOP control valve lever. One joint of 5" drill pipe was squashed but not sheared. Fortunately the pipe did not shear and drop the string down hole. The red "closed" light had been noticed by a crewman and the position of the rams investigated prior to picking up the test string. However, recently another string was accidentally damaged and parted causing the rest of the string to be dropped when the string was picked up with the shear rams closed.

Upon investigation it was found that the shear ram lever on the remote panel was stuck slightly in the closed position after the last operation. While activating the master air valve to operate another BOP function air was directed to the closing actuator on the remote unit moving the 4-way valve from the blind/shear rams into the closed position and closing the rams.

- Supervisors and drill crew personnel need to remember that there is a possibility of BOP remote control panel valves sticking in an open or closed position during testing.
- Proper maintenance on these valves must be carried out on a regular basis, especially as they are not regularly used.
- Also ensure that valve handle locks are employed after operating the shear rams as this will ensure that the control lever has been returned in the neutral position after operating.
